Assessment of Roof Conditions

Town of Lancaster

Thayer Memorial Library and the Town Community Center

August 6, 2015

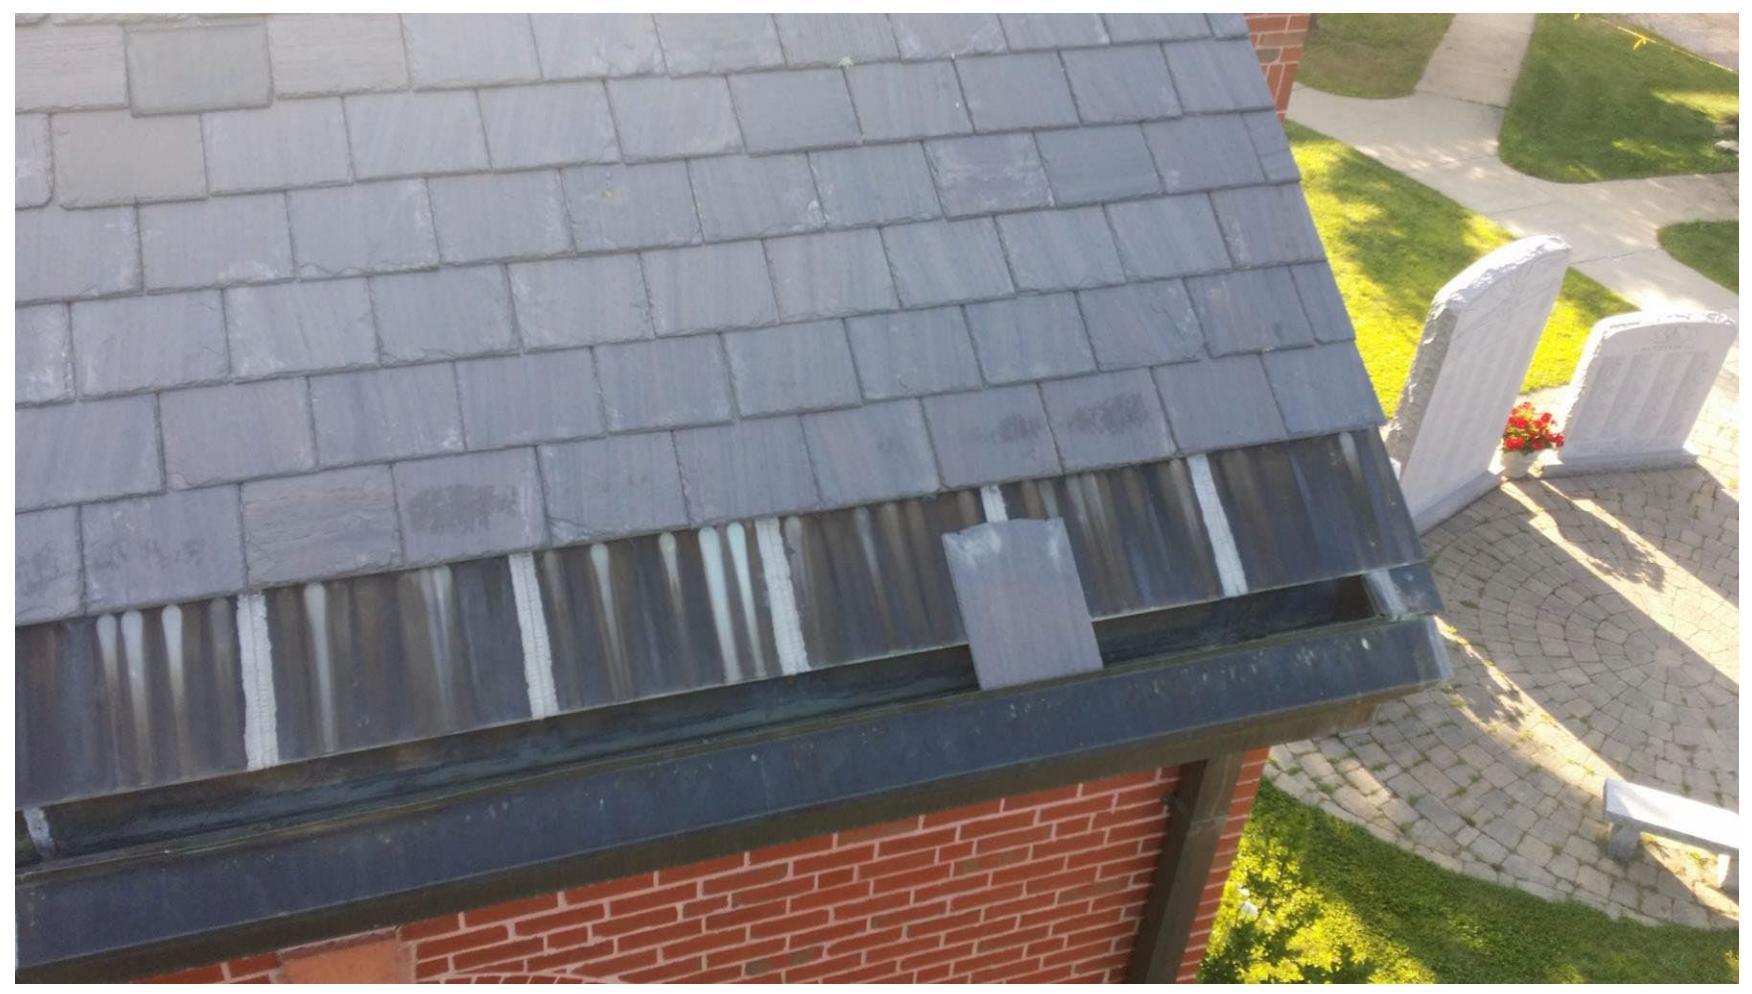
Image 1. Very little breakage was found on the slated portions of the library roof. The vast majority were on the newer sections that are covered in Vermont black slate. Slate repairs should be made with matching slate using either the "hook" or "nail-and-bib" methods only.

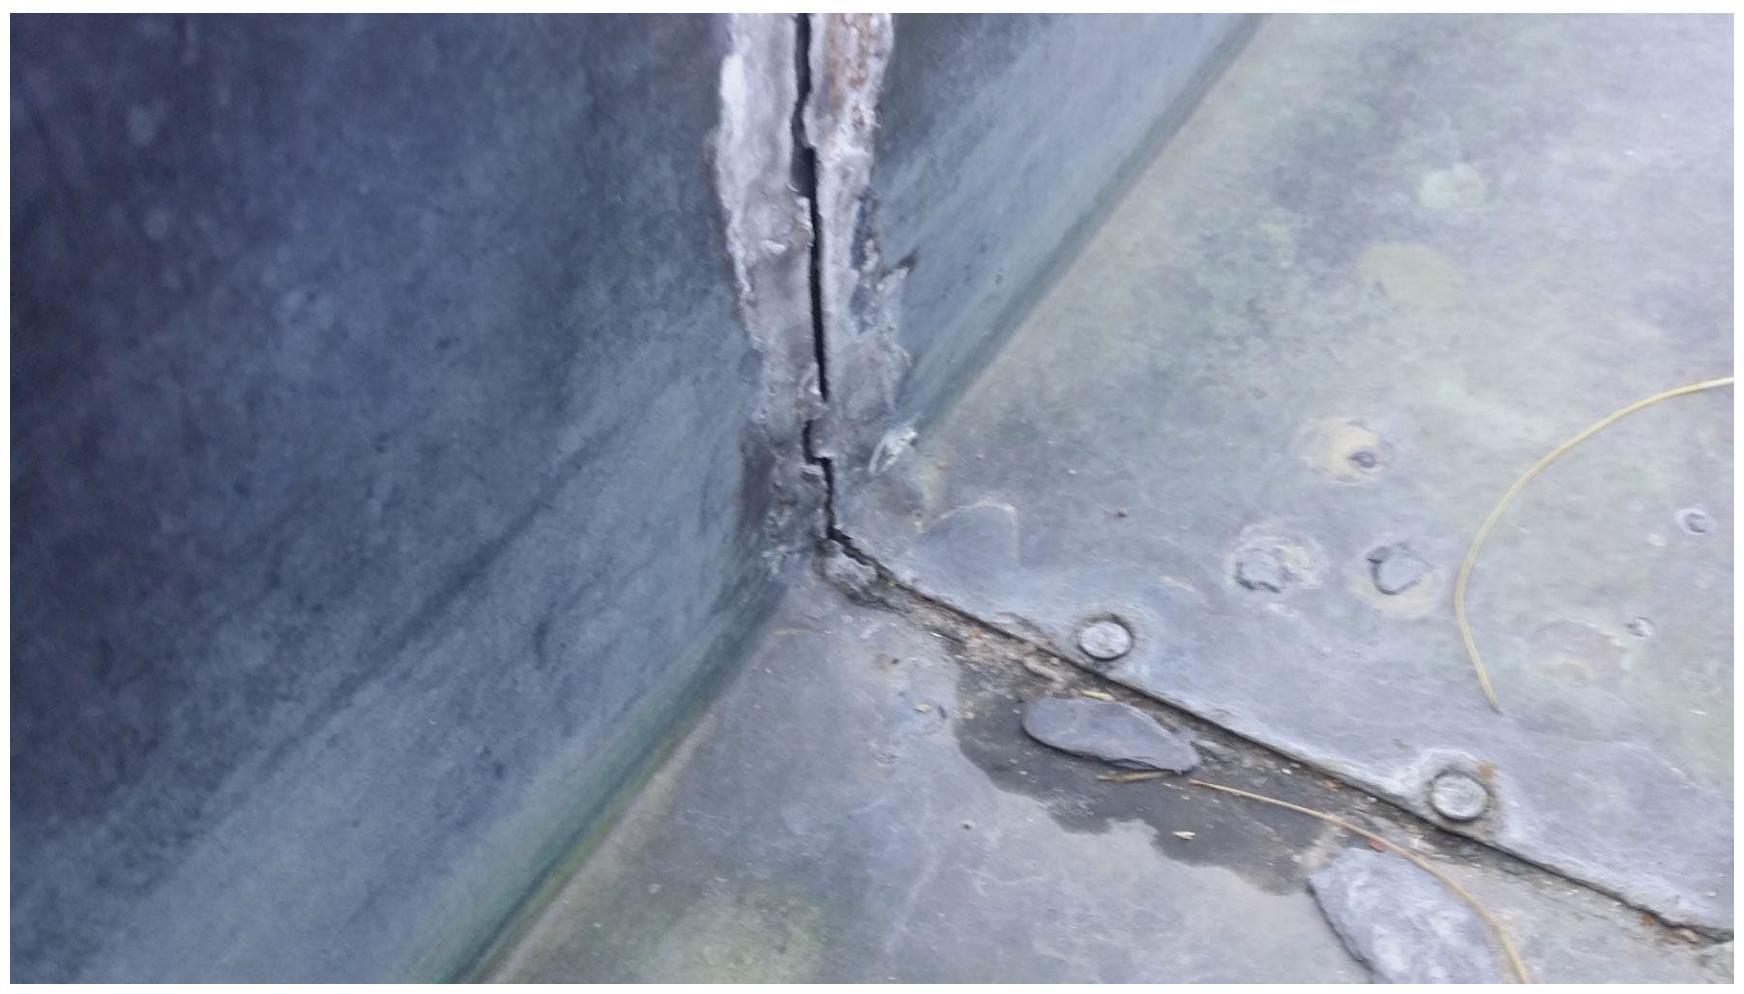
The *gutters on both sides of the new wing* are failing and in poor condition. Hairline cracks have appeared on all solder joints. In some instances, no solder is visible at all. All failing mortar joints should be resoldered with a 50/50 tin/lead mix.

Image 2. Solder joints have cracked and failed leaving the building envelope, below, susceptible to water intrusion. This issue is found consistently throughout both gutter troughs on either side of the 1999 wing.

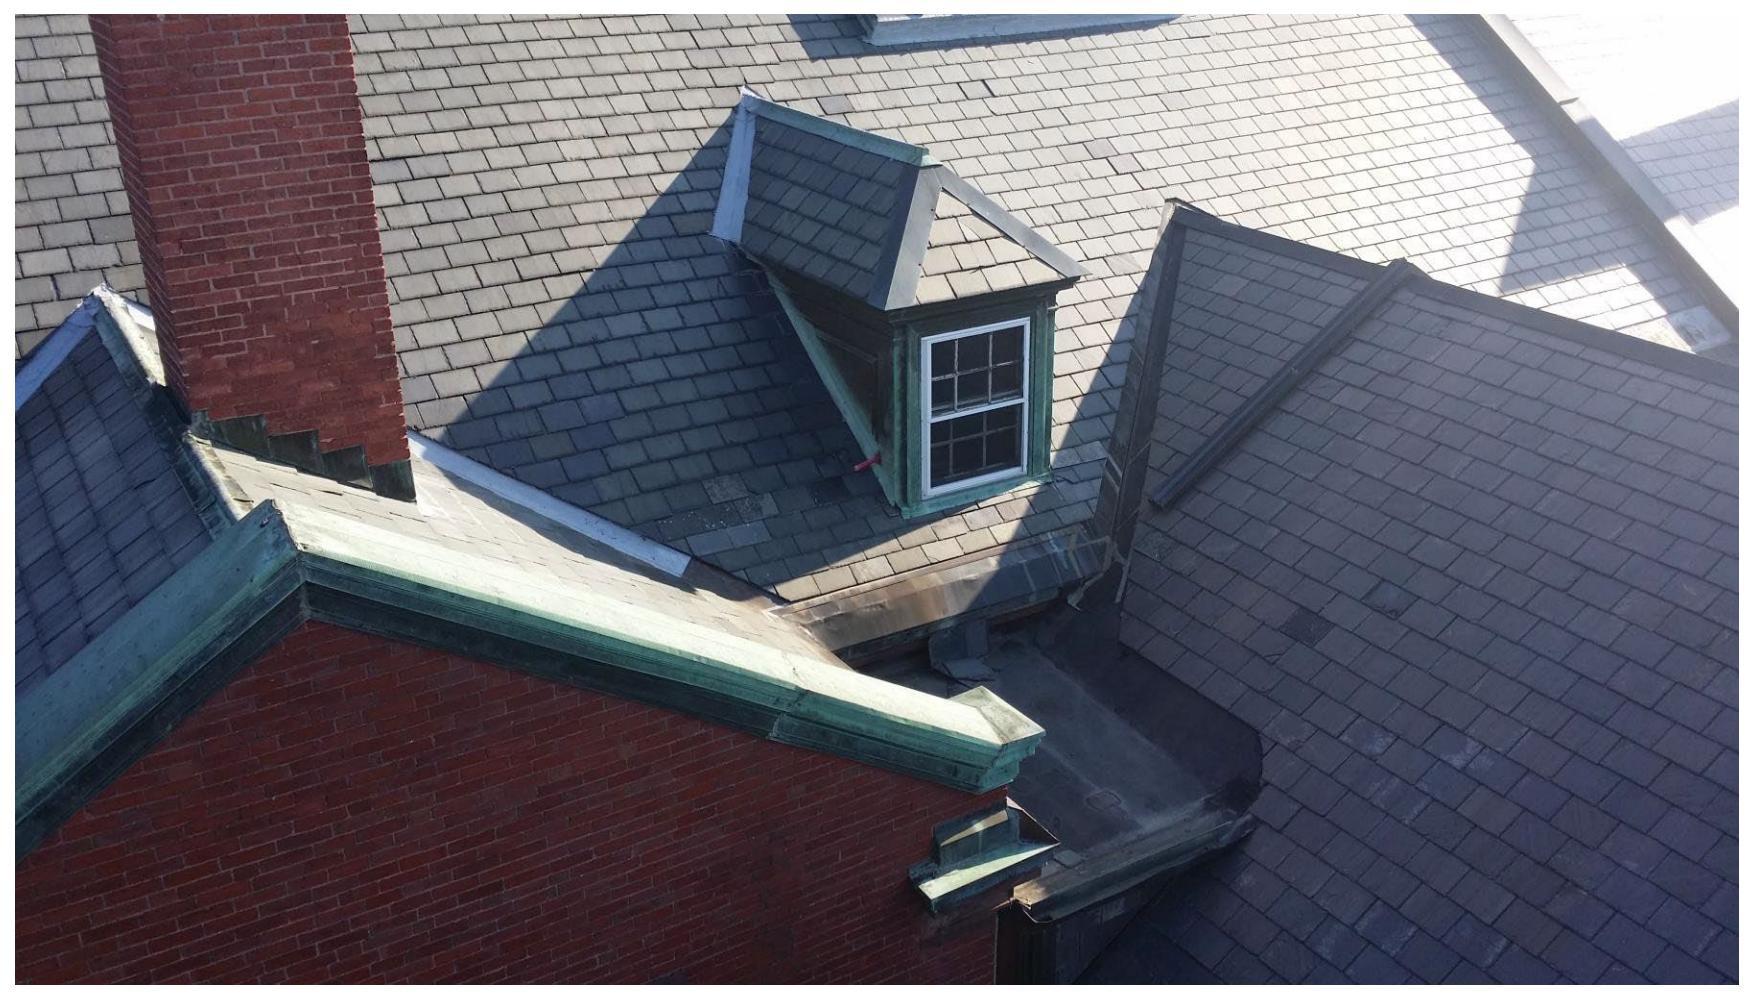
Image 3. A small, rubber-covered roof was added when new wing was joined to the main block of the library. The copper-clad dormer is an important character-defining feature of the building that should be preserved. At left, one of the two chimneys that should be reflashed.

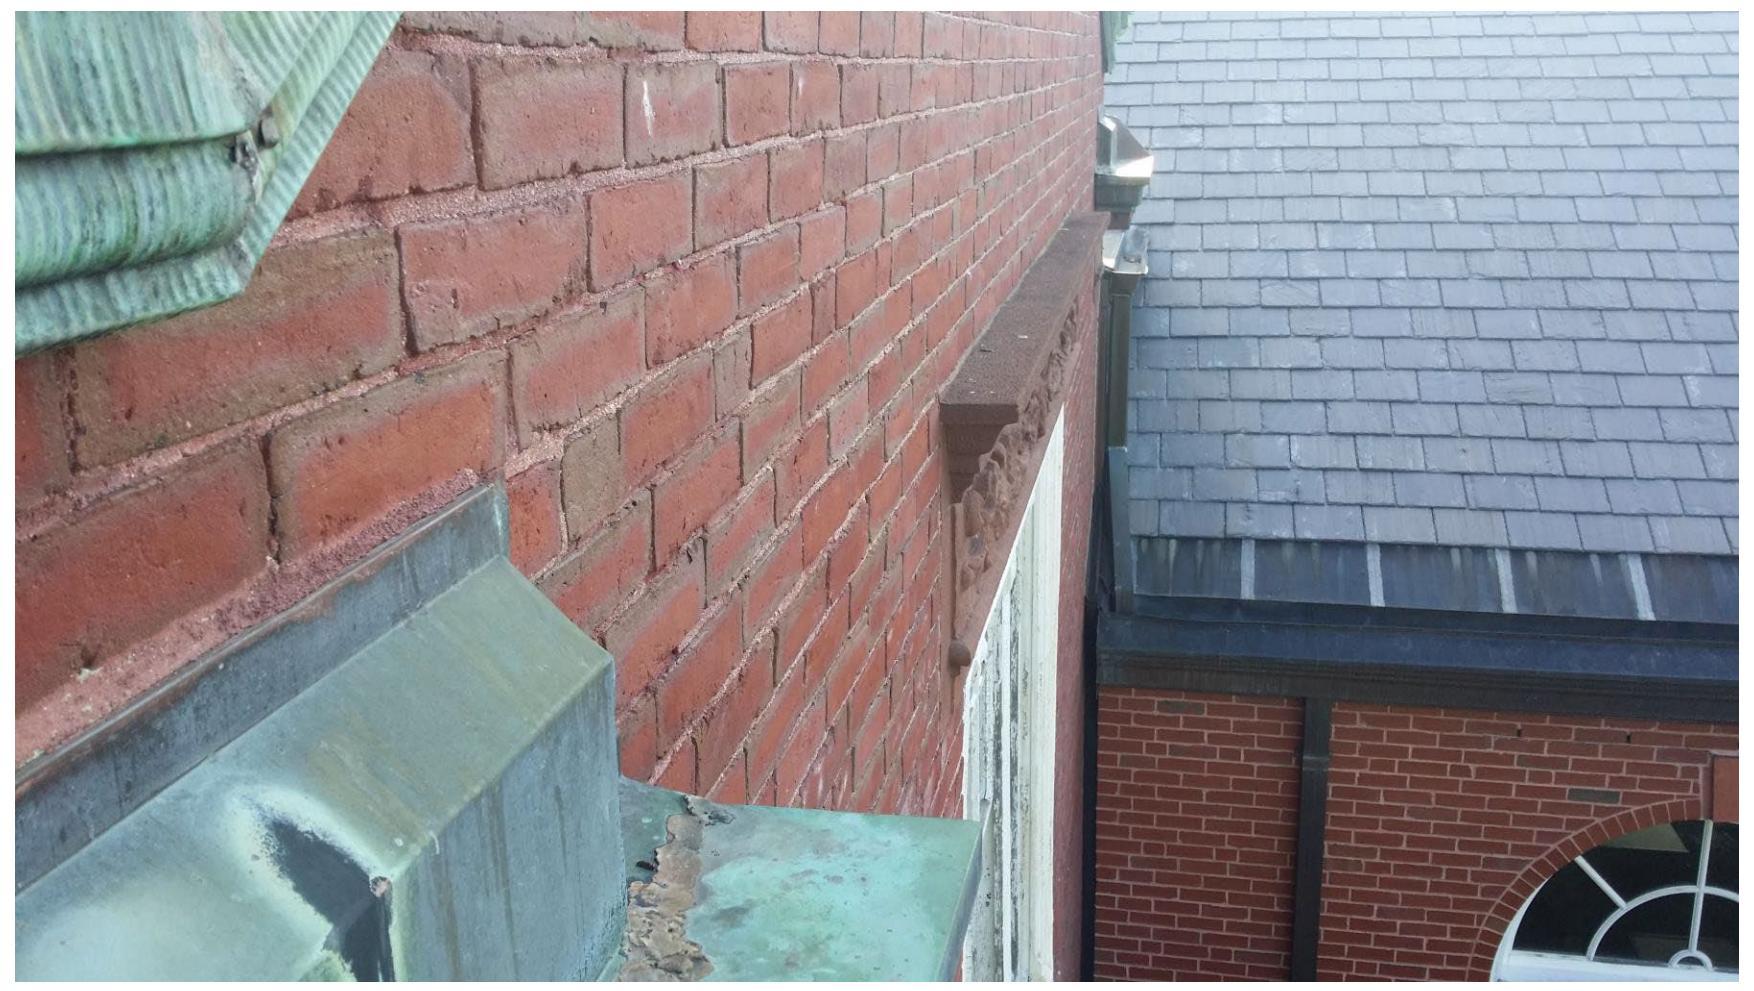
Image 4. Detail view of a brownstone lintel that has held up well over after almost 150 years of service. In the foreground, a cornice return that has been leaking water down the side of the building causing the erosion of brick masonry mortar joint.

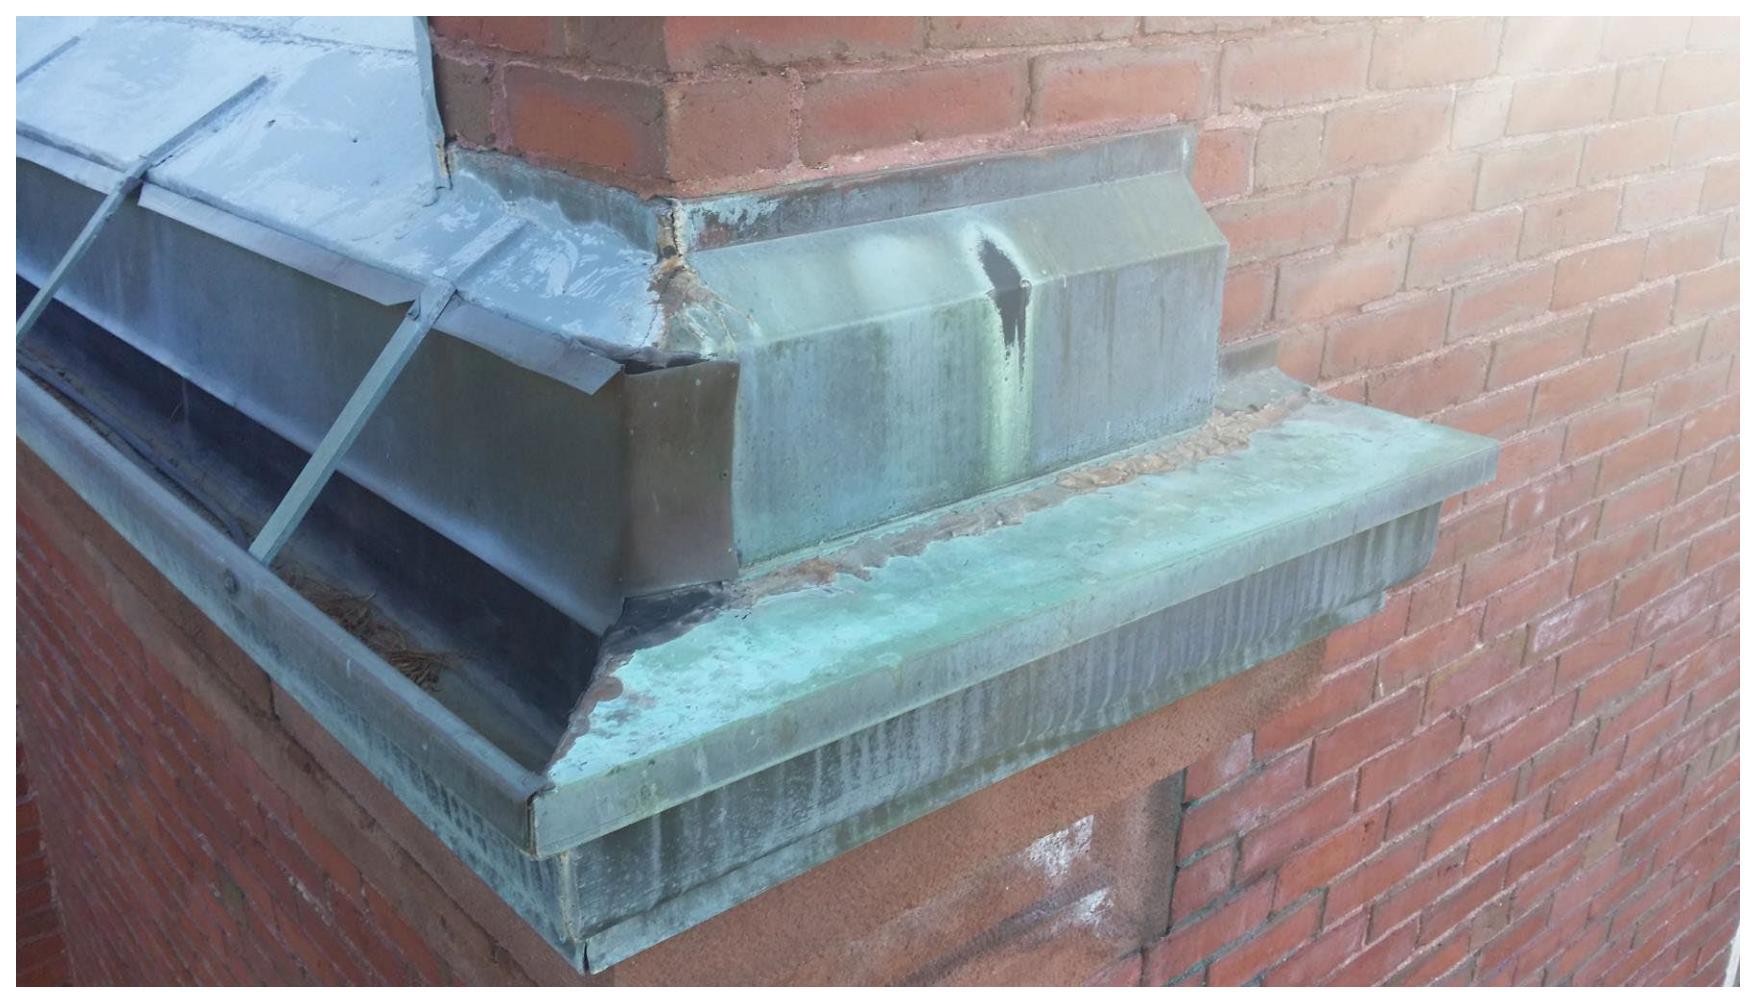
Image 5. Detail view of the problematic cornice return. Note the efflorescence on the masonry below. Efflorescence is the appearance of white, cloudy stains caused by the saturation of masonry and resulting release of soluble salts. Once the cause of the moisture intrusion is corrected the masonry will dry out and the efflorescence will dissipate and vanish over time.

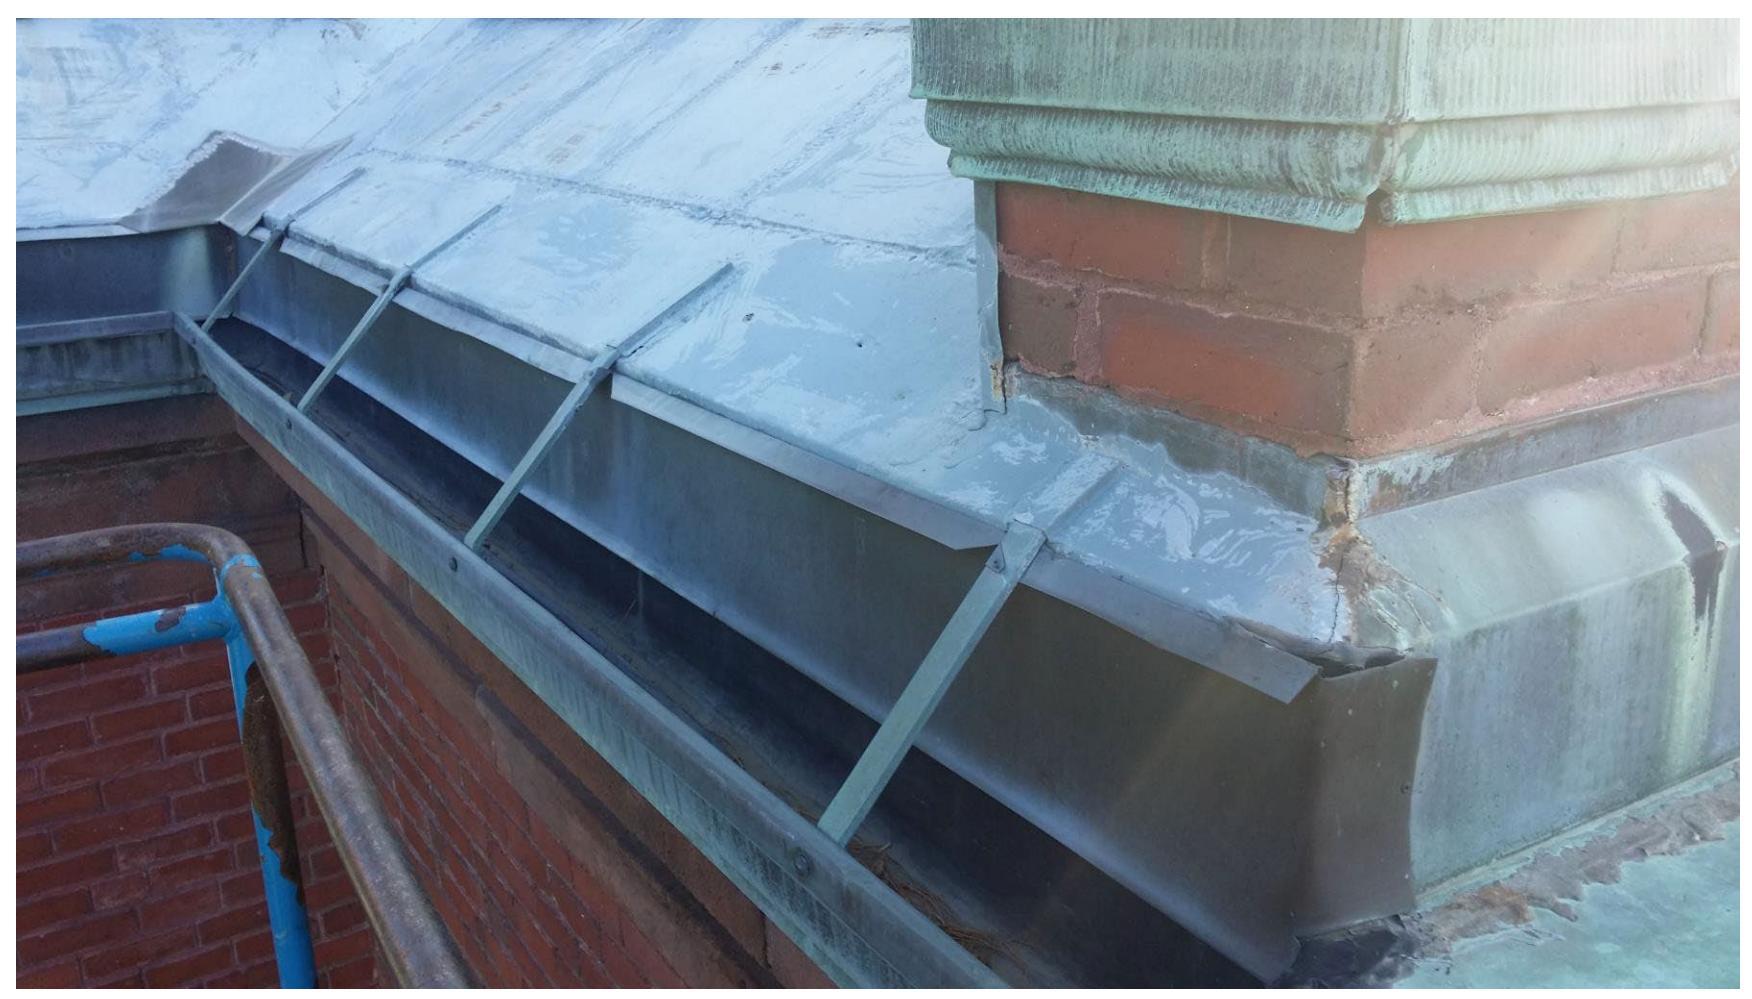
Image 7. Detail view of the gutters on the main block of the library. At some point, an EPDM membrane was added to the gutter troughs. At that time, a copper "counter-flashing" of sorts was added to the curbing to protect the termination of the rubber membrane. This modification should be monitored until such time as the gutters and snow apron are replaced.

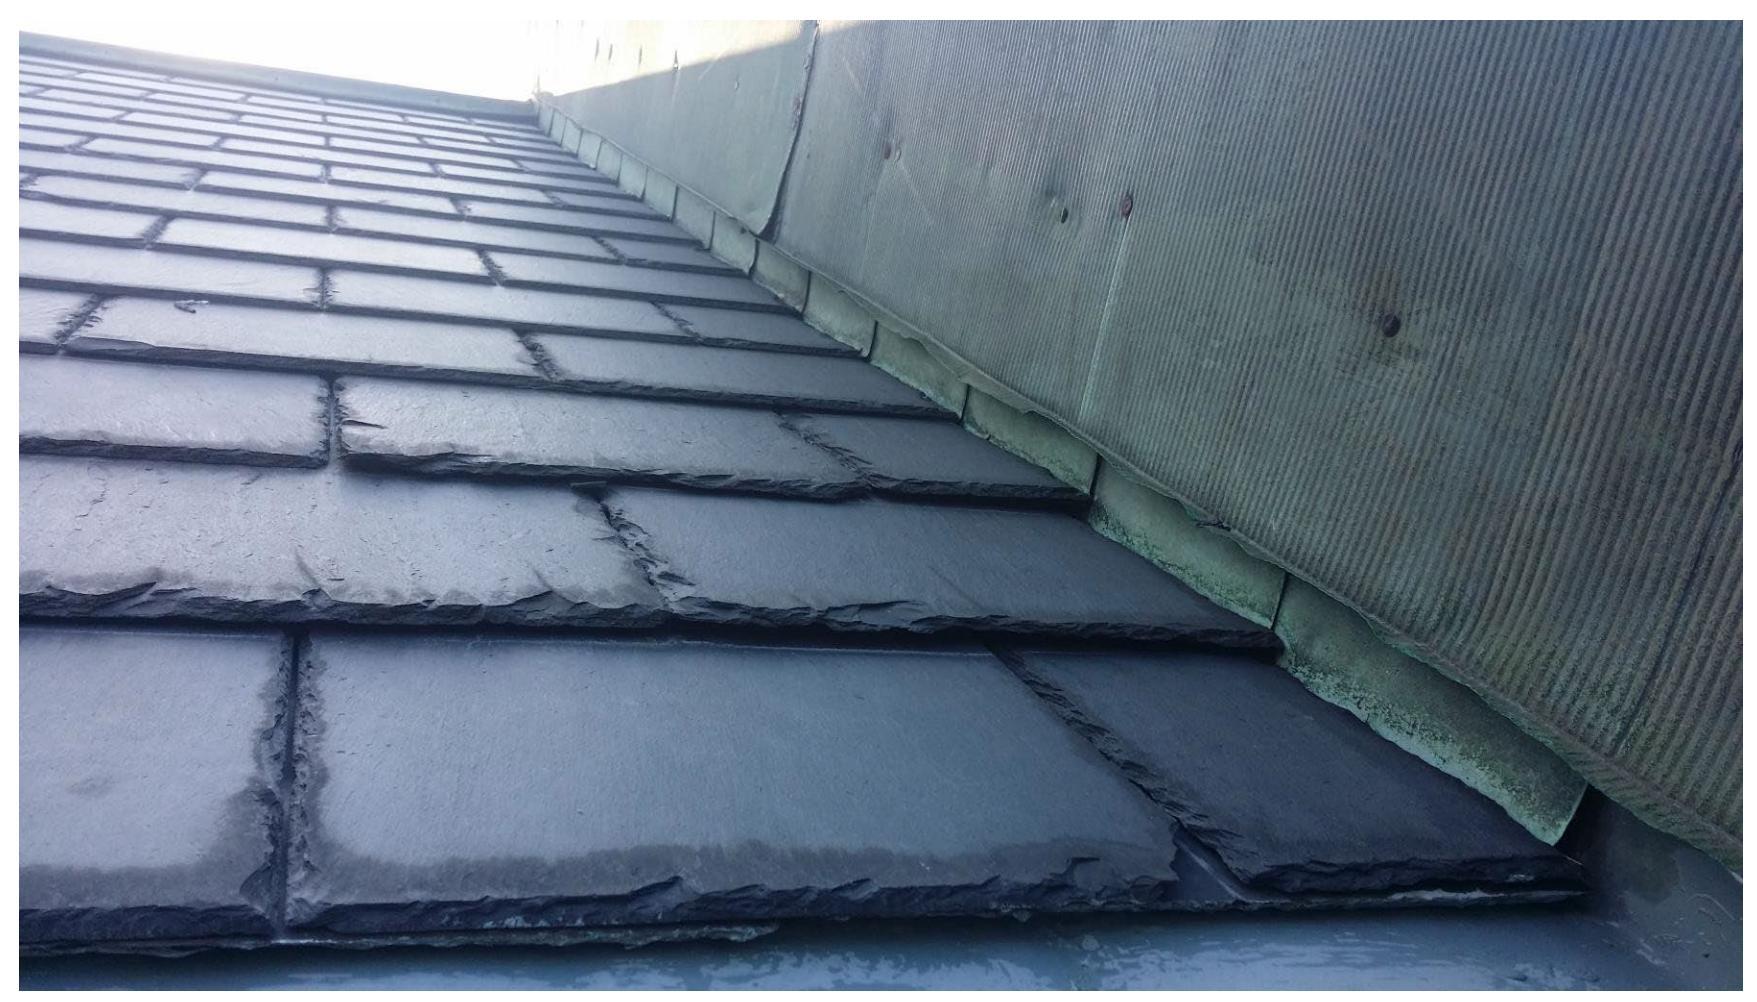
Image 8. Detail view of the Monson slate termination to the sidewall of the rakes of the roof. While approaching the end of their useful service lives, the flashing assemblies on the main block of the library and 1929 children's room should last another four to six years without issue. At that time, a proactive restoration of the existing roofing is recommended.

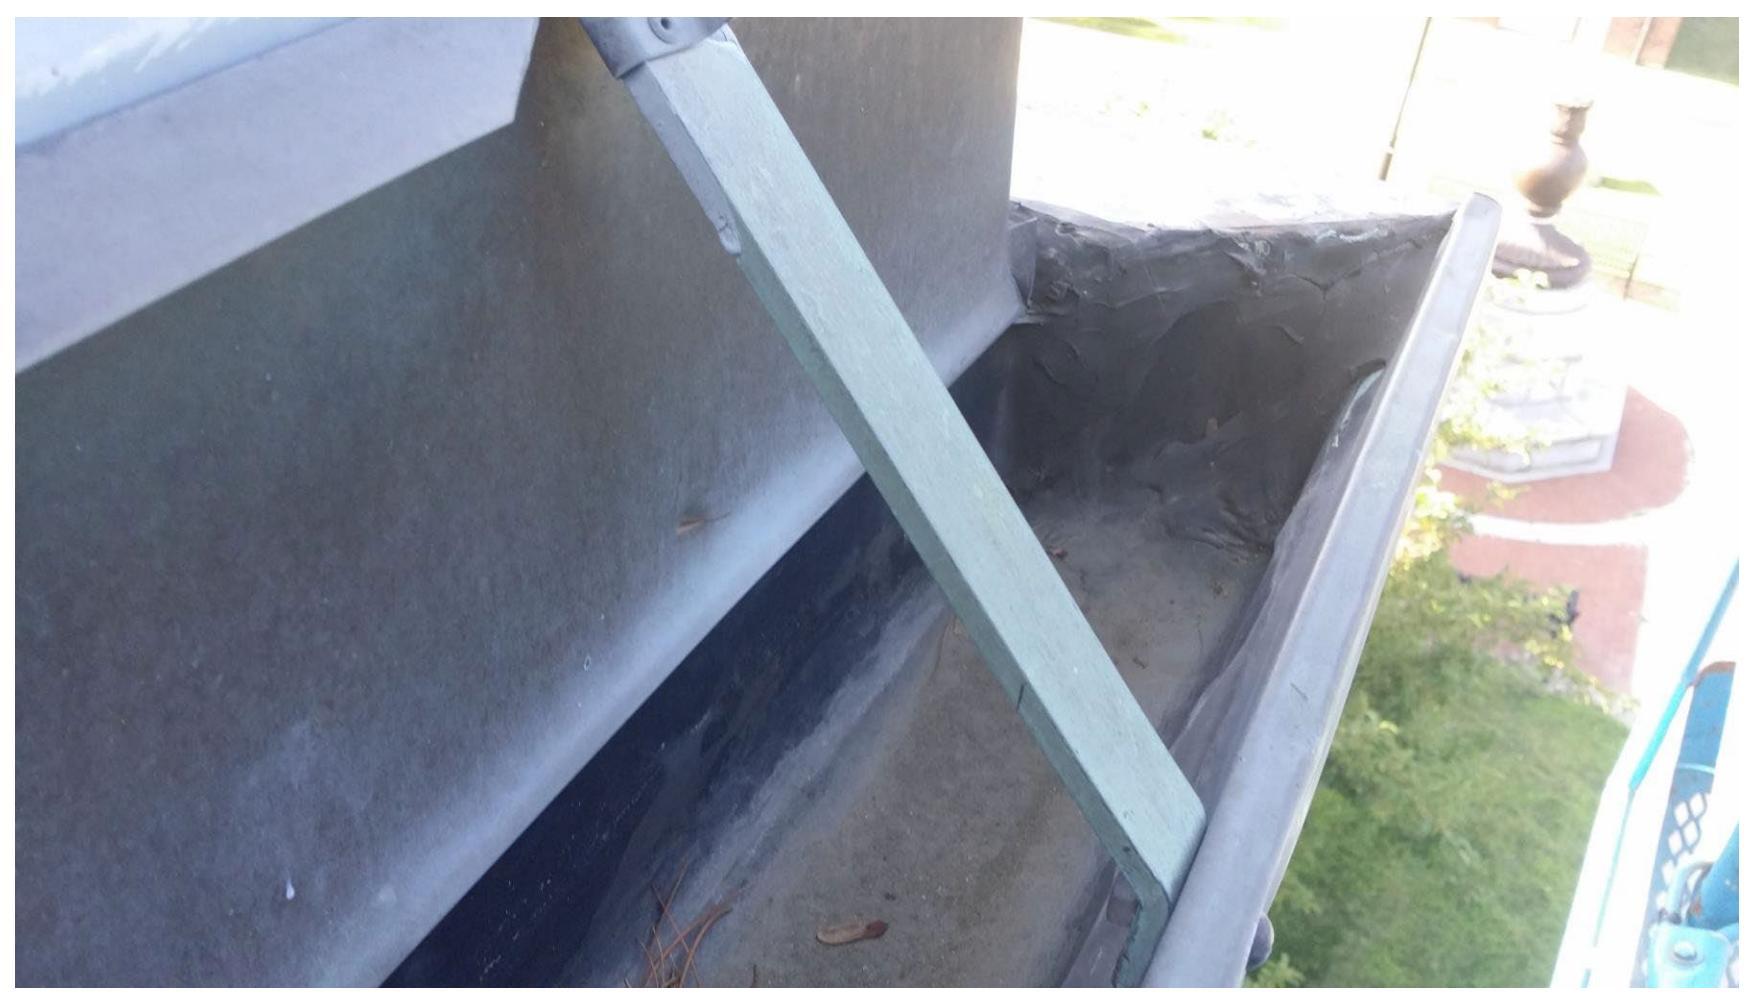
The *gutters on the main block of the library* are lined with a rubber membrane and should be closely monitored. At one location, a failure has allowed water to enter a copper cornice return. This water is draining down the brick masonry wall and causing erosion of the mortar joints. A simple EPDM repair will solve the problem. The outlets in these gutters were clogged with pine needles. Gutters should be inspected and cleaned during the biannual inspection of the roof systems. When the time comes to replace these gutters, it should coincide with replacement of the pans of the snow apron.

Image 10. Termination of the EPDM gutter lining. Failures in this area are allowing precipitation to migrate into the copper cornice and drain down the brick masonry wall of the building. The result is the erosion of mortar joints.

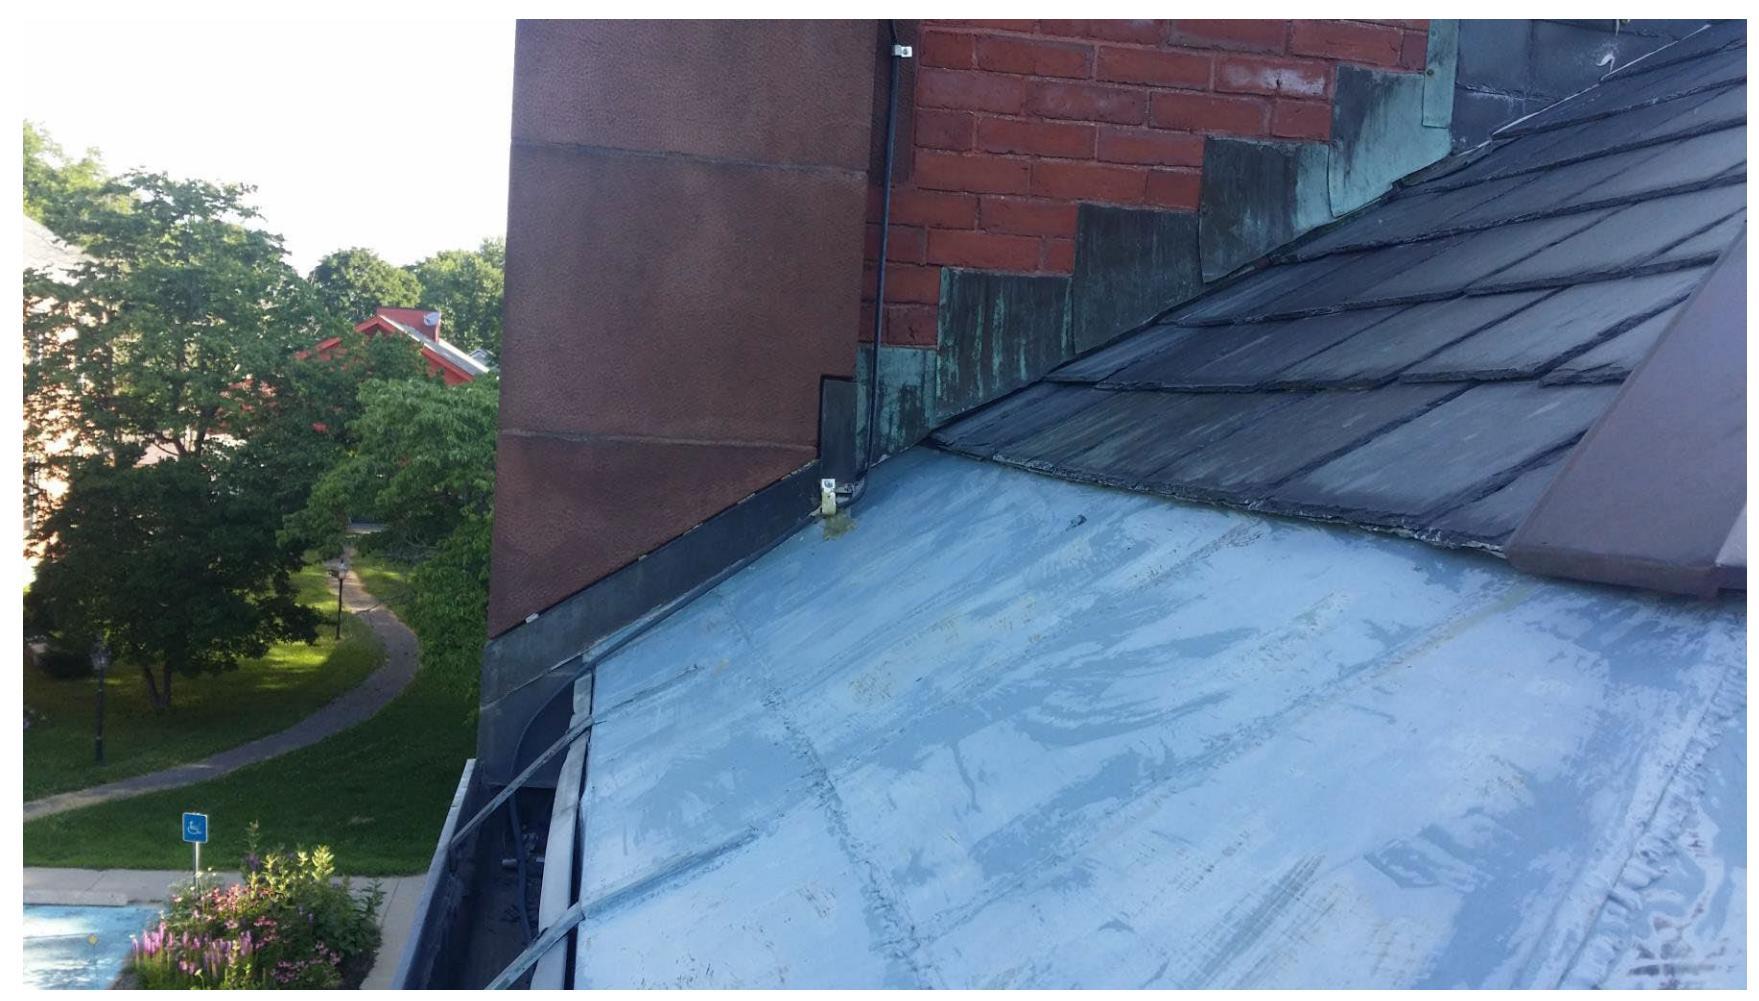
Image 14. The slate tiles, brick masonry, and brownstone of the building are in very good condition. The sheet metal seen here used for gutters, snow pans and counter-flashing is in fair condition at best.

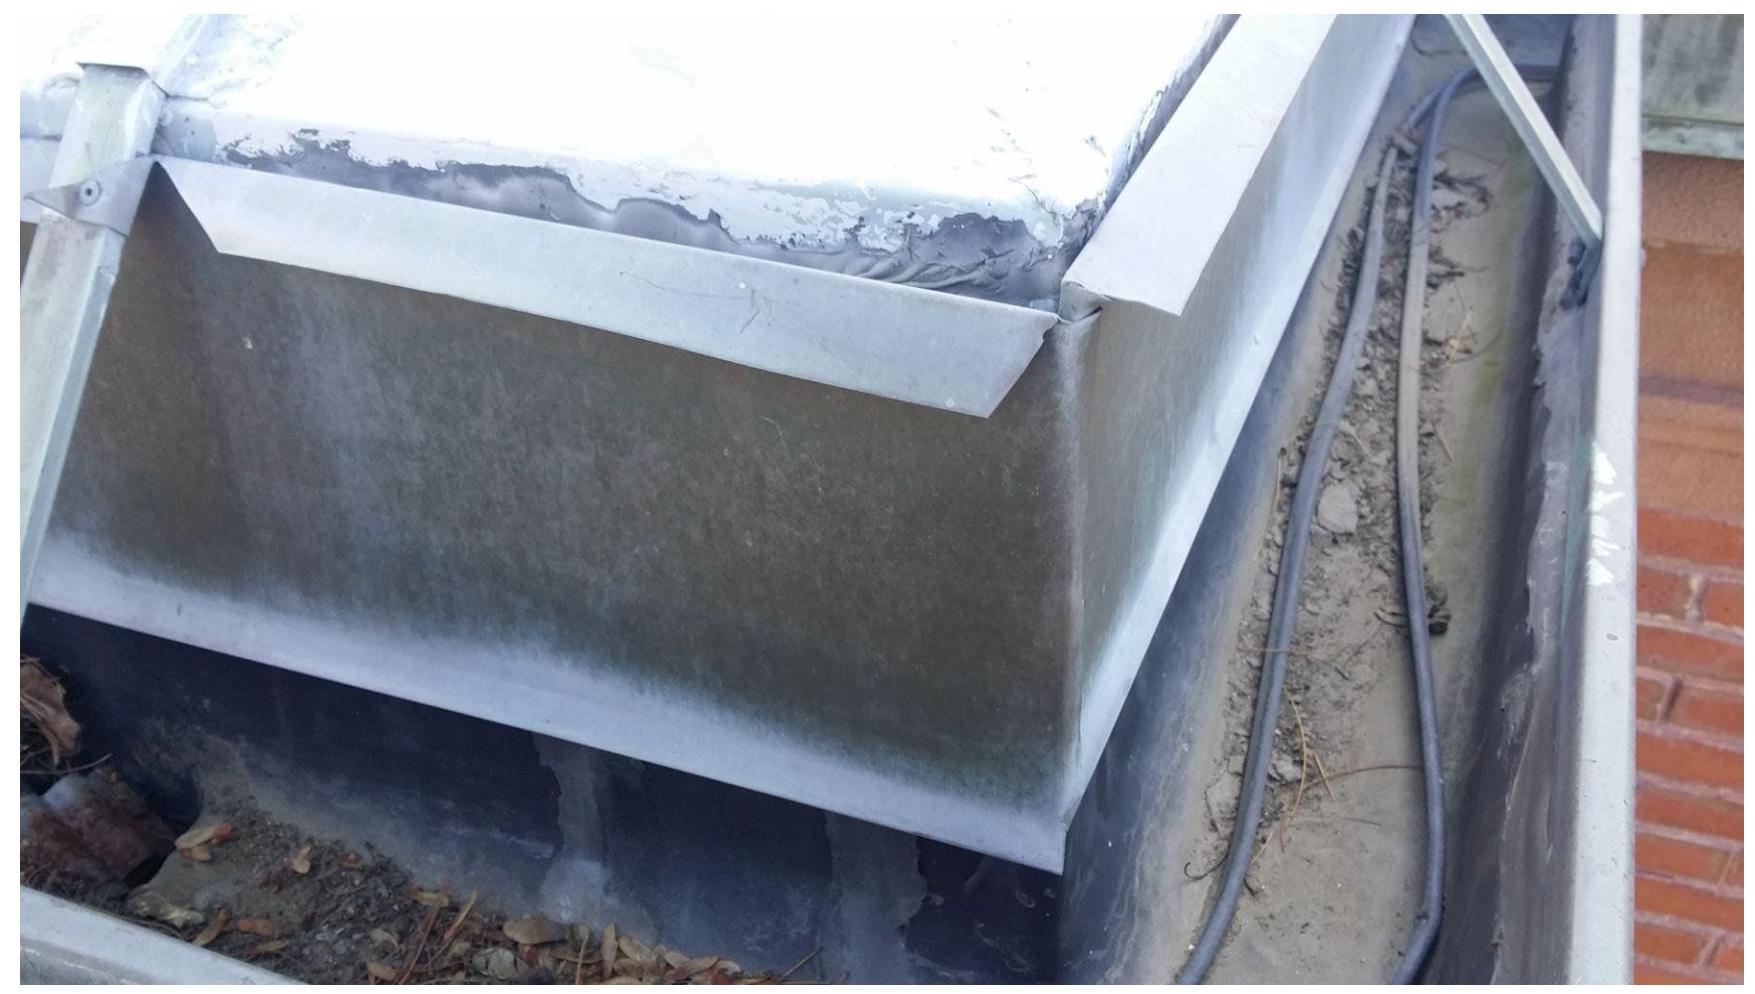
Image 15. Detail view of the gutters. It appears that lap caulk, used to seal joints in EPDM roofing, was applied to the back of the copper "counter-flashing" used to cover the termination of the rubber membrane lining the gutters. The EPDM lining is a stop gap measure that was employed after failures in the gutter troughs or when failures were deemed to be imminent. This system should be closely monitored until such time as the gutters are replaced.

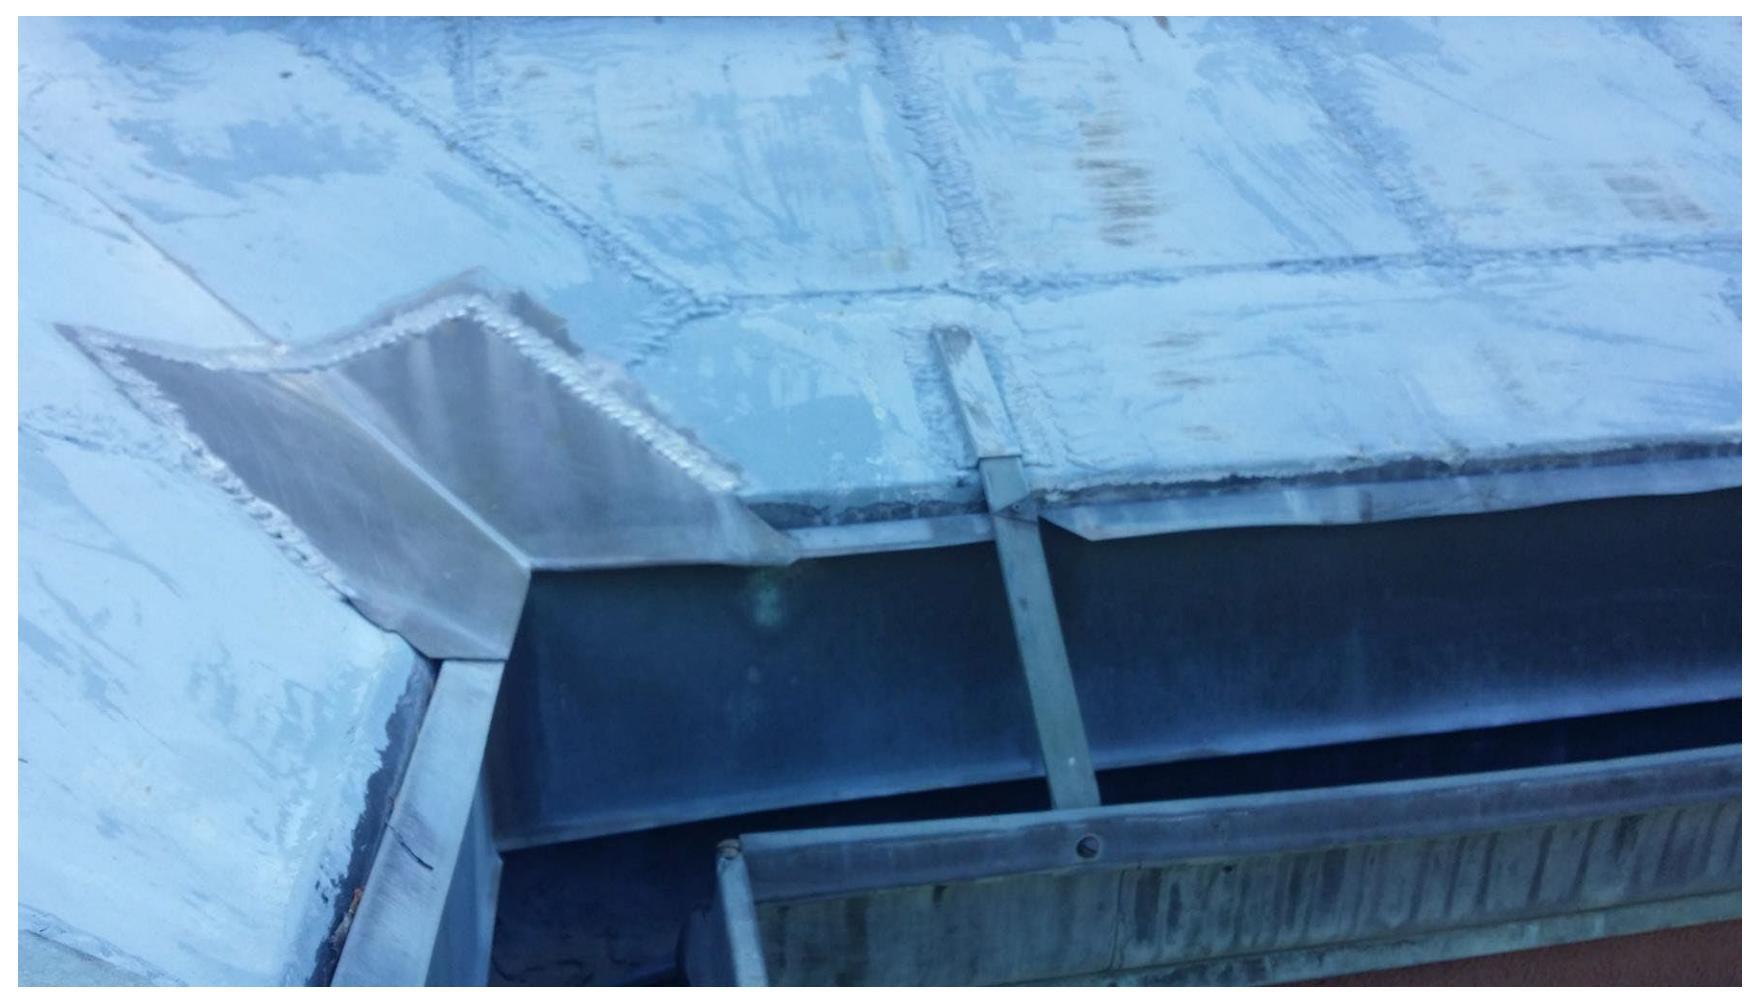
Image 16. Detail view of a sheet metal repair at the valley/snow pan transition. This repair is indicative of the types of failures that can be expected over the next several years. It is strongly recommended that a capital campaign is initiated and/or grants are pursued that will fund a major overhaul of the traditional roof and gutter system.

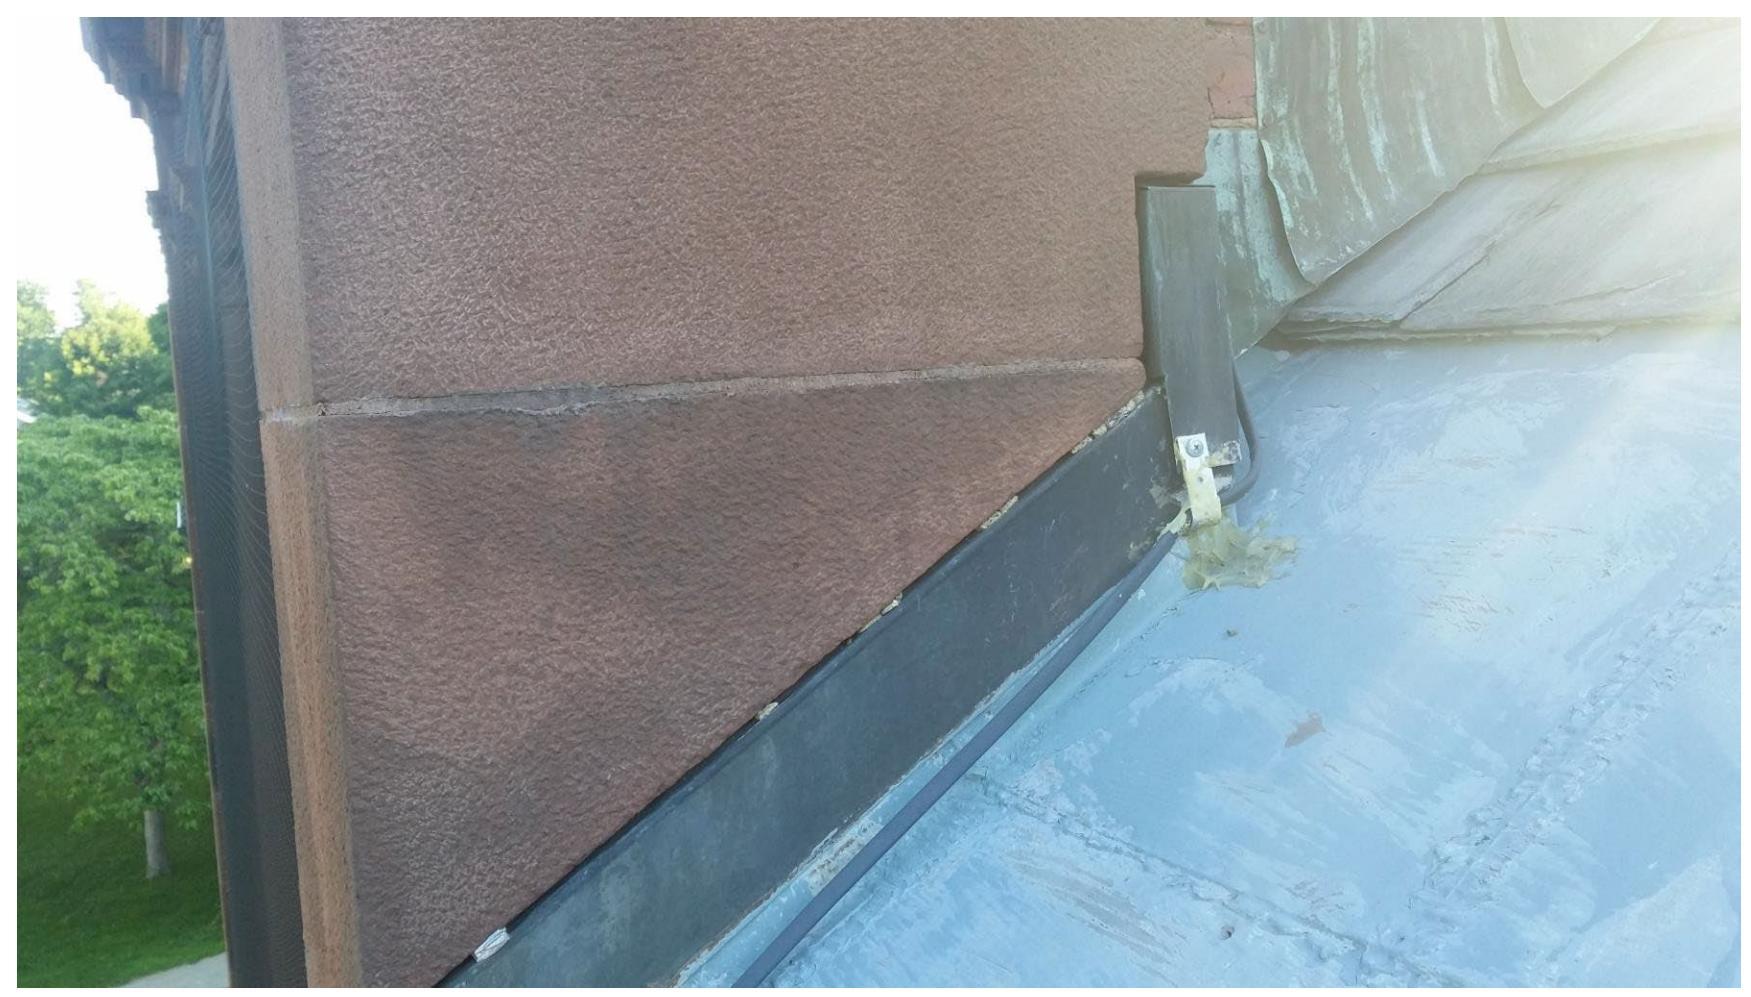
Image 17. The sidewalls of the snow aprons are cut into reglets in the brownstone masonry of the façade. Lead wedges that hold the sheet metal in place. The raggle, or groove, should be pointed in with an appropriate strength mortar or commercial grade mastic sealant.
