Assessment of Roof Conditions

Town of Lancaster

Thayer Memorial Library and the Town Community Center

August 6, 2015

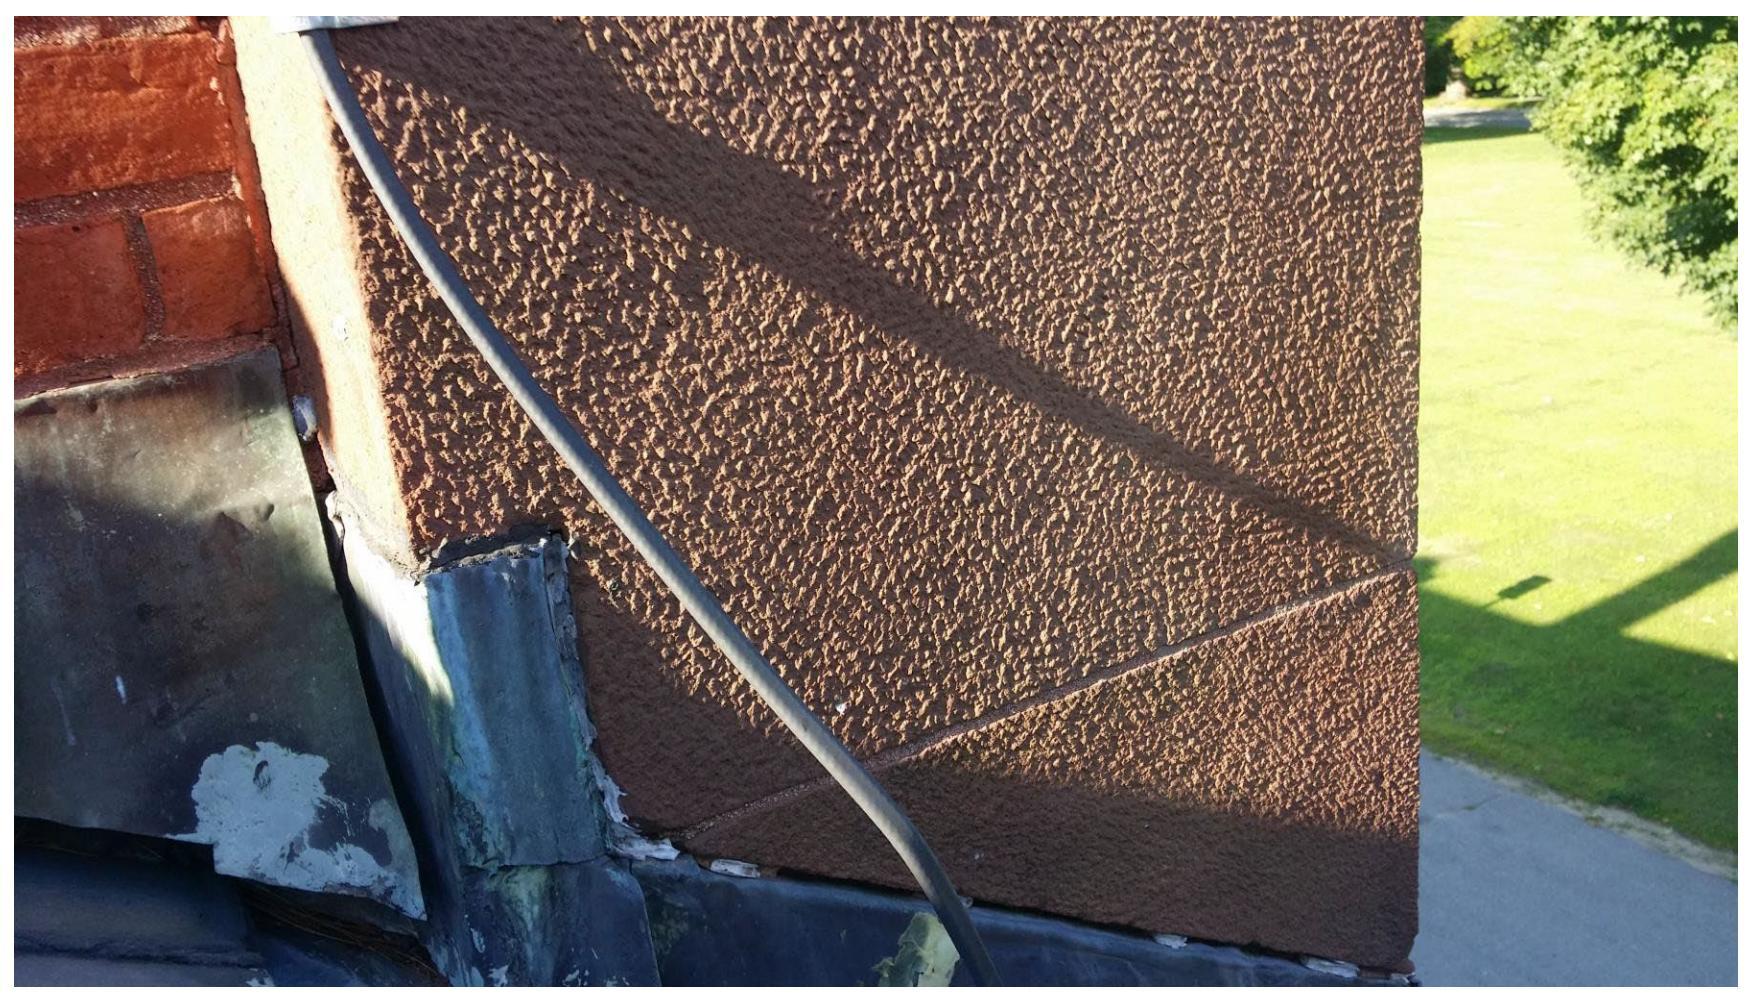
Image 19. Like the brownstone reglet on the other side, the mastic appears to have failed leaving a large void. Left alone and unfilled, this joint could theoretically freeze and expand resulting in the loss of historic fabric.

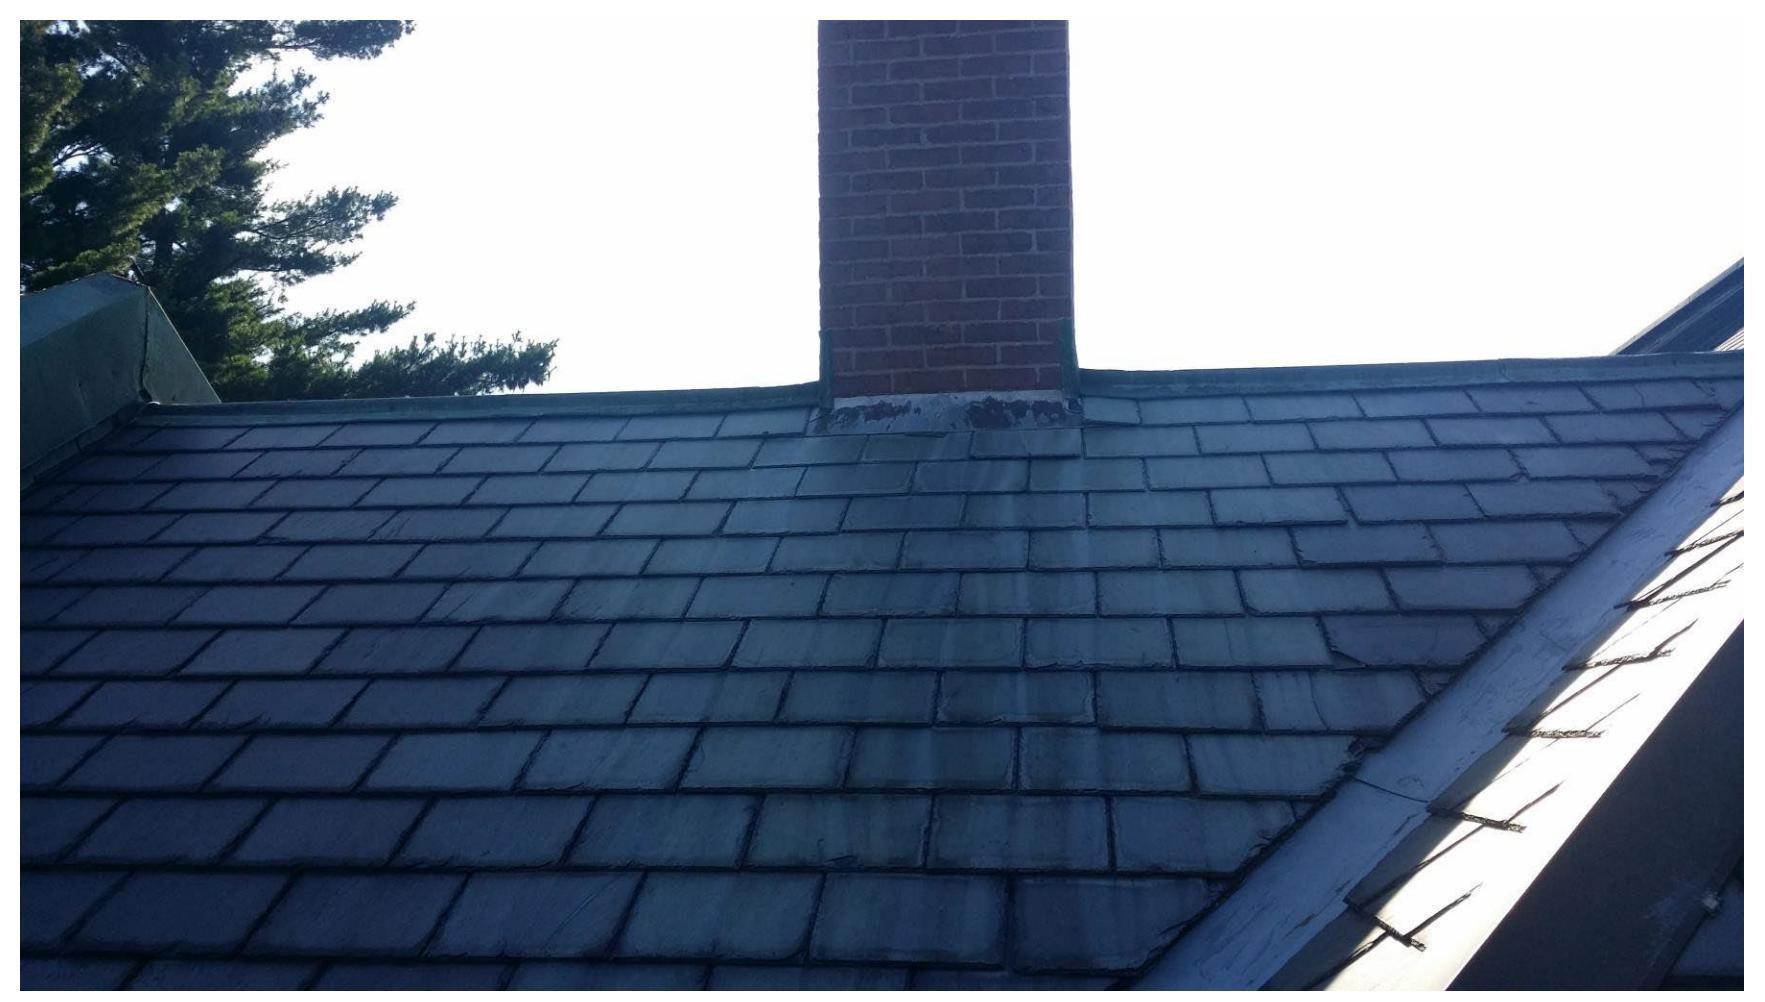
Image 21. The skirt or apron flashing at this chimney protrusion, like the other, should be replaced in kind soon. As copper ages it goes from a shiny "red" color to brown. Over many years it will turn green. As time passes the vert de gris becomes a lighter and lighter shade of green. Finally black patches appear, indicating that the metal is very old. The black patches seen on both chimney flashing assemblies suggest that they predate the 1929 renovations.

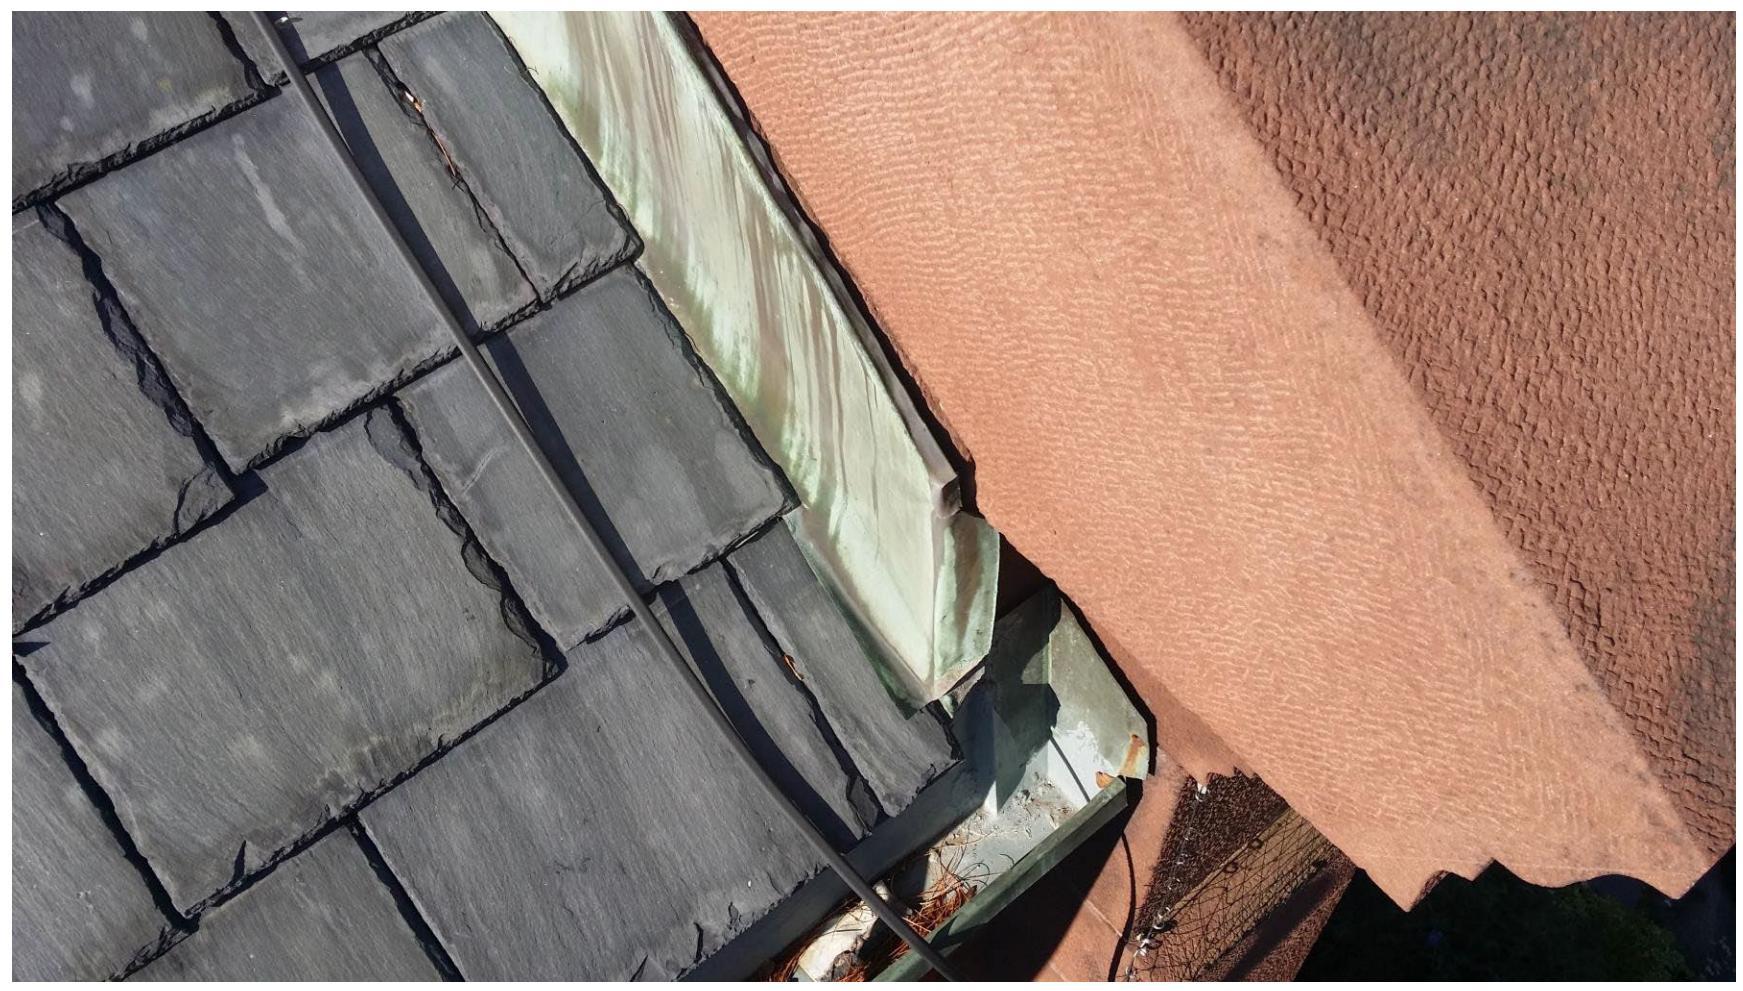
Image 22. The continuous copper counter-flashing behind the primary façade has come free at a few limited locations. The sheet metal should be tucked back in and the entire raggle either repointed or recaulked.

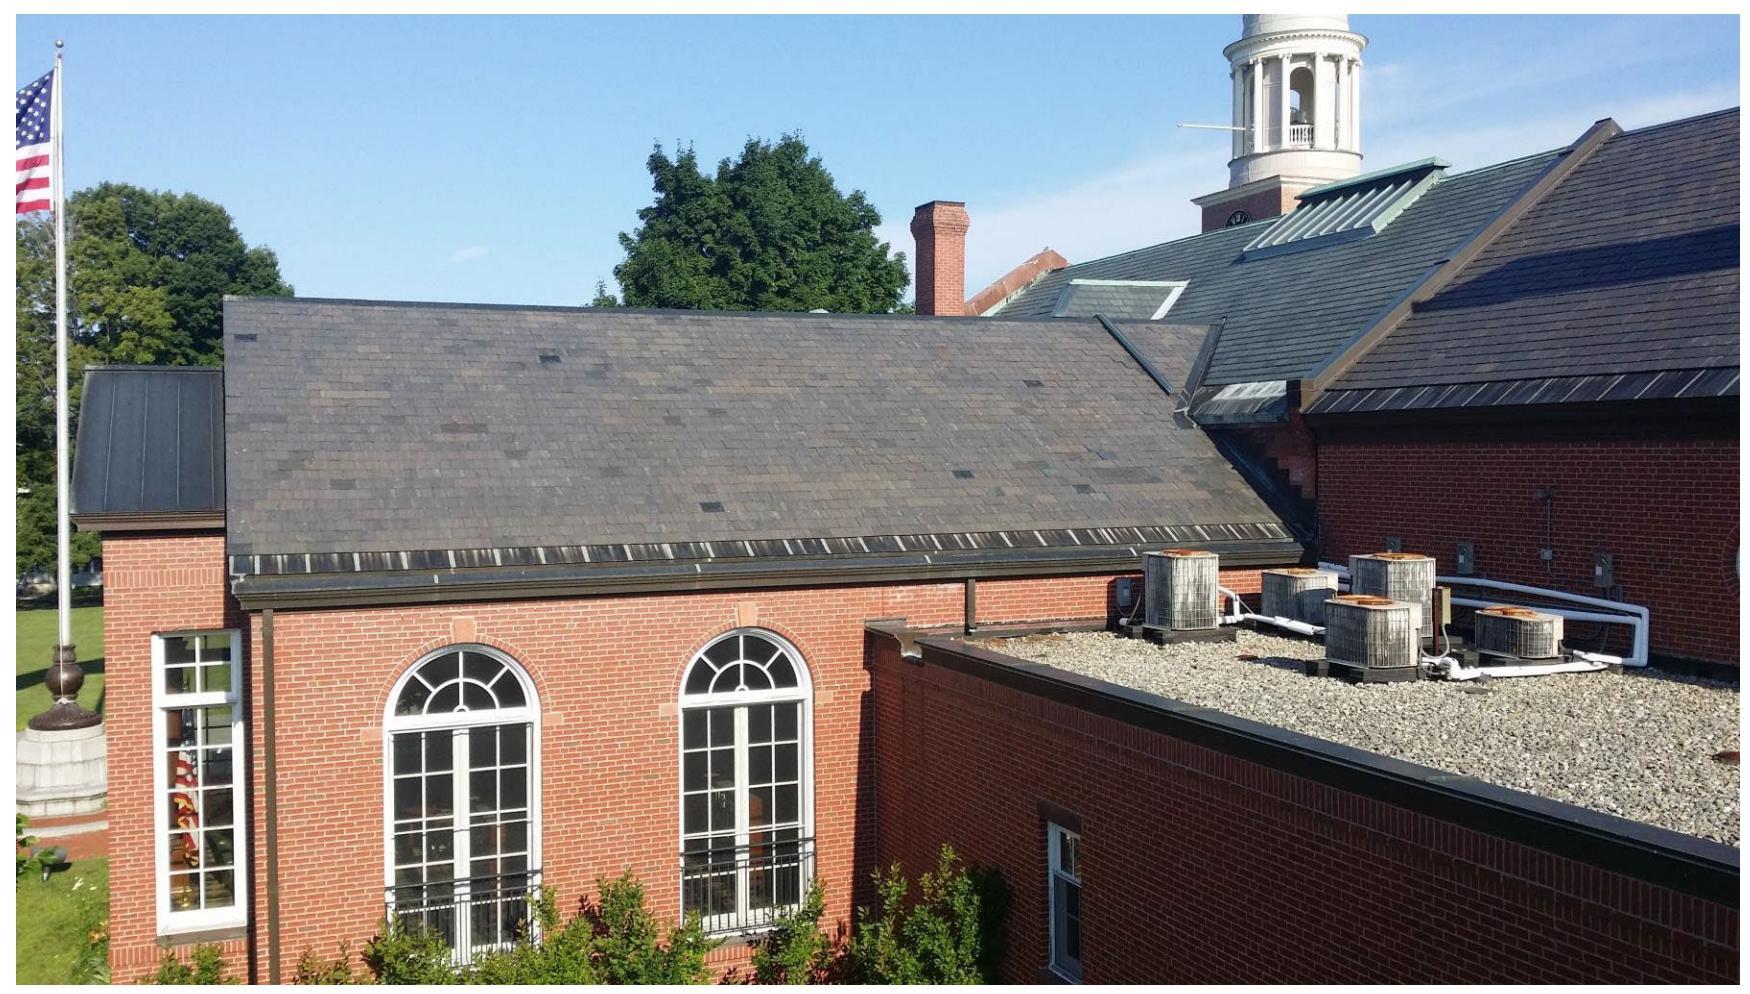
Image 23. Broad view of the wing added in 1999. Several slates have been replaced by units that were painted black. The slate is Vermont black (called "Winchester Black" in 1998 construction documents) and still commercially available. Repair and replacement units should also be Vermont black slate.

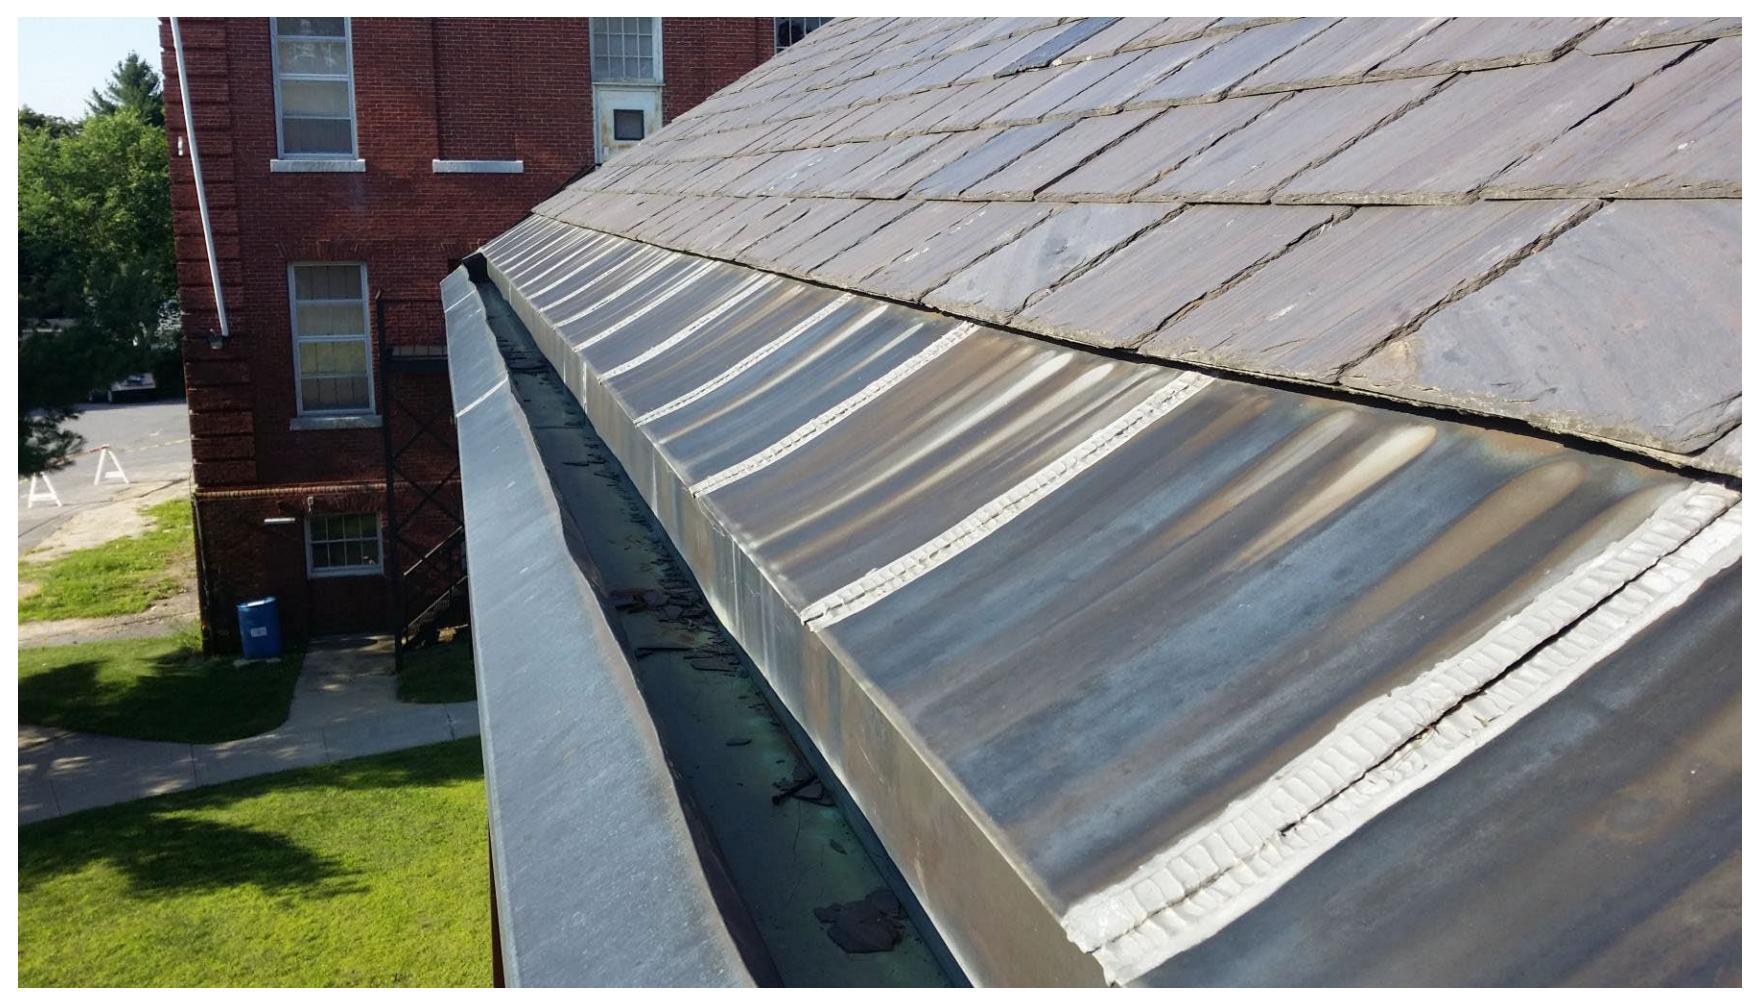
Image 26. Like the gutters and snow pans on the other side of the 1999 wing, all solder joints have cracked and separated. These joints should be cleaned and resoldered to prevent moisture from migrating into the cornice and causing damage.

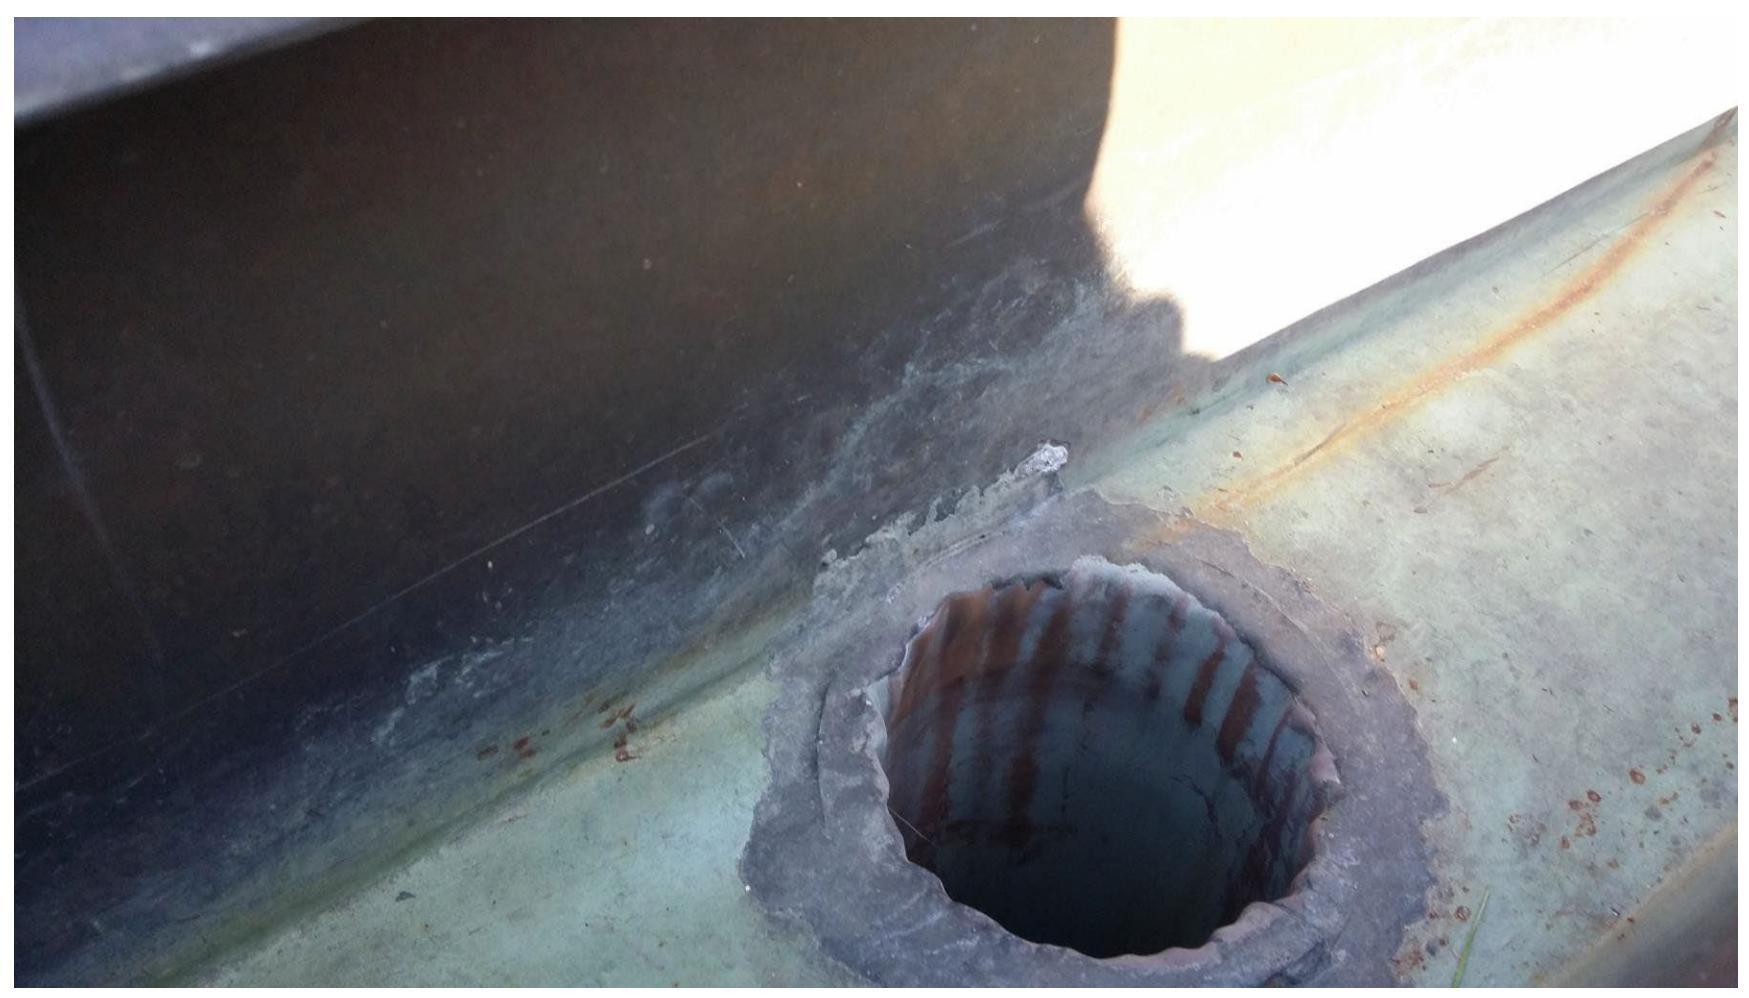
Image 27. An outlet in the gutter trough, solder joint still intact. The green patina seen in the bottom of the gutter trough is relatively advanced given the age of the materials. This is because black and purple slate are comprised of a variety of minerals and iron that green ad gray slate are not. It is not unlike a galvanic reaction in which rain water running over differential materials will cause the copper to react.

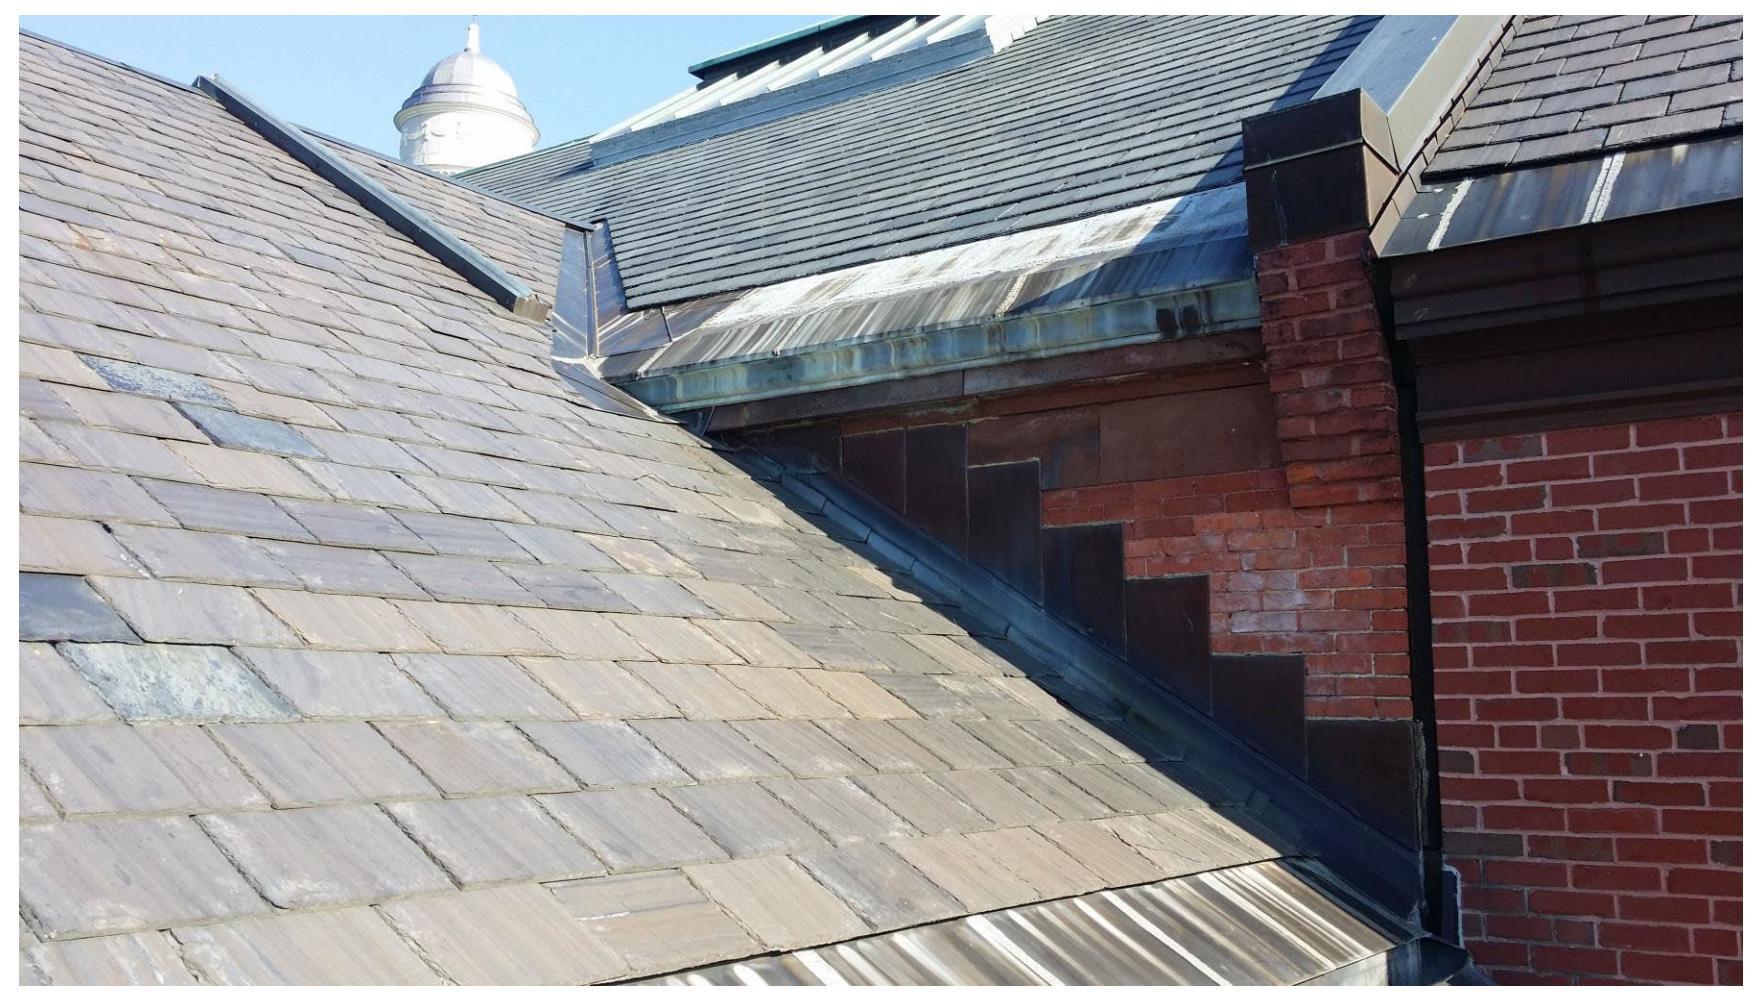
Image 28. A broad view of the area above which water intrusion occurred during the past winter. The flashing assembly, where the newer, 1999 wing's roof meets the sidewall of the main block of the library is highly suspect. If ice damming occurred in this area it is not difficult believe that melt water had a relatively easy time finding a point of intrusion.

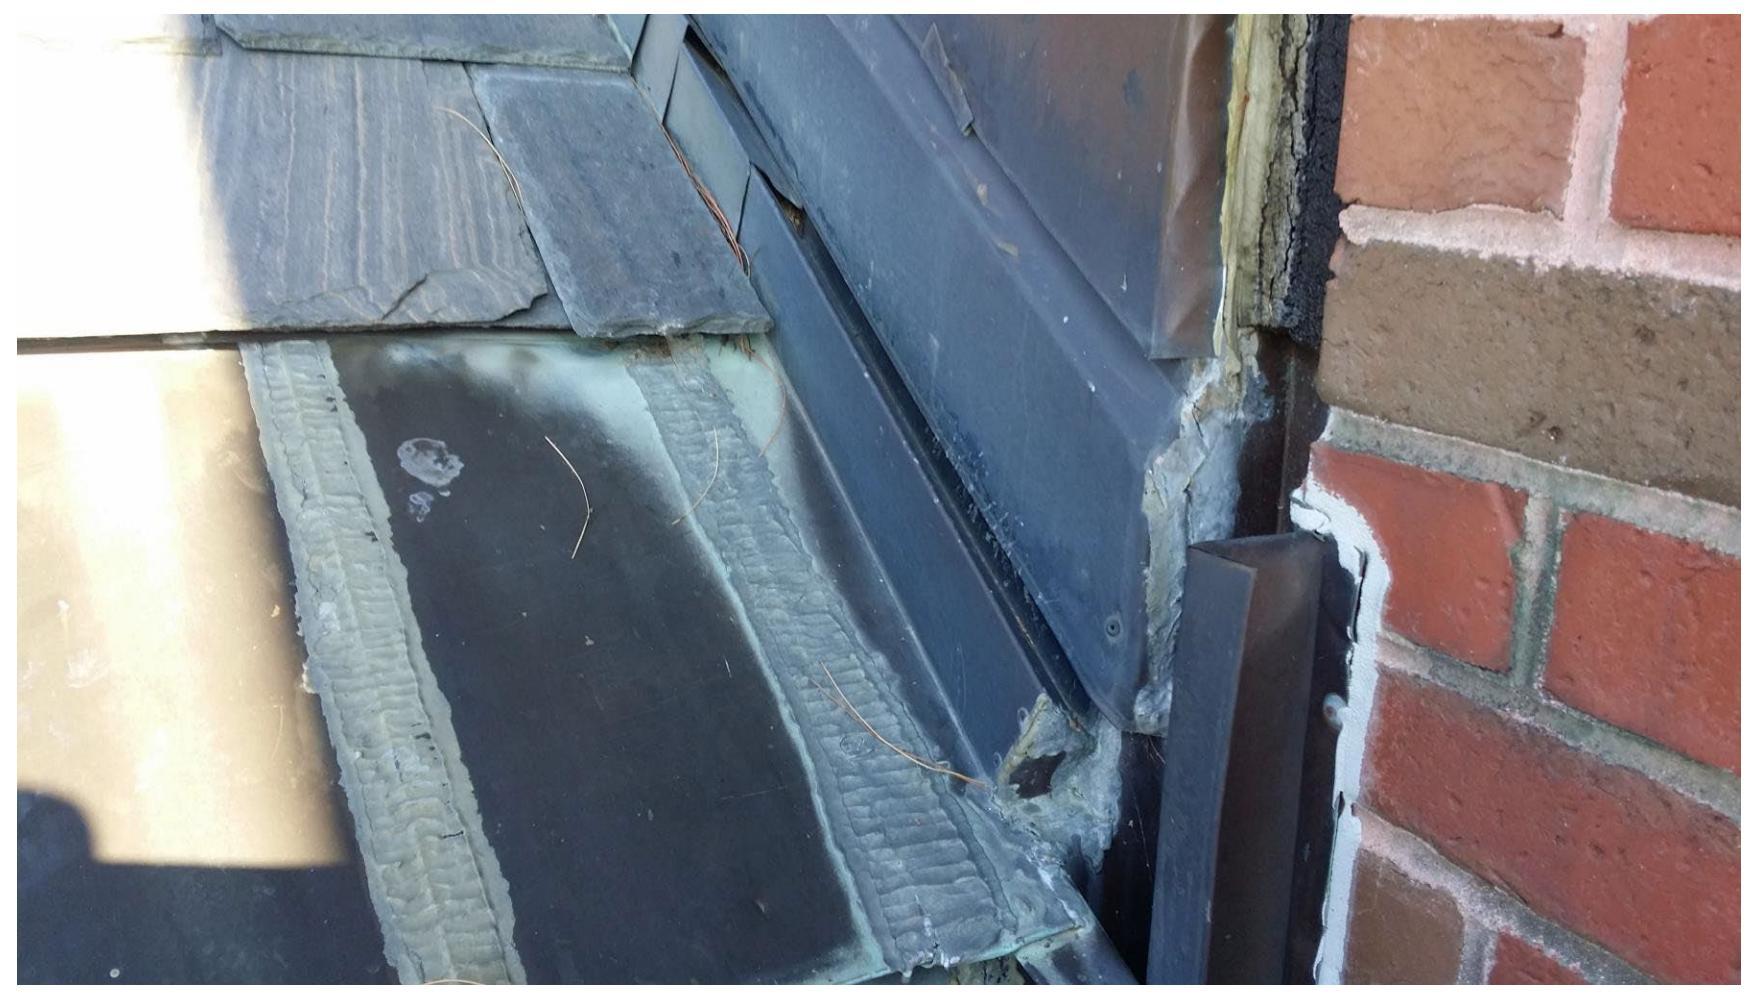
Image 30. No detail exists in the bid or construction documents that indicates what was supposed to happen here. It appears that the designers were anticipating a significant amount of movement between the original library building and new 1999 additions. The variety of caulk solder joints, and sheet metal employed looks like a variety of repairs or post-construction actions employed by the roofer while still in the warranty period or shortly thereafter.

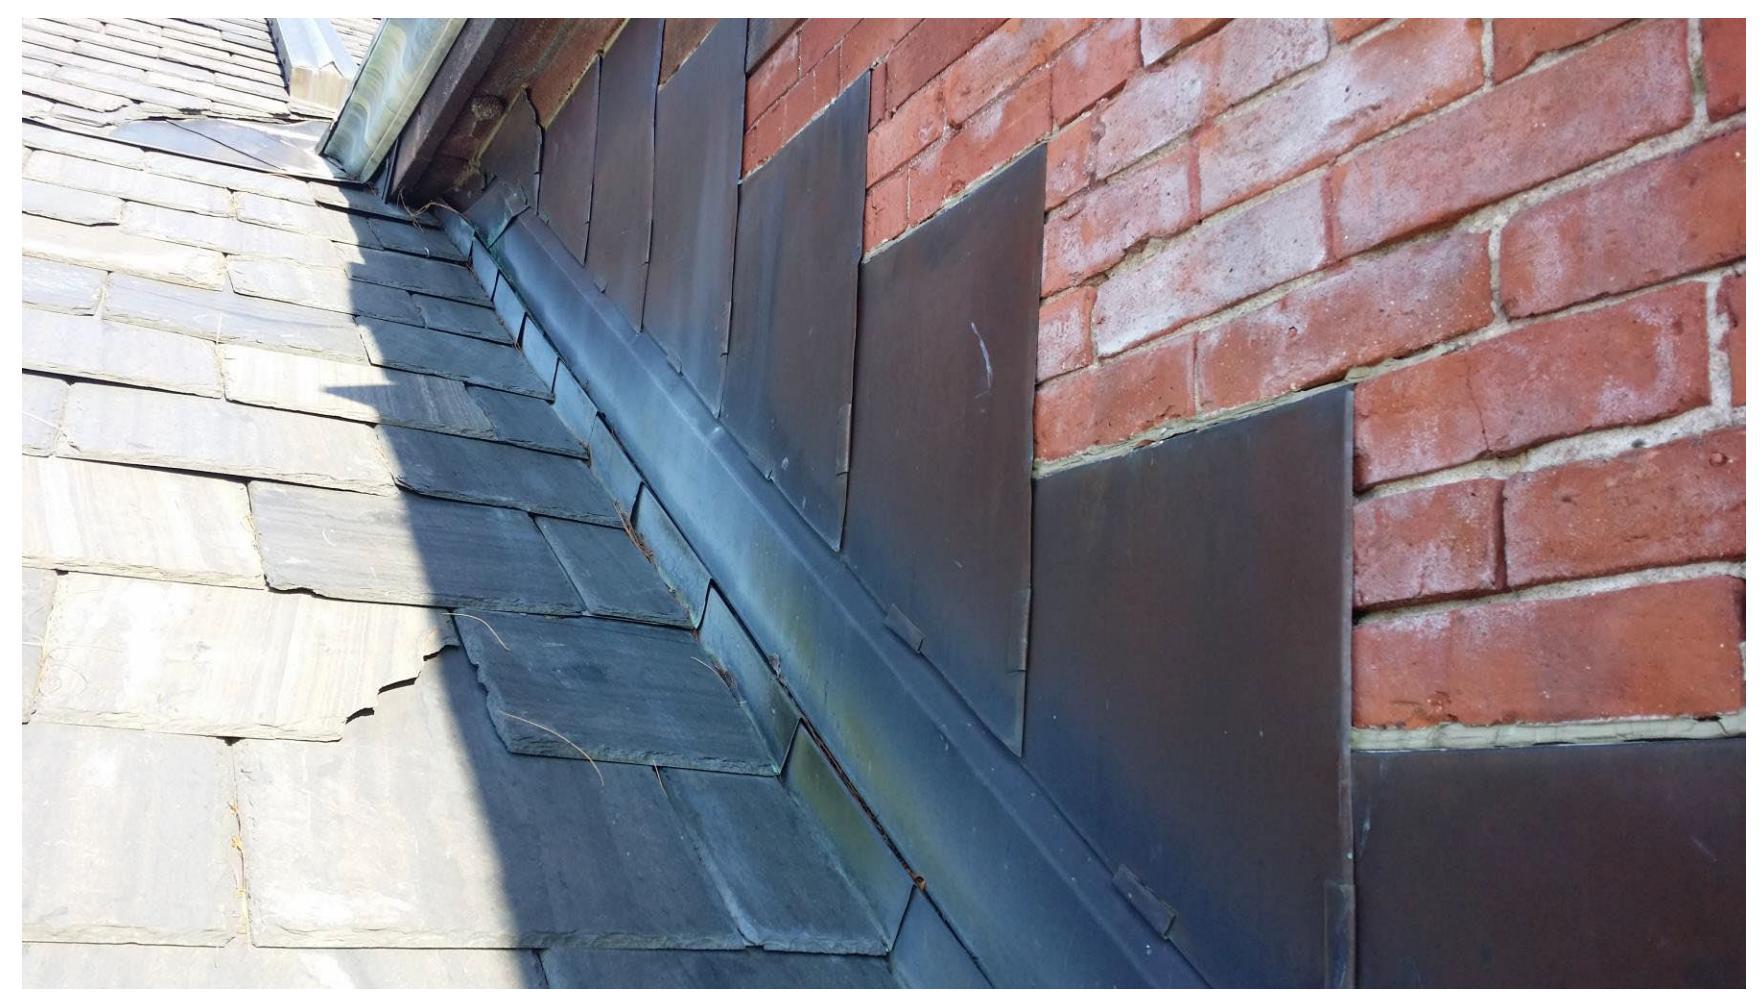
Two *sidewall flashing assemblies*, illustrated in addenda A and H, are odd and potentially problematic. In the bid documents dated 21 April 1998, the detail where the addition meets the main block of the library calls for a 2" isolation/expansion joint with a typical step-flashing assemble at the roof above. The drawings appear to fail to address the detail where the roof above the new wing meets the sidewall of the main block of the library.

Image 31. The drawings appear to fail to address this detail where the roof above the new wing meets the sidewall of the main block of the library. An examination of the shop drawings offered by the roofing contractor on 03 November 1998 suggests two options: first, the detail as presented in the bid documents; and, second, the design as built. On the drawing that reflects the as built design, the odd design is circled and a handwritten note says, "Reverse fold so flashing doesn't catch water." A crude sketch alongside the note suggests a way that it could be done differently.

Because the design requirements of the building call for as much as 2" of movement between the main block of the building and the additions, an engineer or architect should be consulted. The range of movement anticipated seems at first to be excessive and beyond the pale of this consultant's experience, but really depends on how the project was designed from the foundation up. A structural engineer familiar with newer additions joined to historic building stock is the proper resource to advise further.

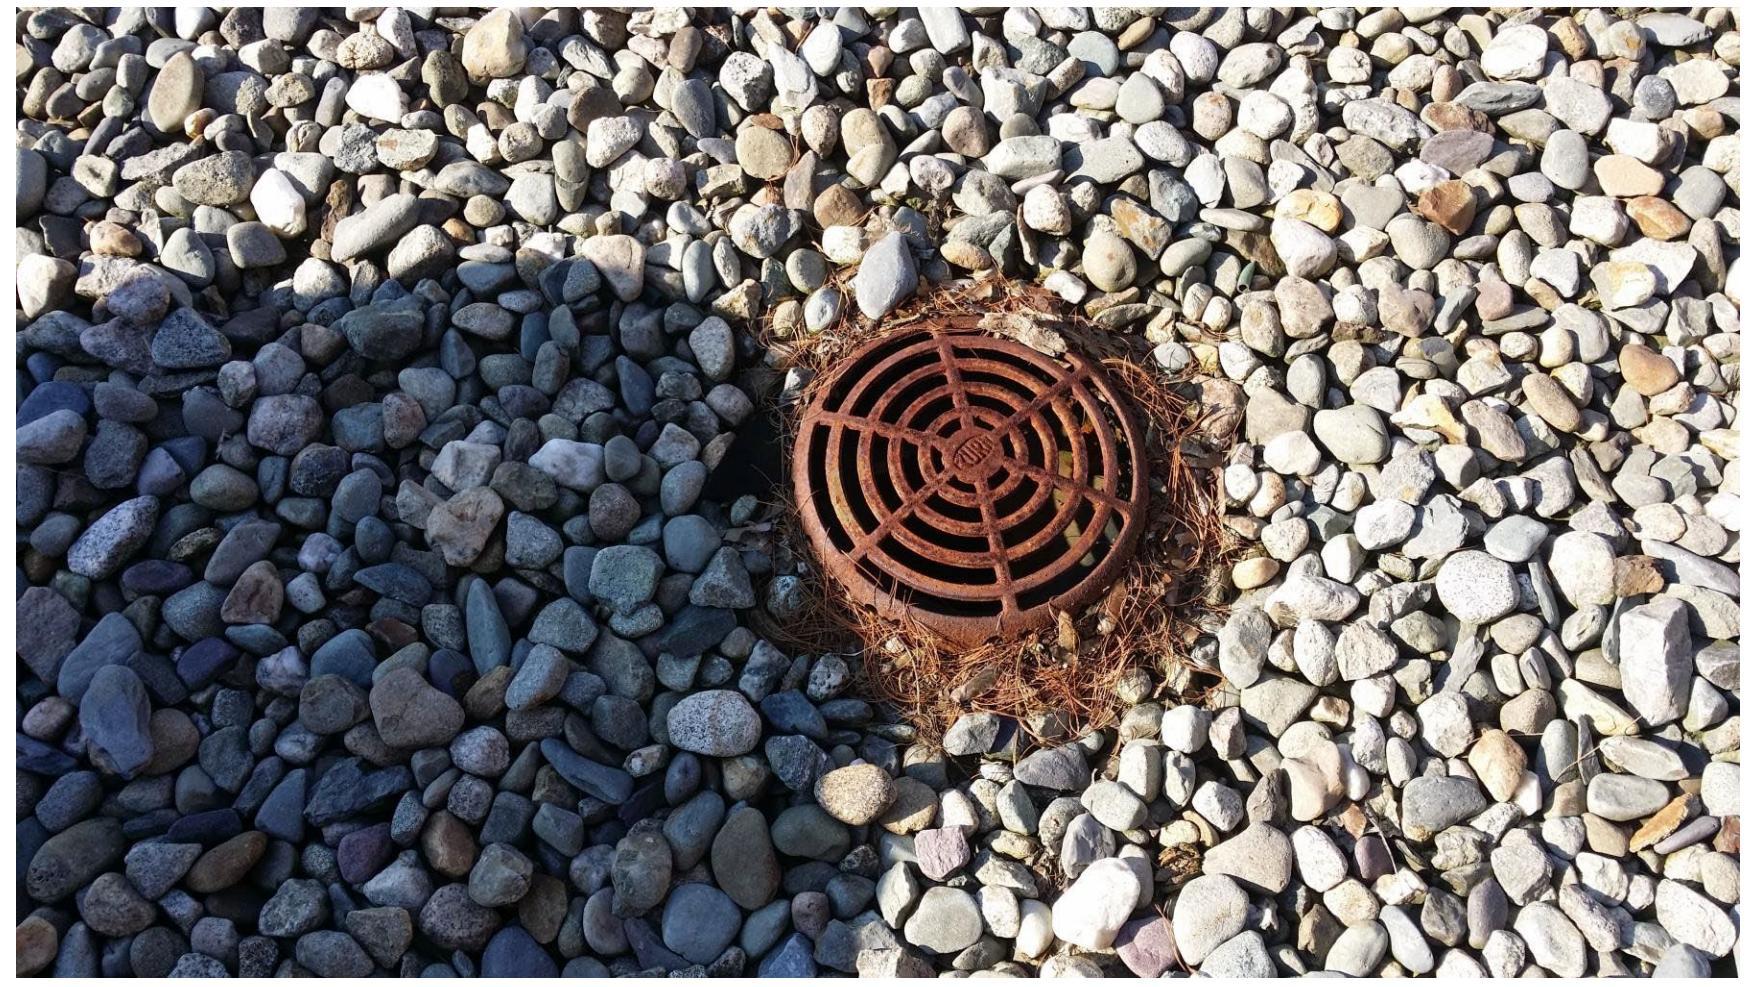
Image 33. A build-up of pine needles around internal drains inhibits proper drainage. Pine needles and other debris should be cleared away during biannual roof inspections.

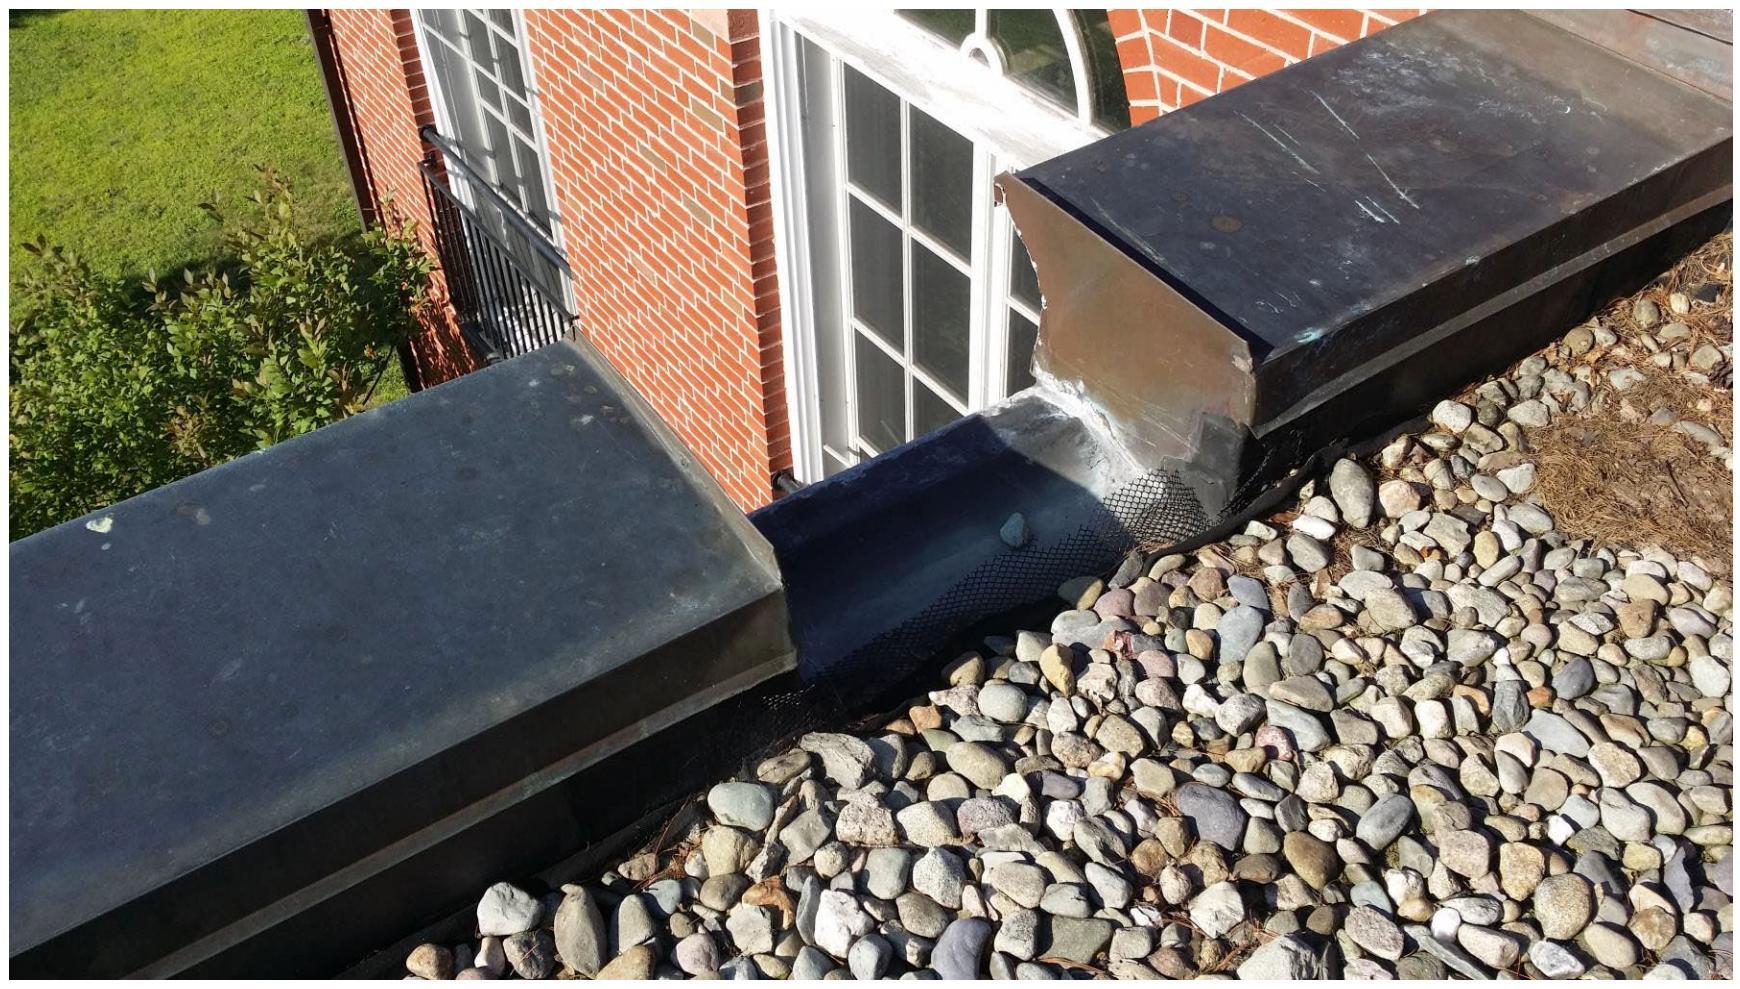
Image 34. The ballasted, flat roofs appear to be in fair condition. However, a build-up of pine needles around internal drains inhibits proper drainage. As a result, runoff at the scupper has caused brick masonry mortar joints to deteriorate.
