Assessment of Roof Conditions

Town of Lancaster

Thayer Memorial Library and the Town Community Center

August 6, 2015

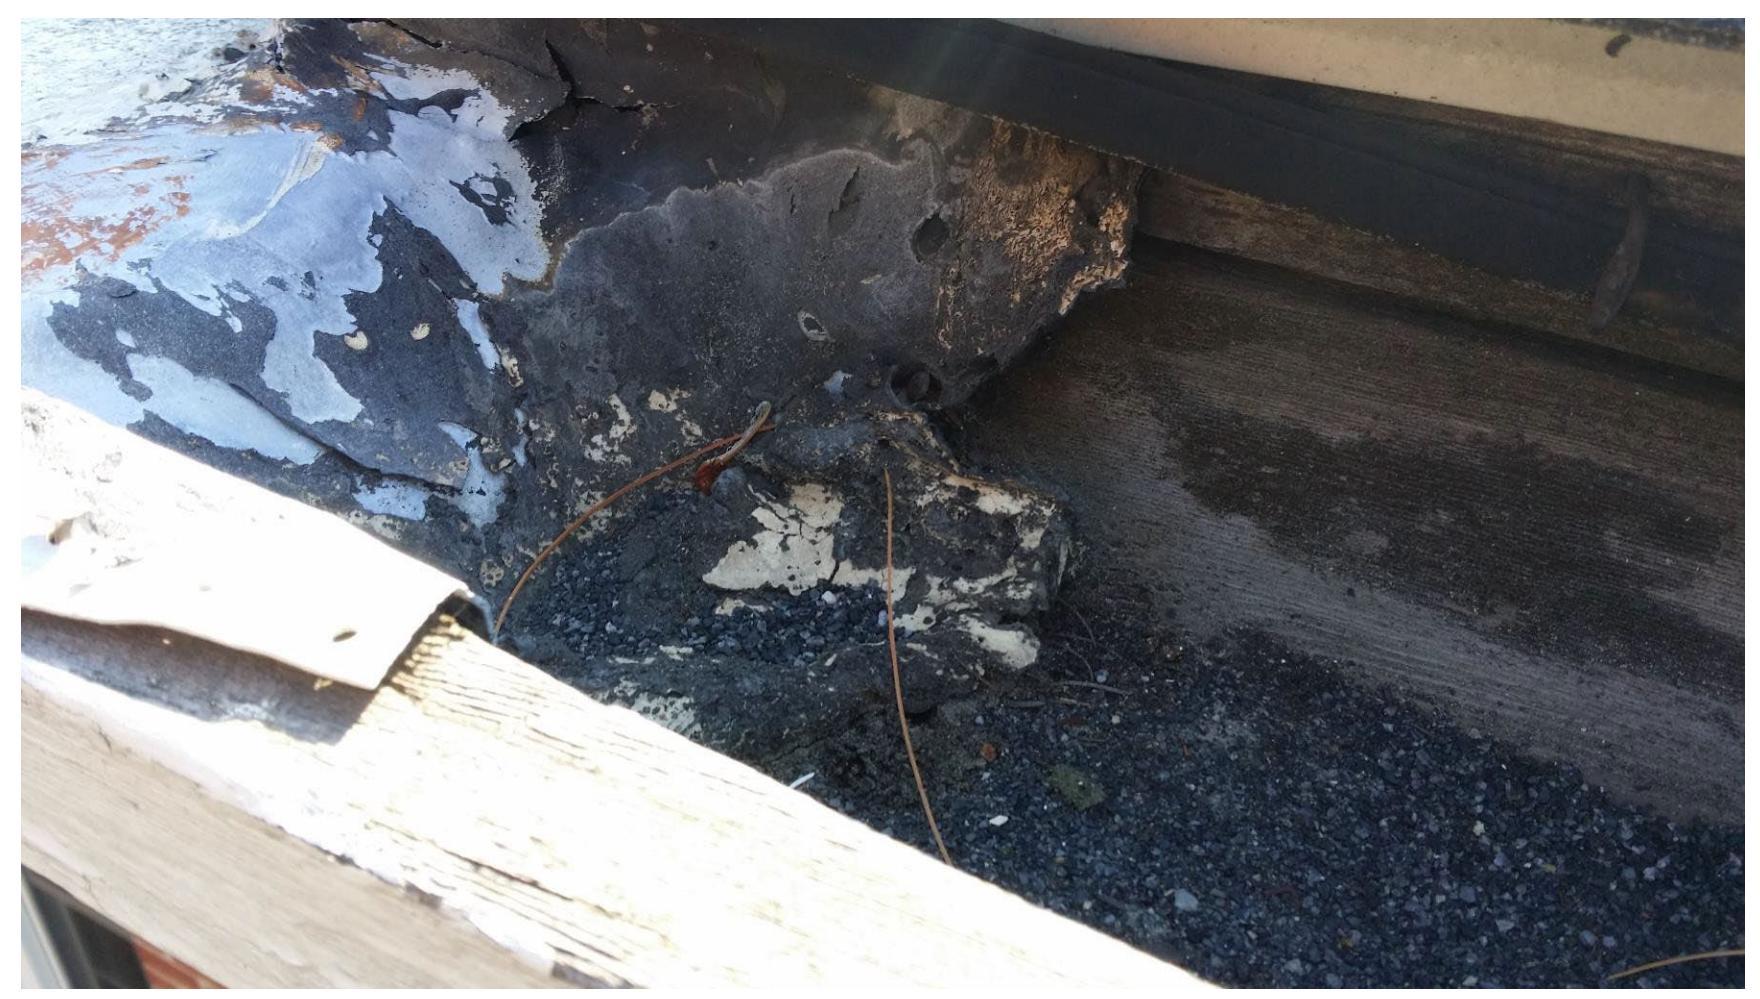
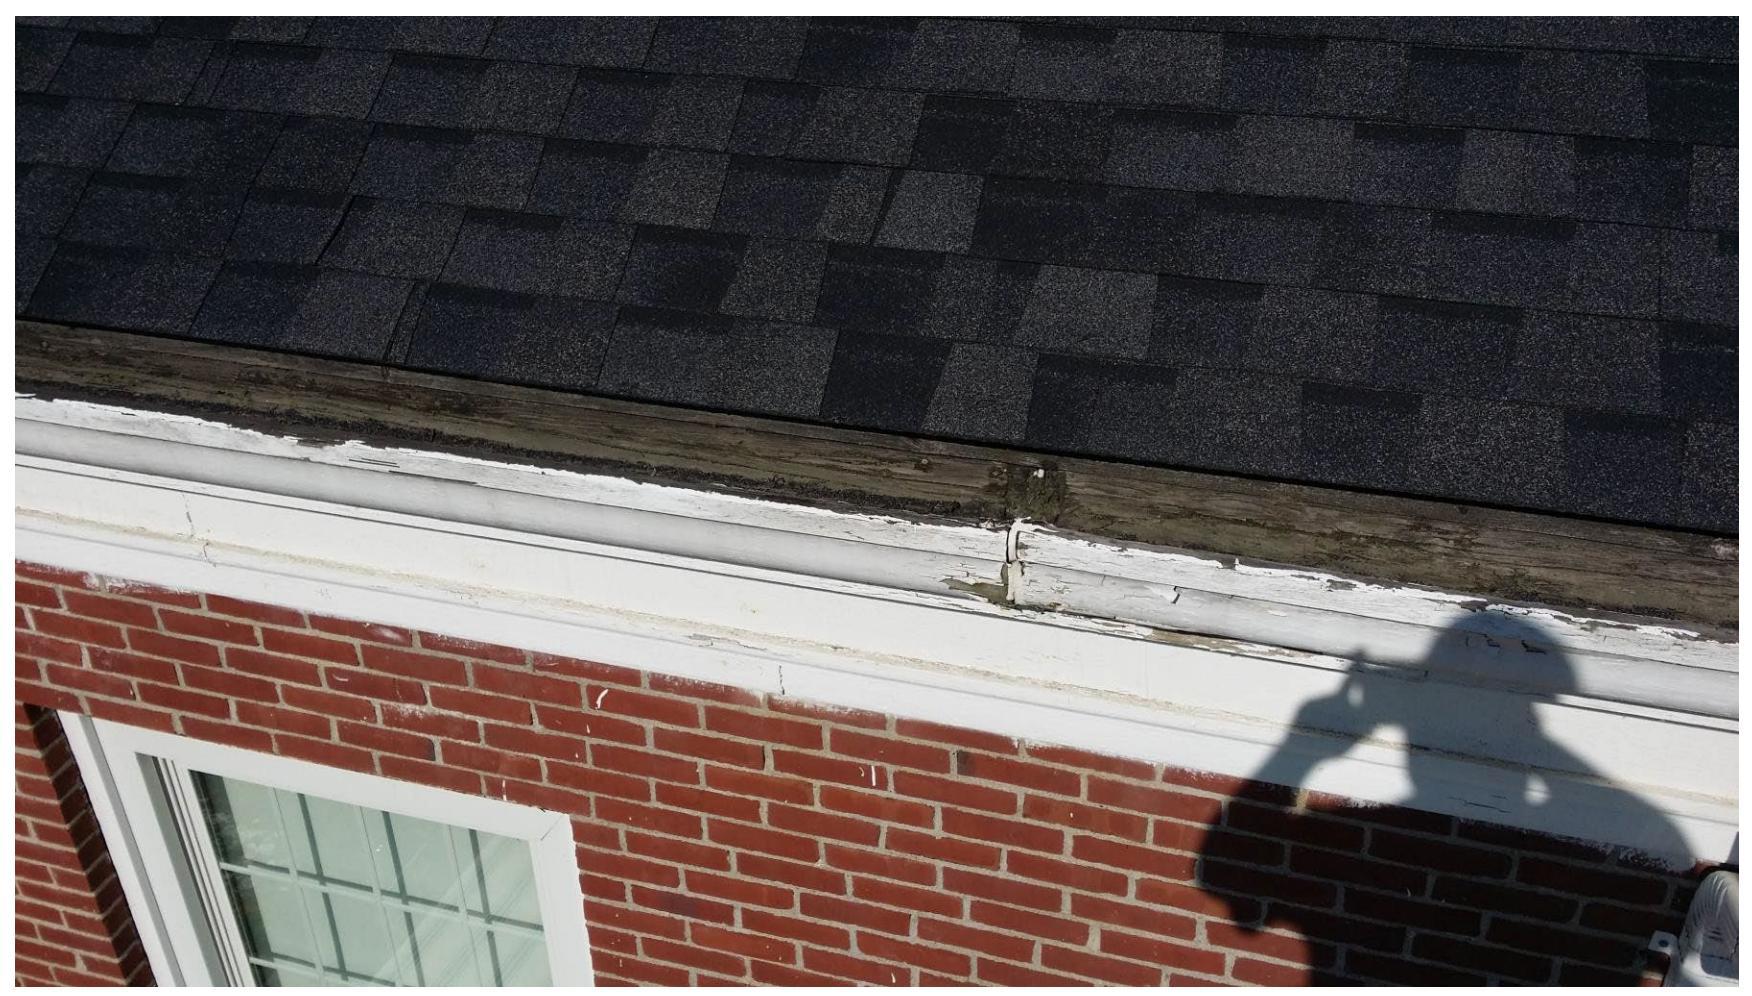
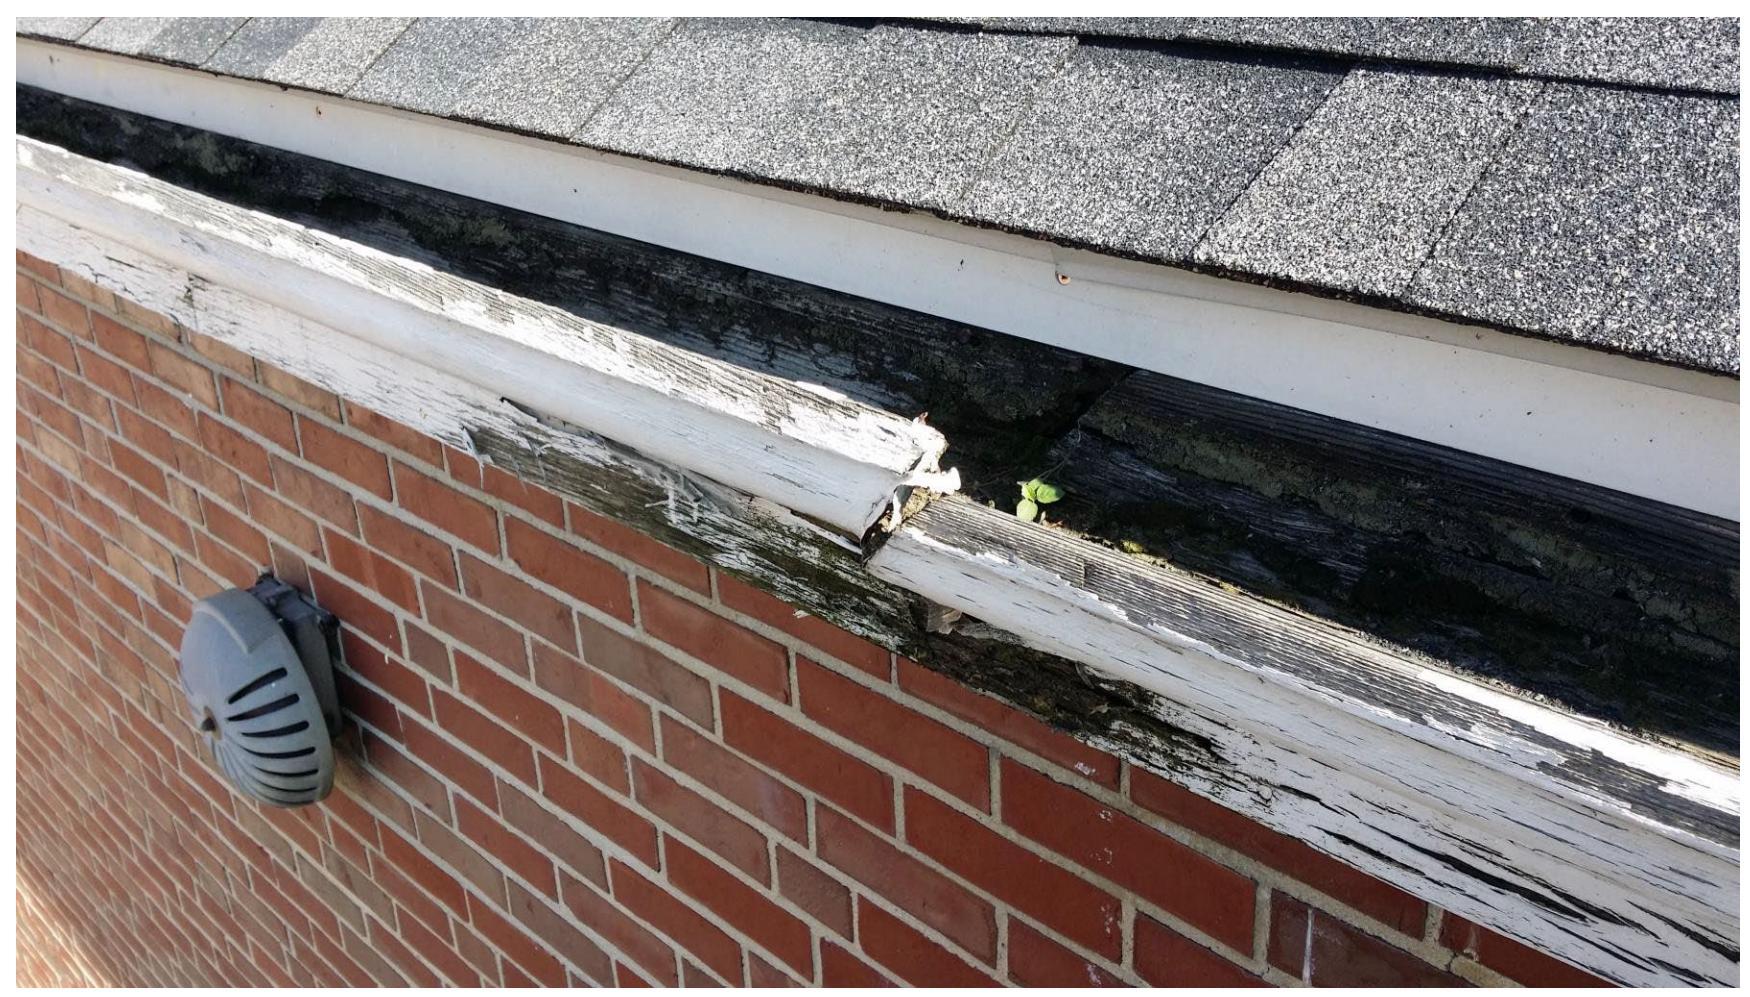
The *wooden gutters* on the community center are failing at most miter and scarf joint locations. They should be replaced with new white aluminum gutters. When calculating drainage capabilities, one square inch of outlet opening is required for each 100 SF area of roof surface being drained. Hence, the 4" outlets are more than adequate as each can service 1,250 SF of roof surface area. Metal wire strainers should be installed at each outlet and checked biannually. If the strainers are maintained and allowed to perform their intended function cleaning the gutters will be limited to the troughs. Otherwise, leaves and debris will find their way into and clog the conductor pipes. If not maintained, gutters will do more harm than good as they require a commitment to maintenance of the system.

Image 37. The wooden gutters on the community center are failing at most miter and scarf joint locations. They should be replaced with new white aluminum gutters. When calculating drainage capabilities, one square inch of outlet opening is required for each 100 SF area of roof surface being drained. Hence, the 4" outlets are more than adequate as each can service 1,250 SF of roof surface area

Image 40. The wooden gutters on the community center are failing at most miter and scarf joint locations. They should be replaced with new white aluminum gutters.

Image 45. The wooden gutters on the community center are failing at most miter and scarf joint locations. They should be replaced with new white aluminum gutters.

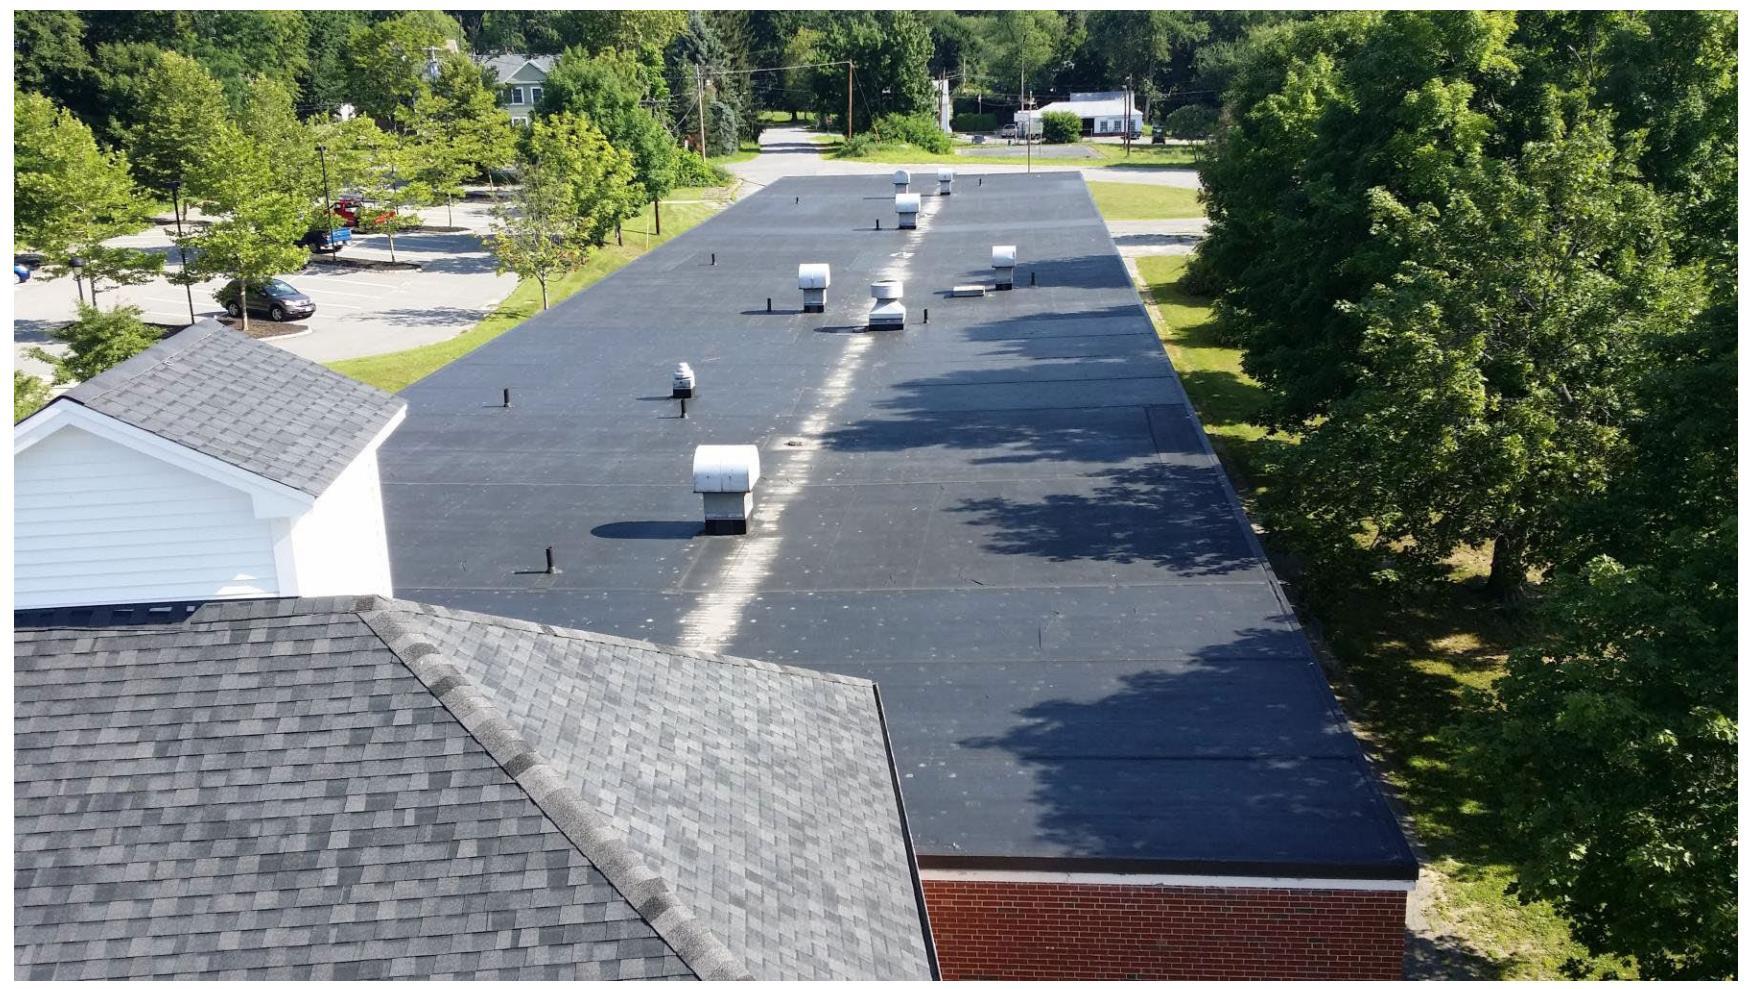
Image 42. The EPDM rubber roof on top of the school portion of the community center is in fair condition. If regularly inspected and maintained this roof should be expected to last another ten years or more.

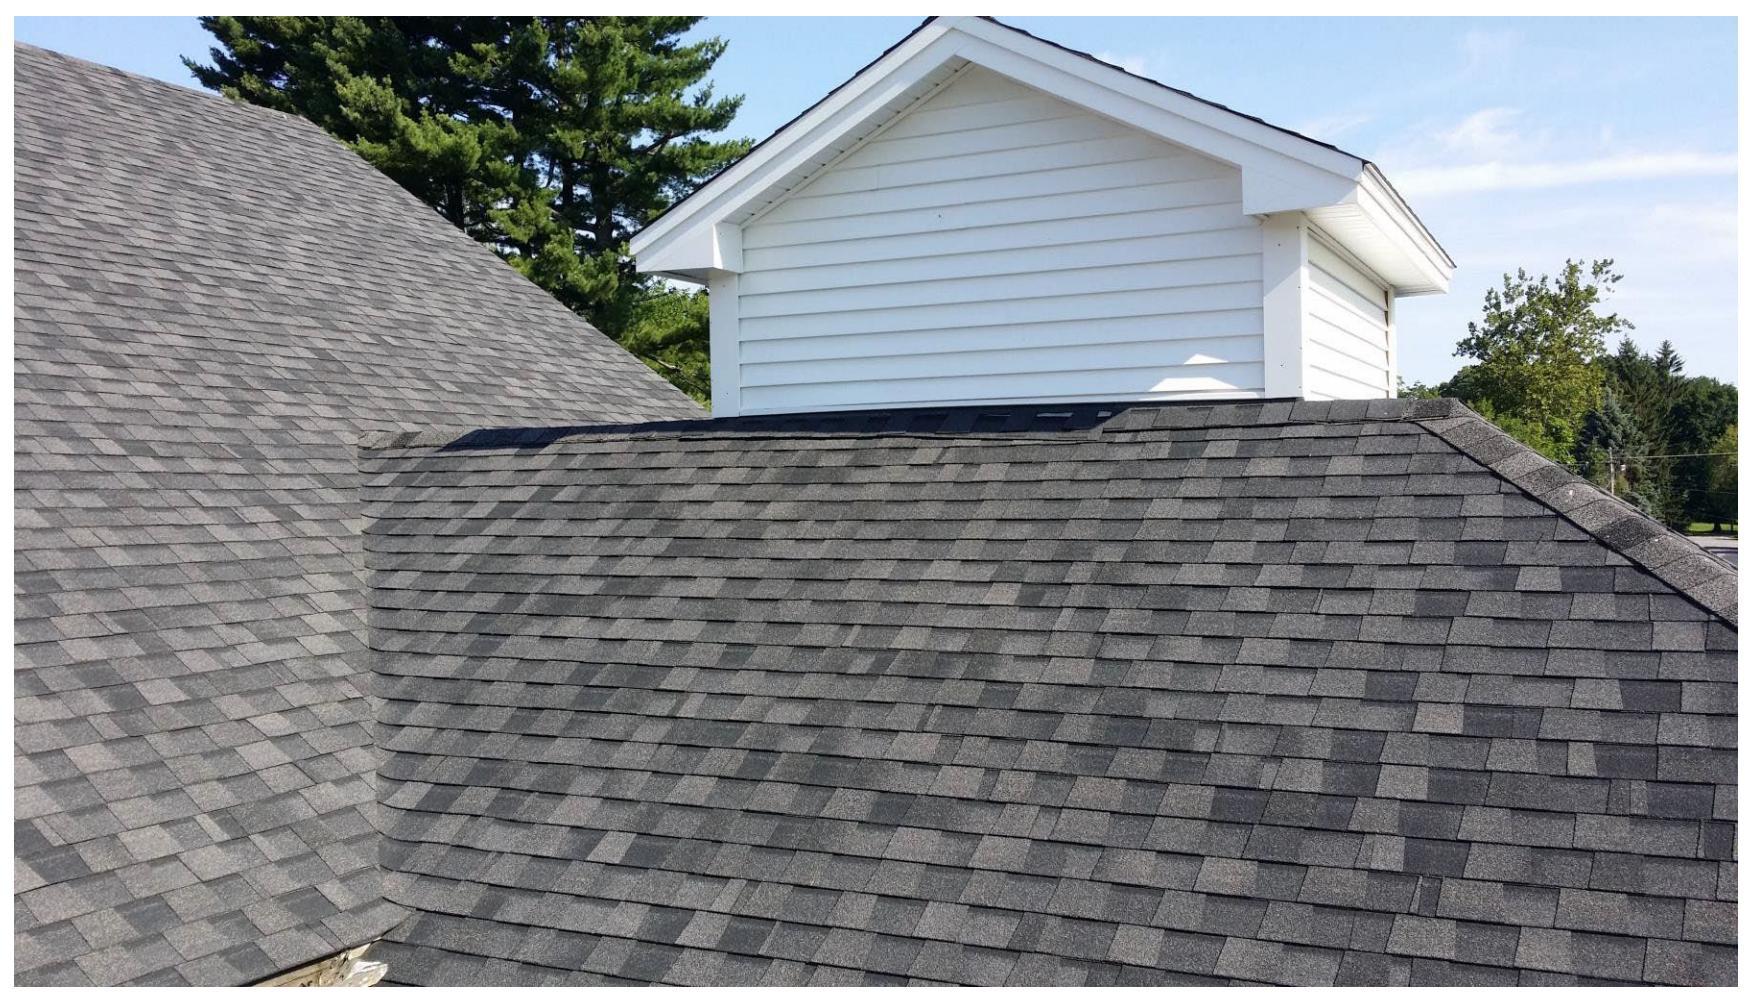
The *asphalt shingle roofing* atop the community center is relatively new and in very good condition. The single exception is where a white shed end wall meets a roof ridge. Some shingles have slipped and should be refastened. The *EPDM rubber roof* on top of the school portion of the building is in fair condition. If regularly inspected and maintained this roof should be expected to last another ten years or more.

Image 43. The asphalt shingle roofing atop the community center is relatively new and in very good condition. The single exception is where a white shed end wall meets a roof ridge. Some shingles have slipped and should be refastened.

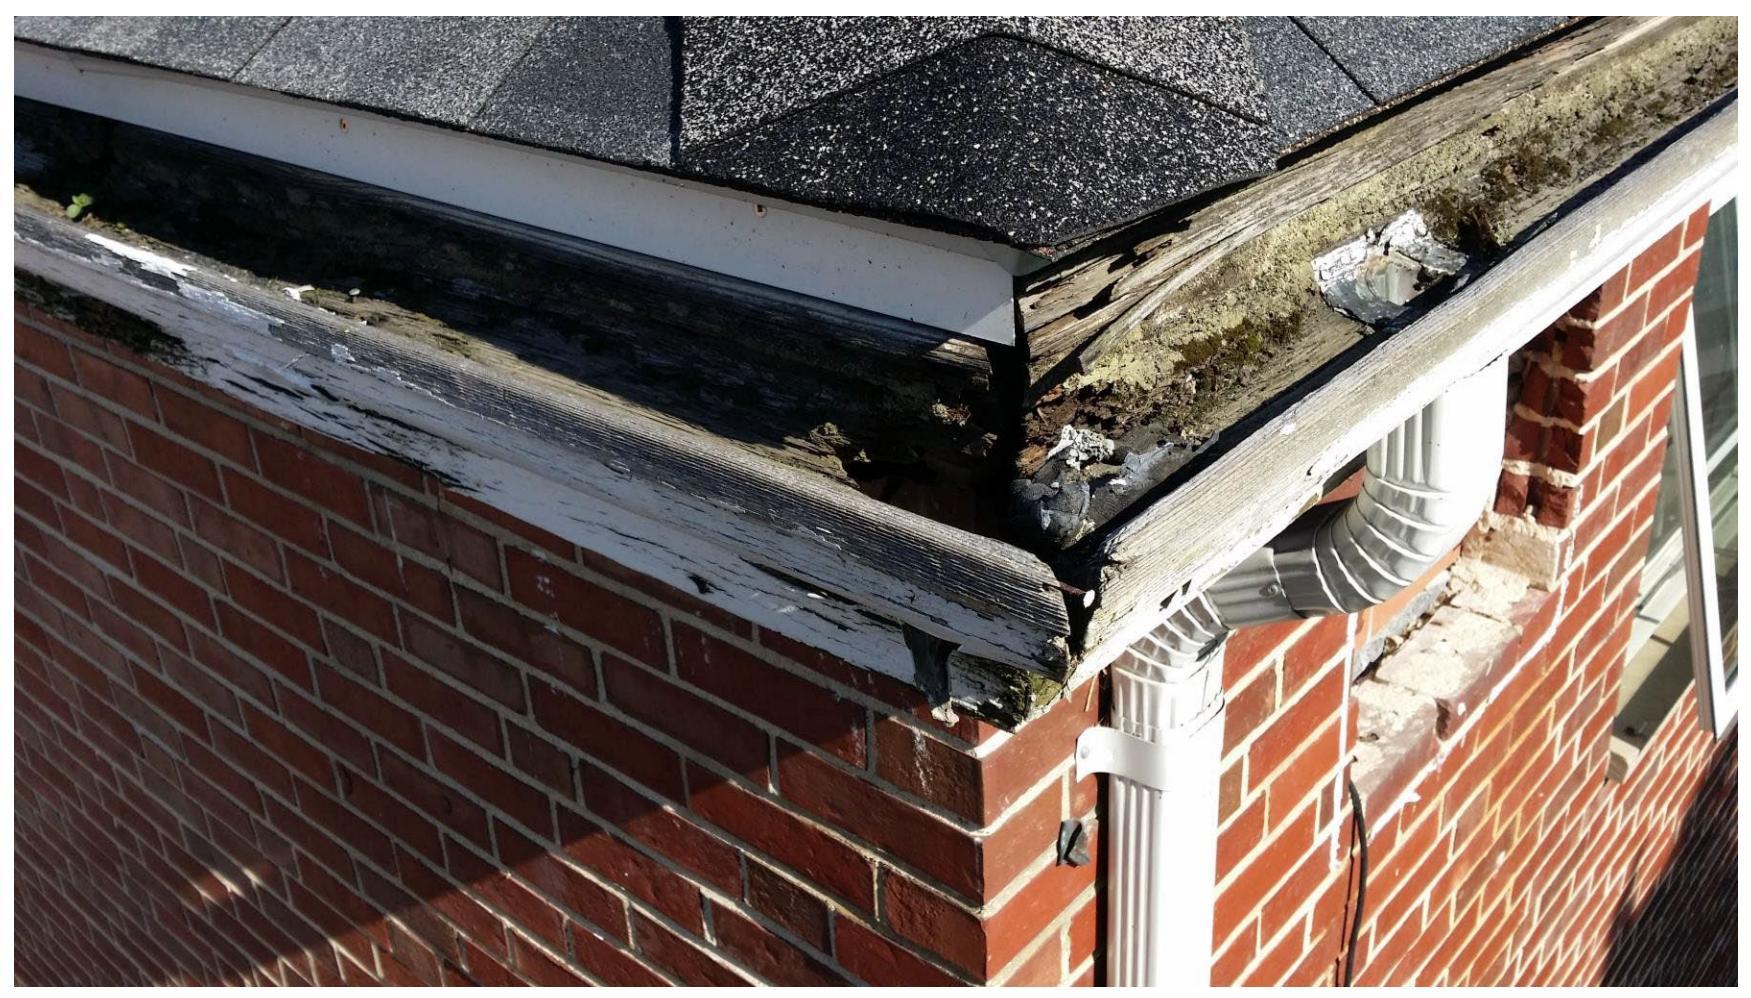
The *fascia plate* above the wooden gutters is particularly problematic. The fascia, soffit, frieze, brackets, panels, moldings, and other wood members must be scraped, sanded and primed where failures have occurred. Afterward, the entire cornice should receive a prime and topcoat in the existing color scheme. All actions that involve the handling of wood must be performed in full compliance with the EPA's *Renovation, Repair and Painting* (RRP) regulations by a certified contractor if testing detects the presence of lead.

Image 44. The fascia plate above the wooden gutters is particularly problematic. The fascia, soffit, frieze, brackets, panels, moldings, and other wood members must be scraped, sanded and primed where failures have occurred. Afterward, the entire cornice should receive a prime and topcoat in the existing color scheme. All actions that involve the handling of wood must be performed in full compliance with the EPA's Renovation, Repair and Painting (RRP) regulations by a certified contractor if testing detects the presence of lead.
