Assessment of Roof Conditions

Town of Lancaster

Thayer Memorial Library and the Town Community Center

August 6, 2015

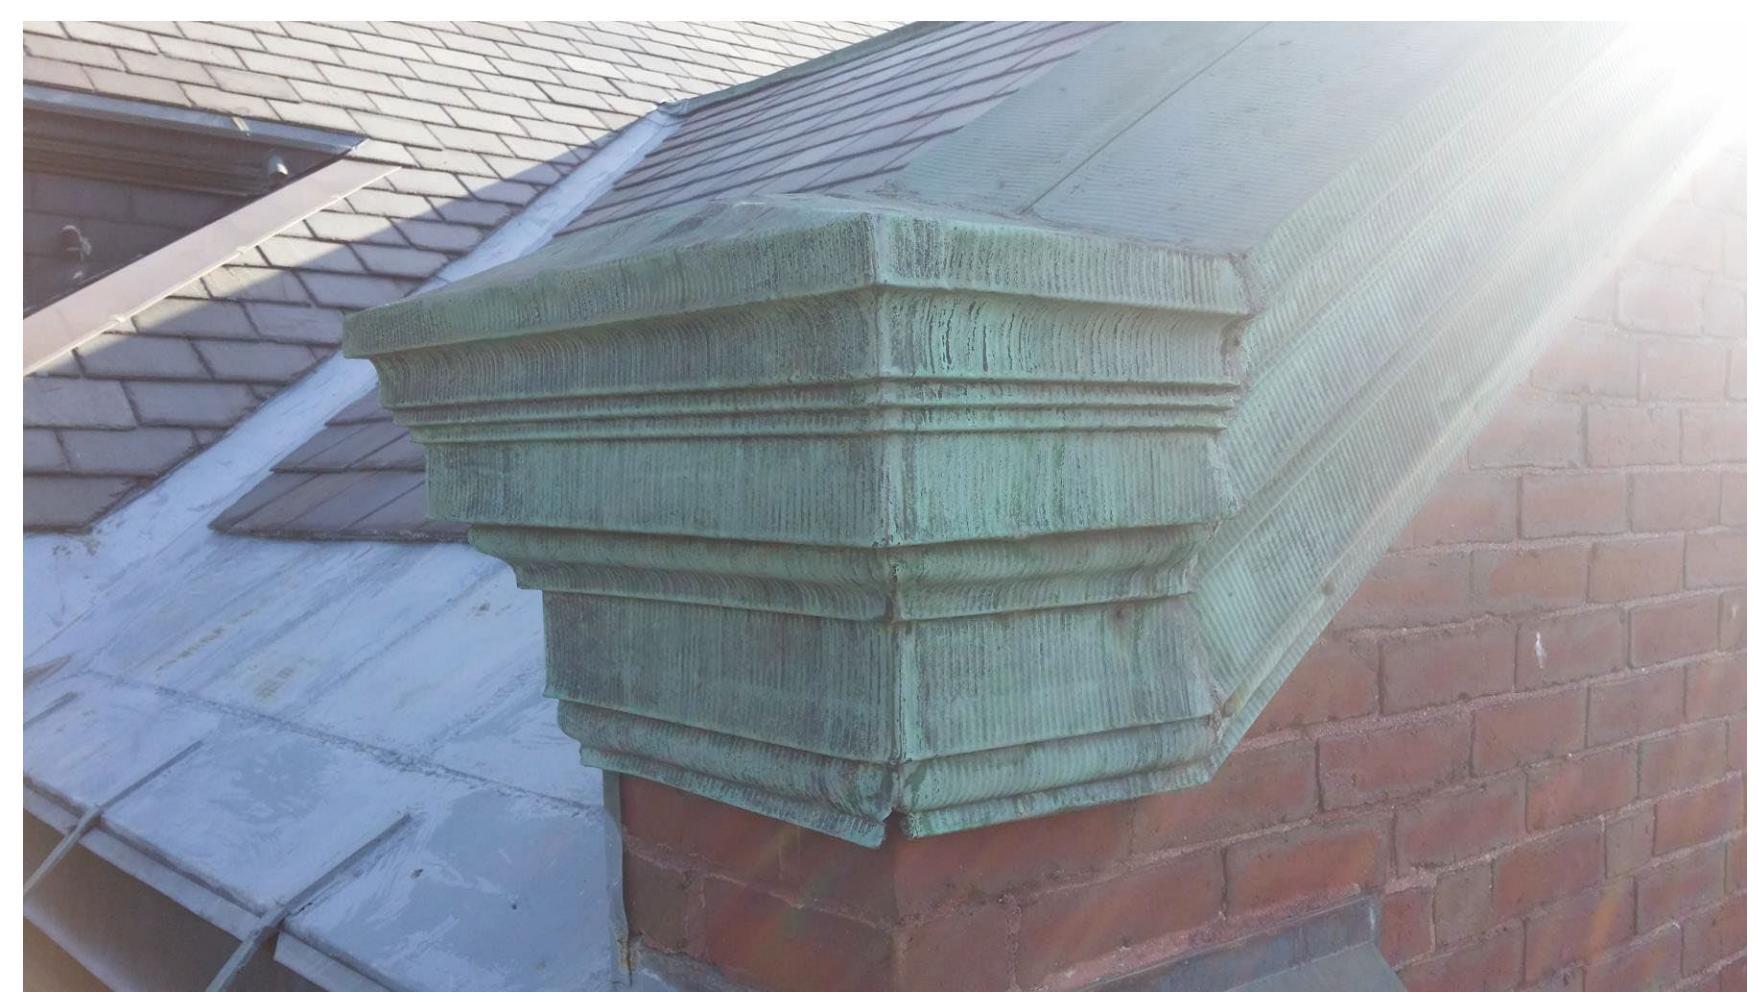
Image 6. Detail view of the ornate copper detail work atop the parapet at the rakes of the roof. This detail likely dates to the work that took place in 1929 and the ribbed sheet metal is consistent with practices in the 1920s and 30s. This historic fabric should be preserved as long as possible.

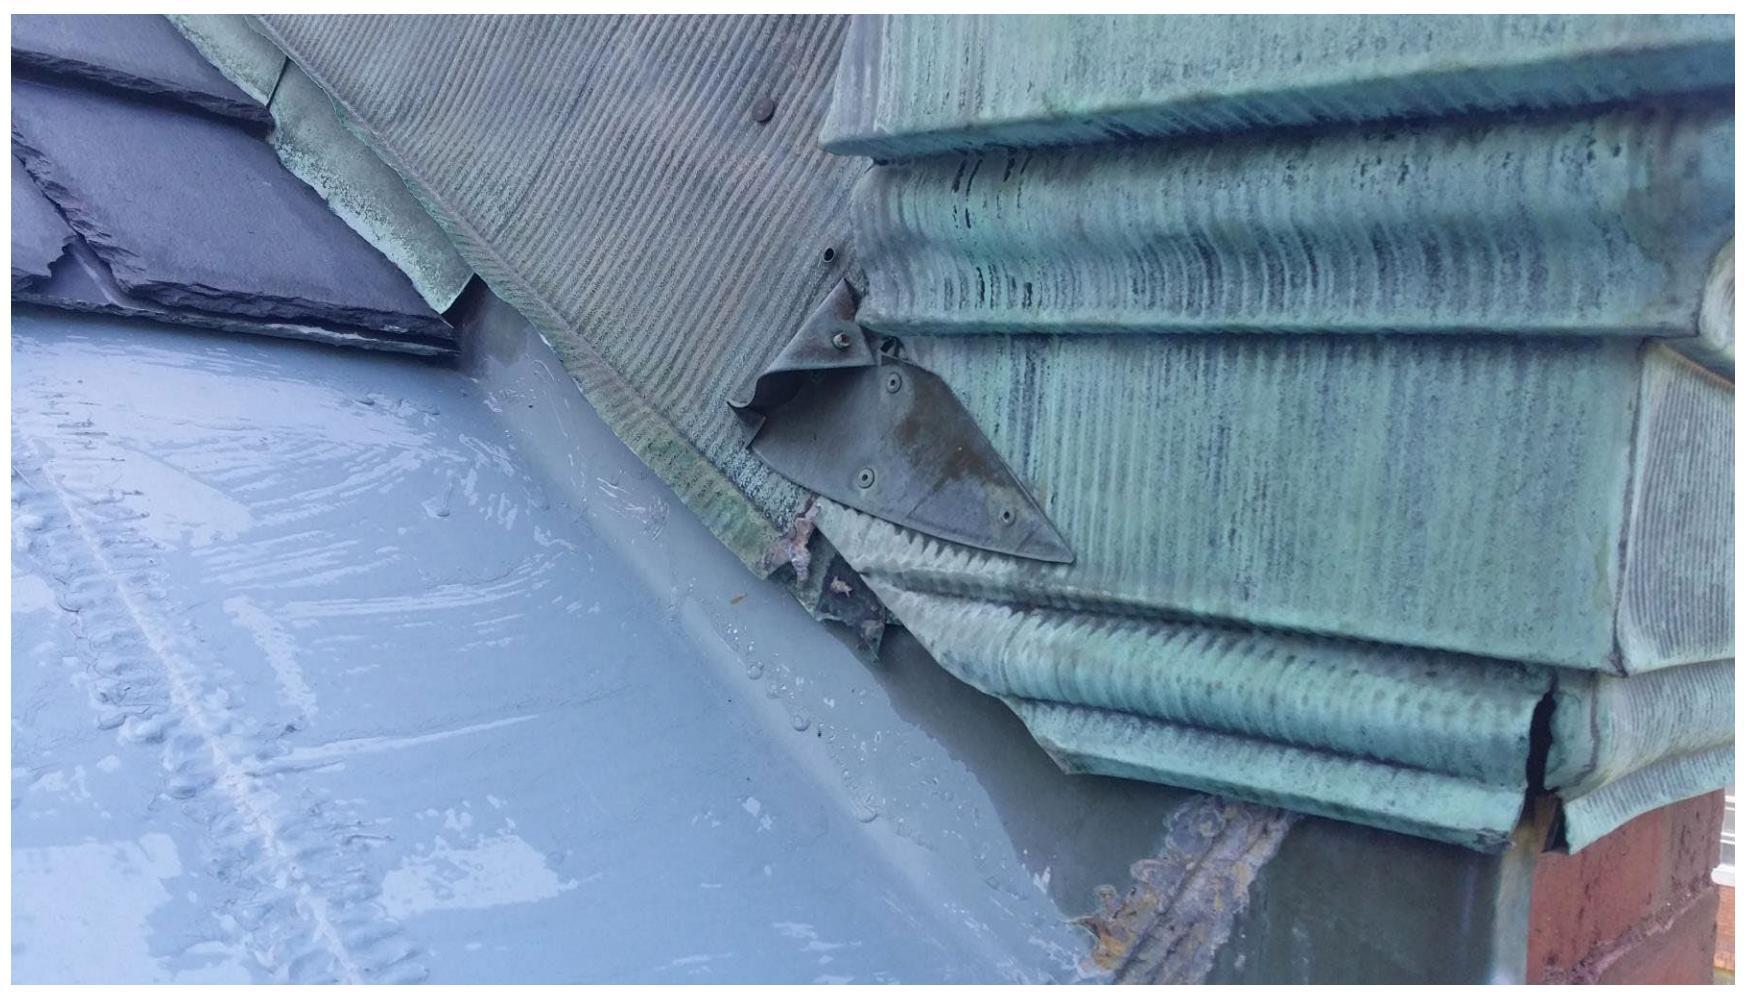
Image 9. Copper sheet metal repair using copper and brass rivets (typ.)

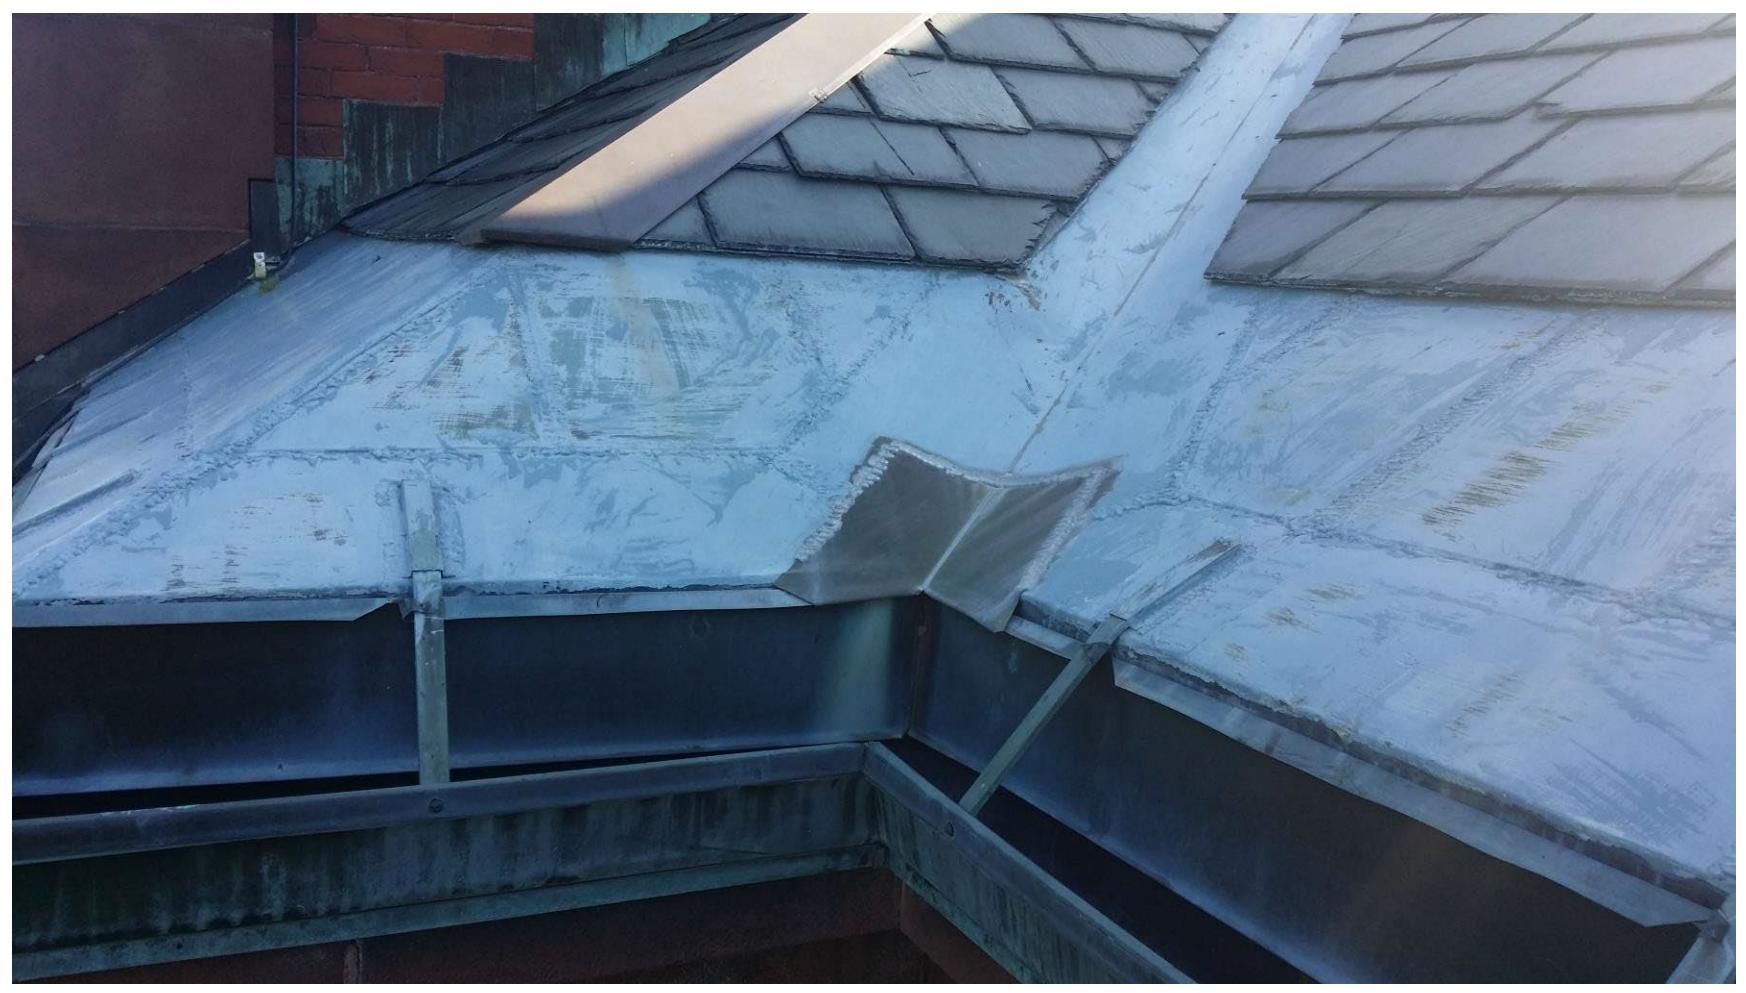
Image 11. Additional view of gutters and snow apron.

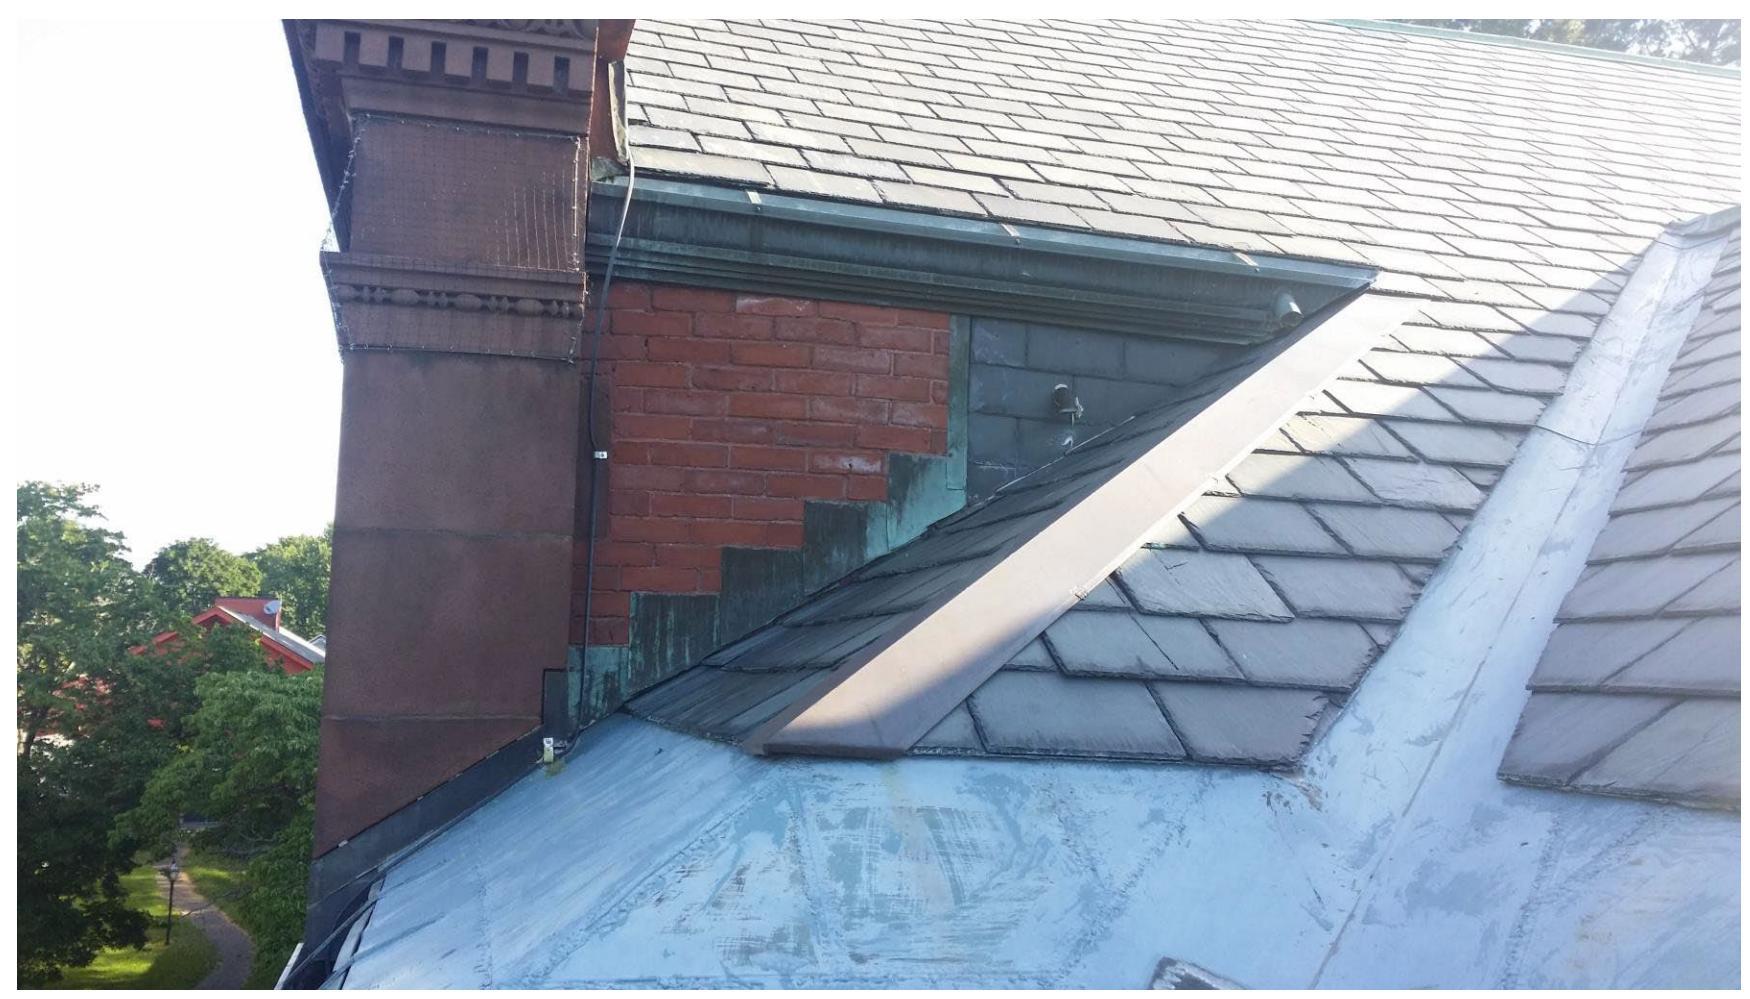
Image 12. Sidewall assembly at the front of the library. Note the "newer" copper hip flashing, dating to the 1999 project. Valleys and flat-lock snow pans are coated in a gray material, perhaps to give the appearance of lead-coated copper.

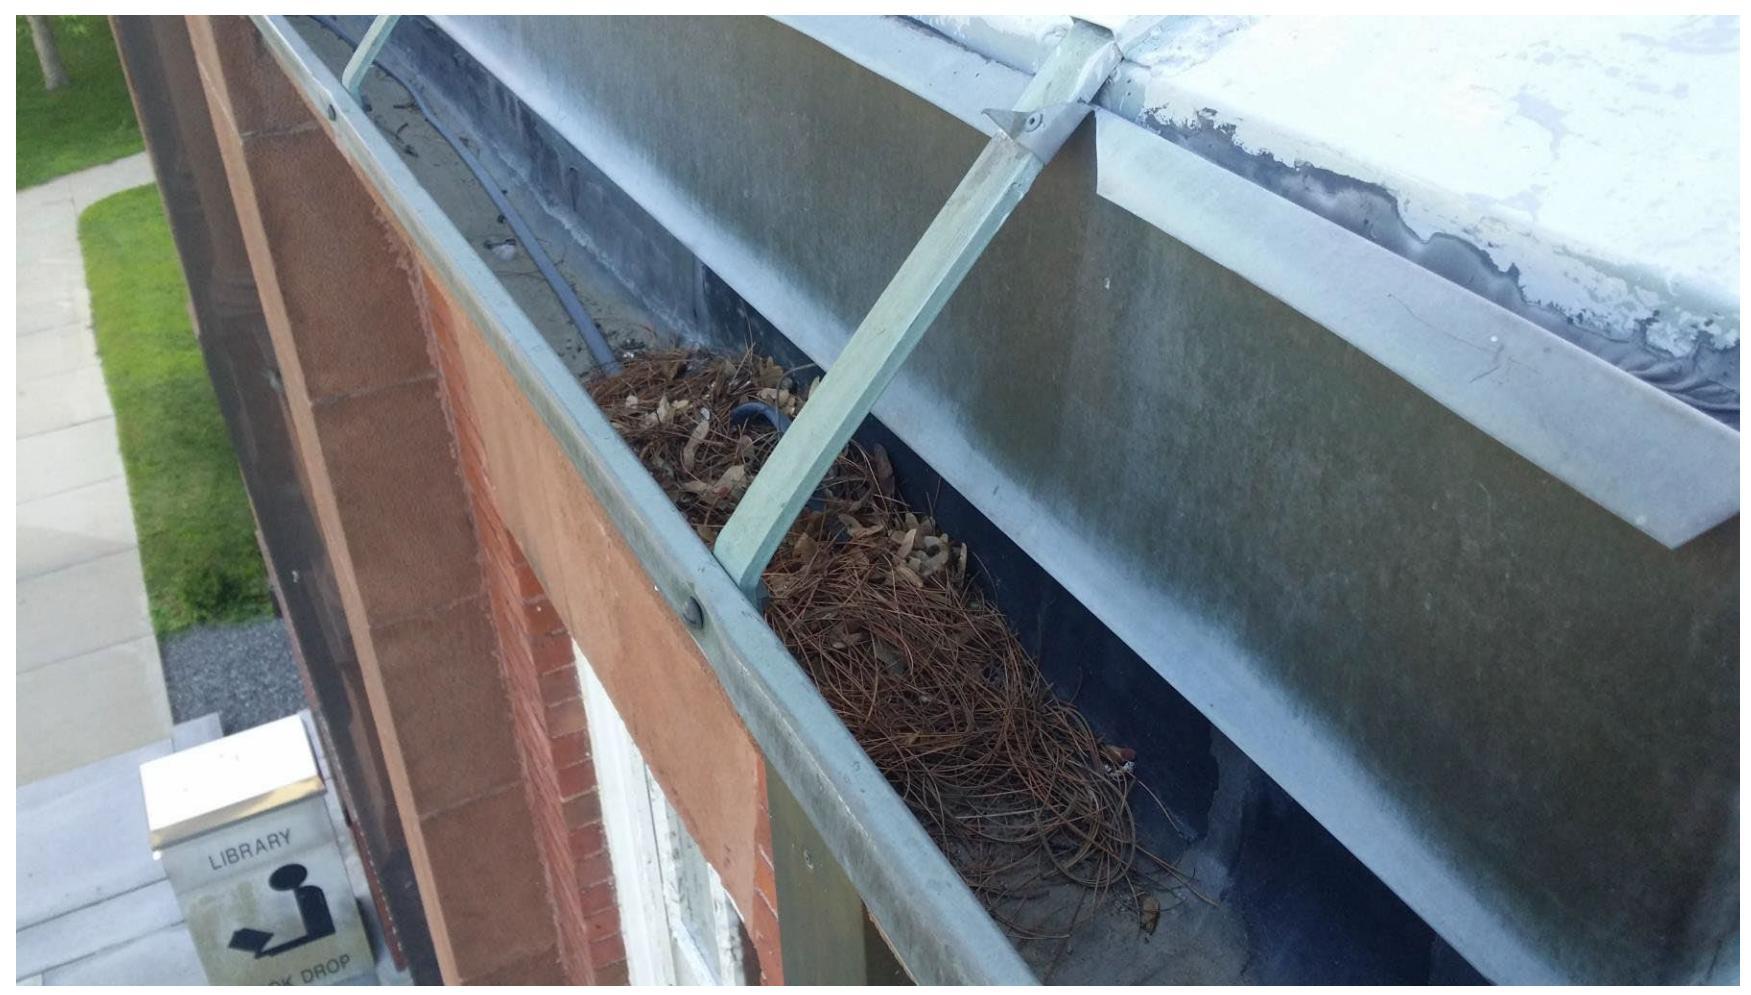
Image 13. Pine needles and other debris have clogged up the outlets in the gutters. In addition to rainfall overflow, these gutters quickly freeze and exacerbate the issues of ice damming. Gutters should be cleaned biannually during roof inspections.

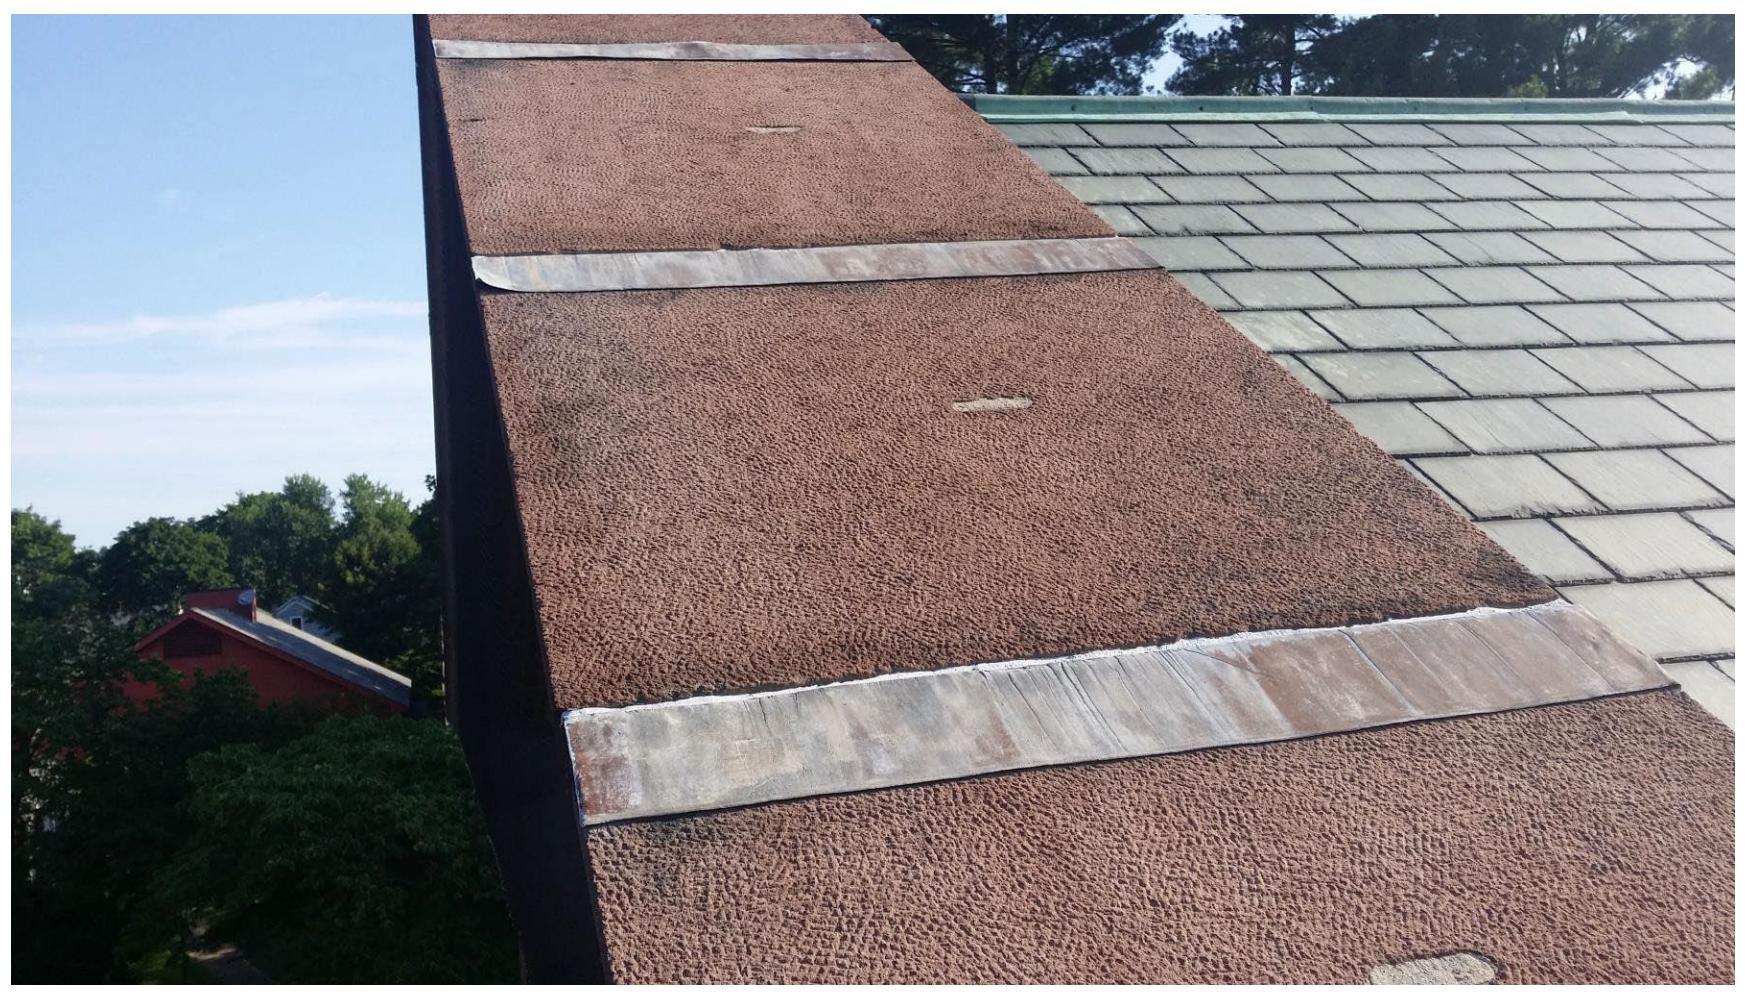
Image 18. The mortar joints where the brownstone coping slabs are joined are covered by a sheet lead detail. The sheet lead is cut into and caulked in a reglet detail. These joints should be monitored biannually and recaulked whenever necessary.

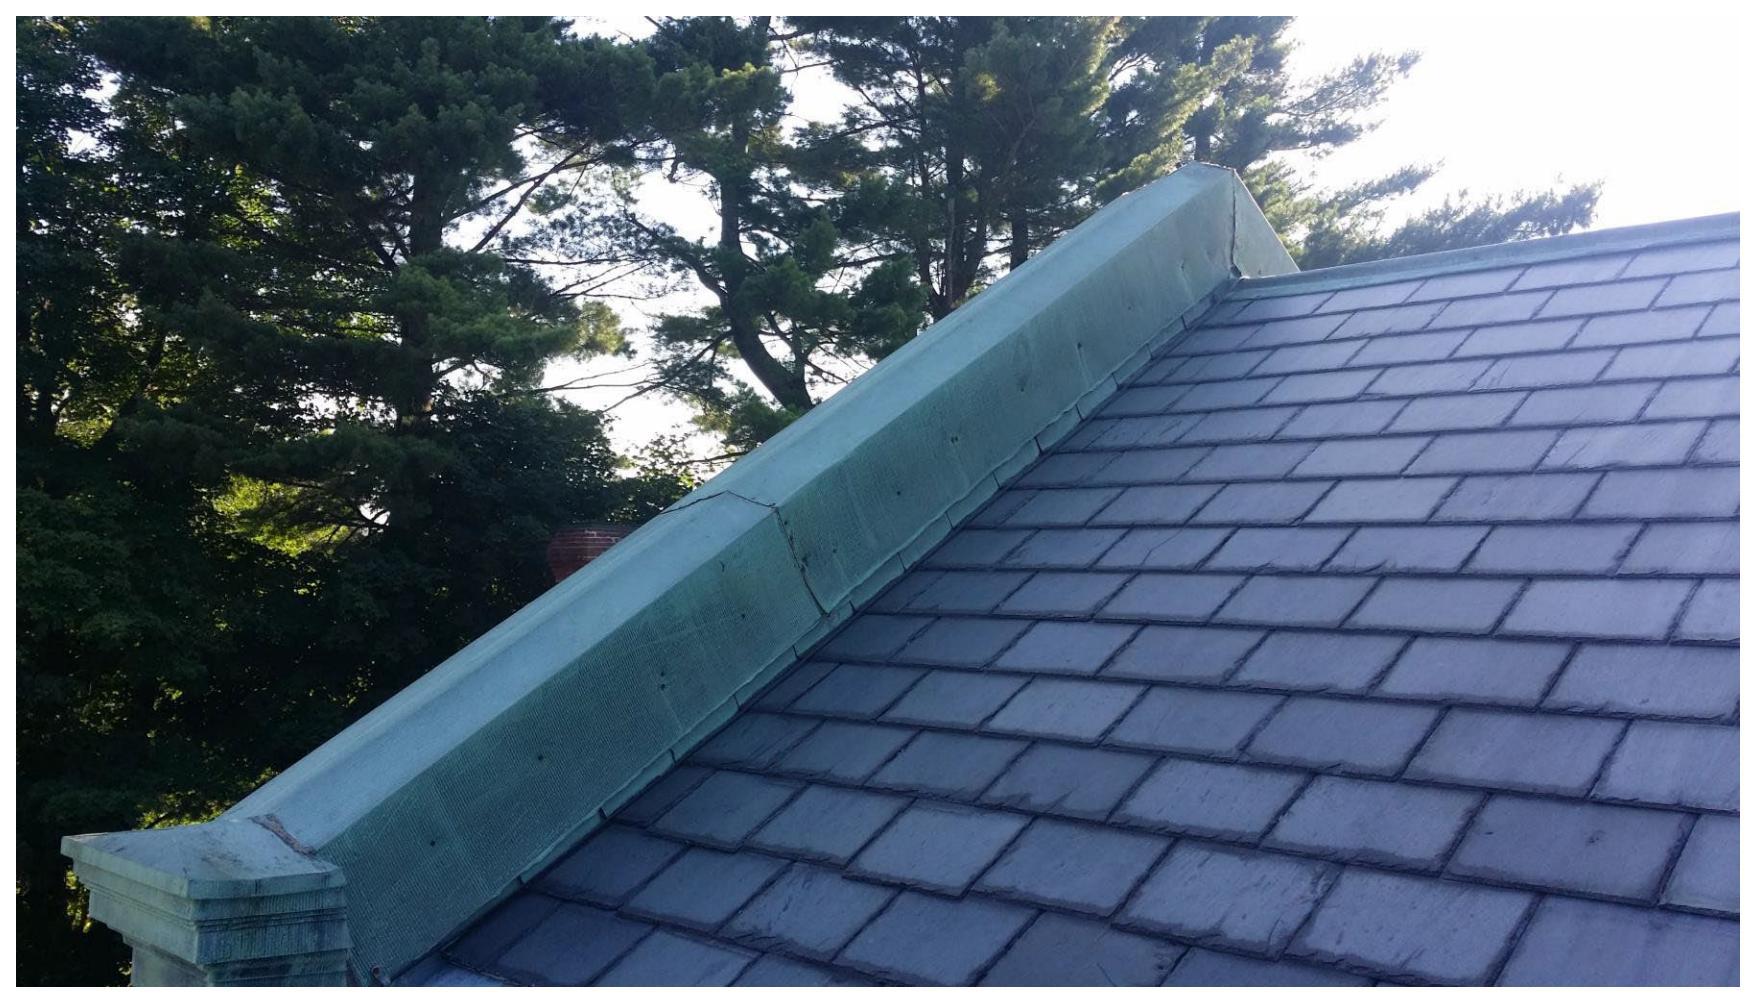
Image 20. The copper copping at the rakes of the roof has weathered nicely and continues to perform well.

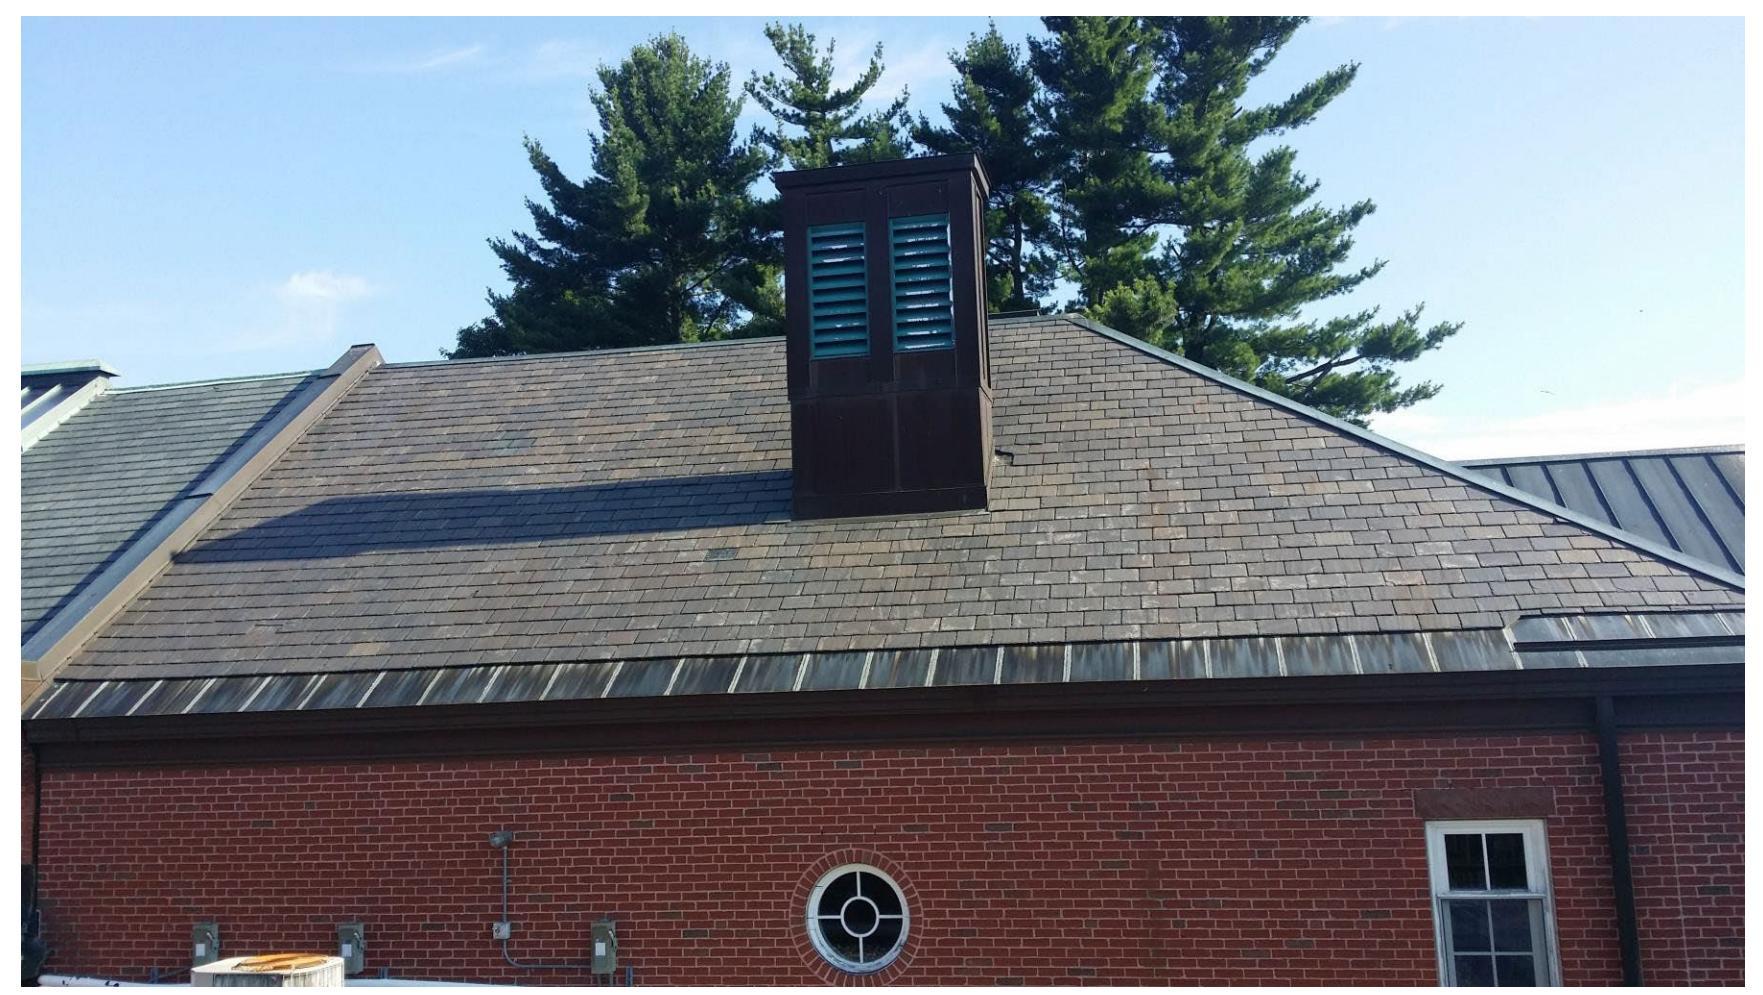
Image 24. A pair of "chimneys" in the rear wing roof are comprised of copper sheet metal and performing well. The copper snow pans and sheet metal cornice also appear to be in good serviceable condition.

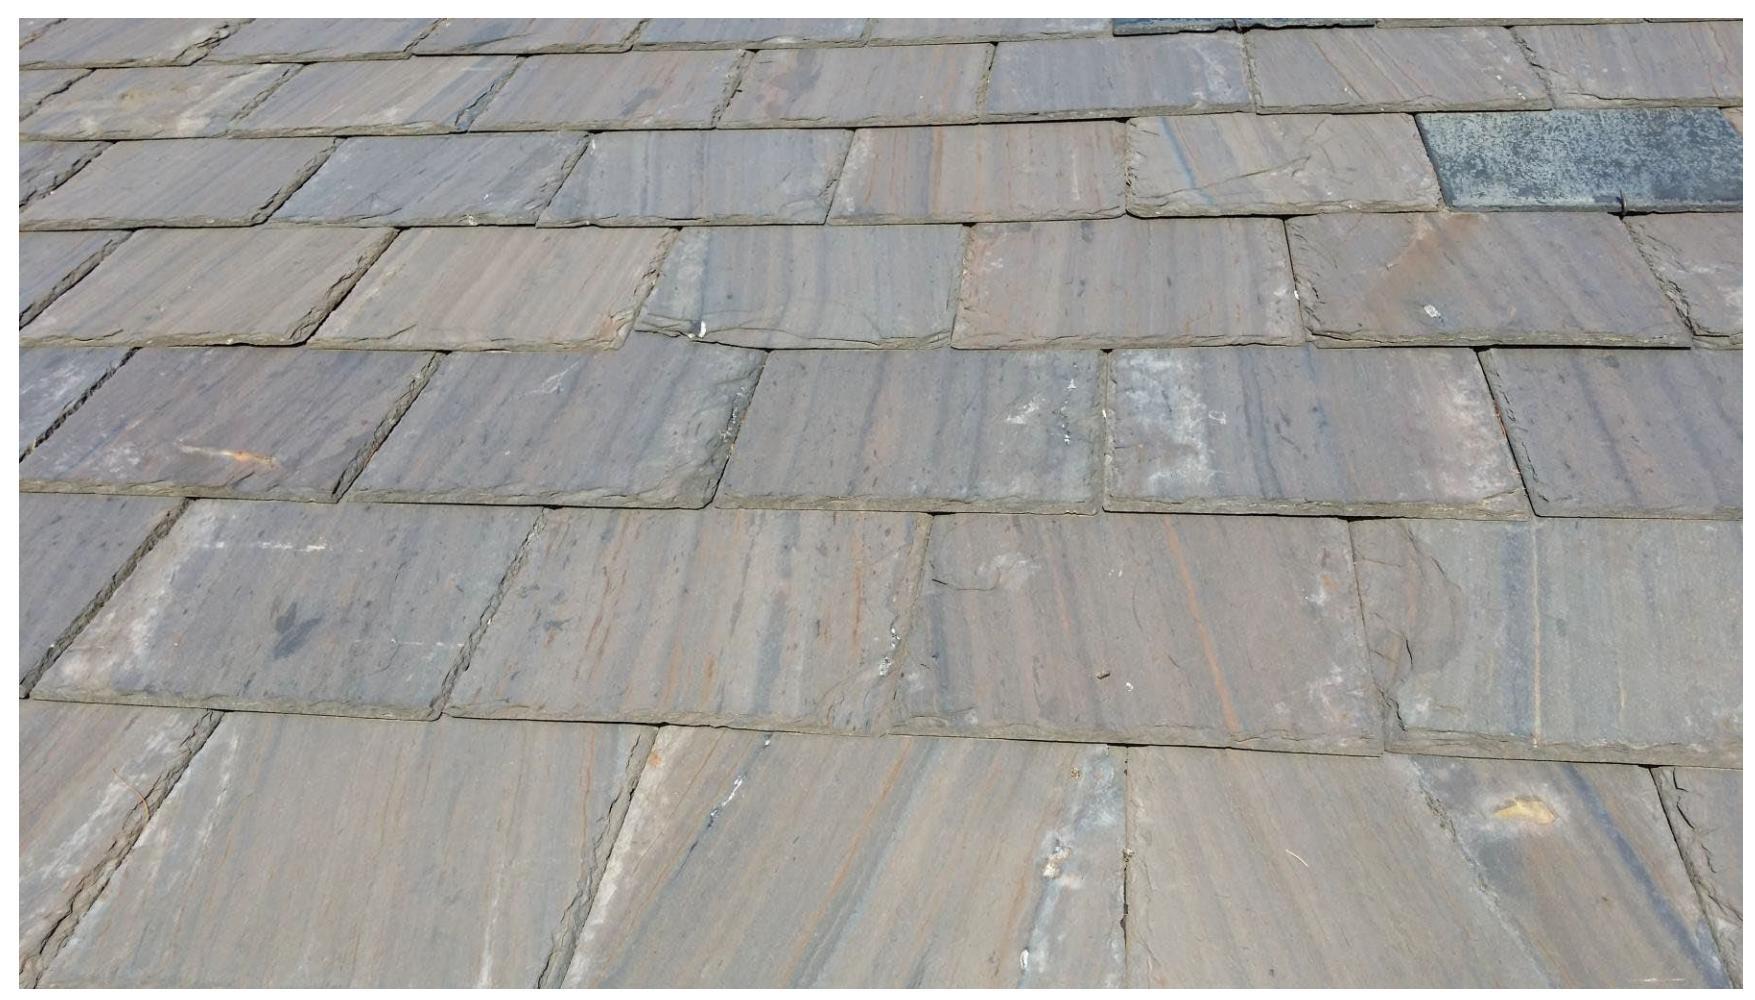
Image 25. The new wing and addition are covered with slate identified in 1998 documents as Vermont Structural "Winchester Black" slate. The slate is characterized by varying strata of dark gray shades (sometimes called "tiger stripe") and were machine punched at the quarry. The slate tiles are 16" long and 10" wide. All are nominally 3/16" to ¼" thick. Vermont black slate is categorized as ASTM grade S1 and good for 150 years or more.

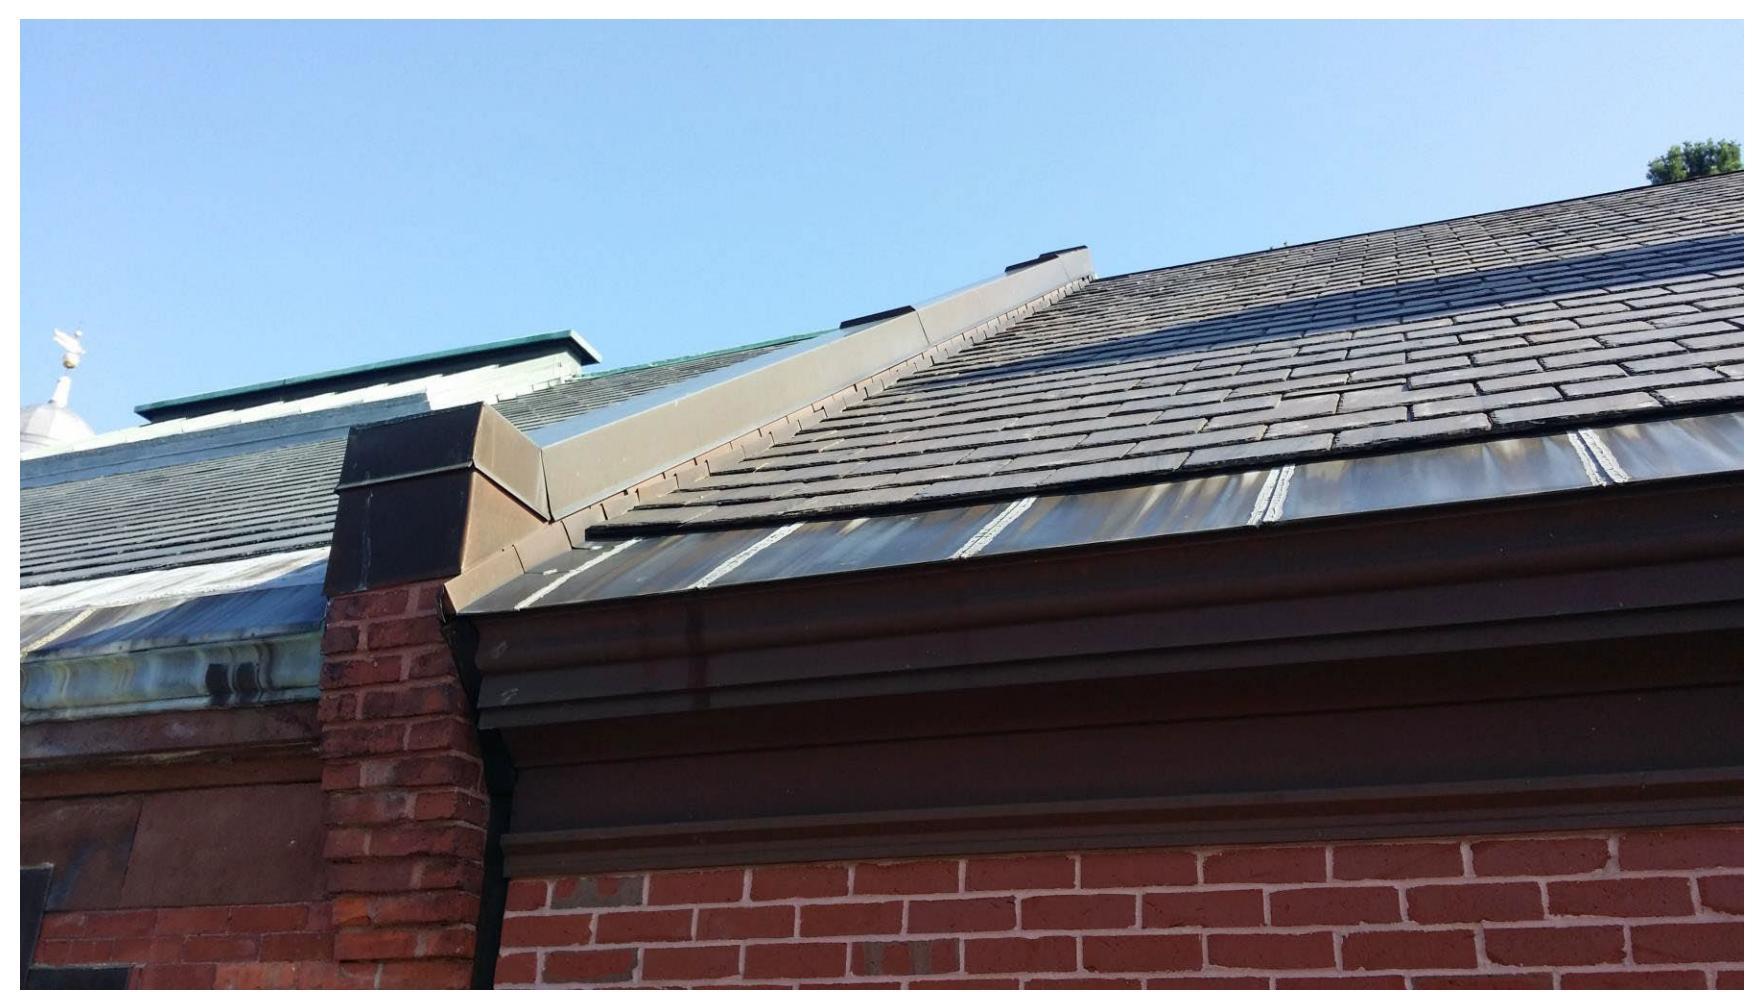
Image 29. This sidewall detail, where the 1999 addition meets the original, main block of the library, is detailed in Addendum H. While no known water intrusion has occurred here, it is this detail that seems to have been somewhat employed in the area depicted in image # 28.

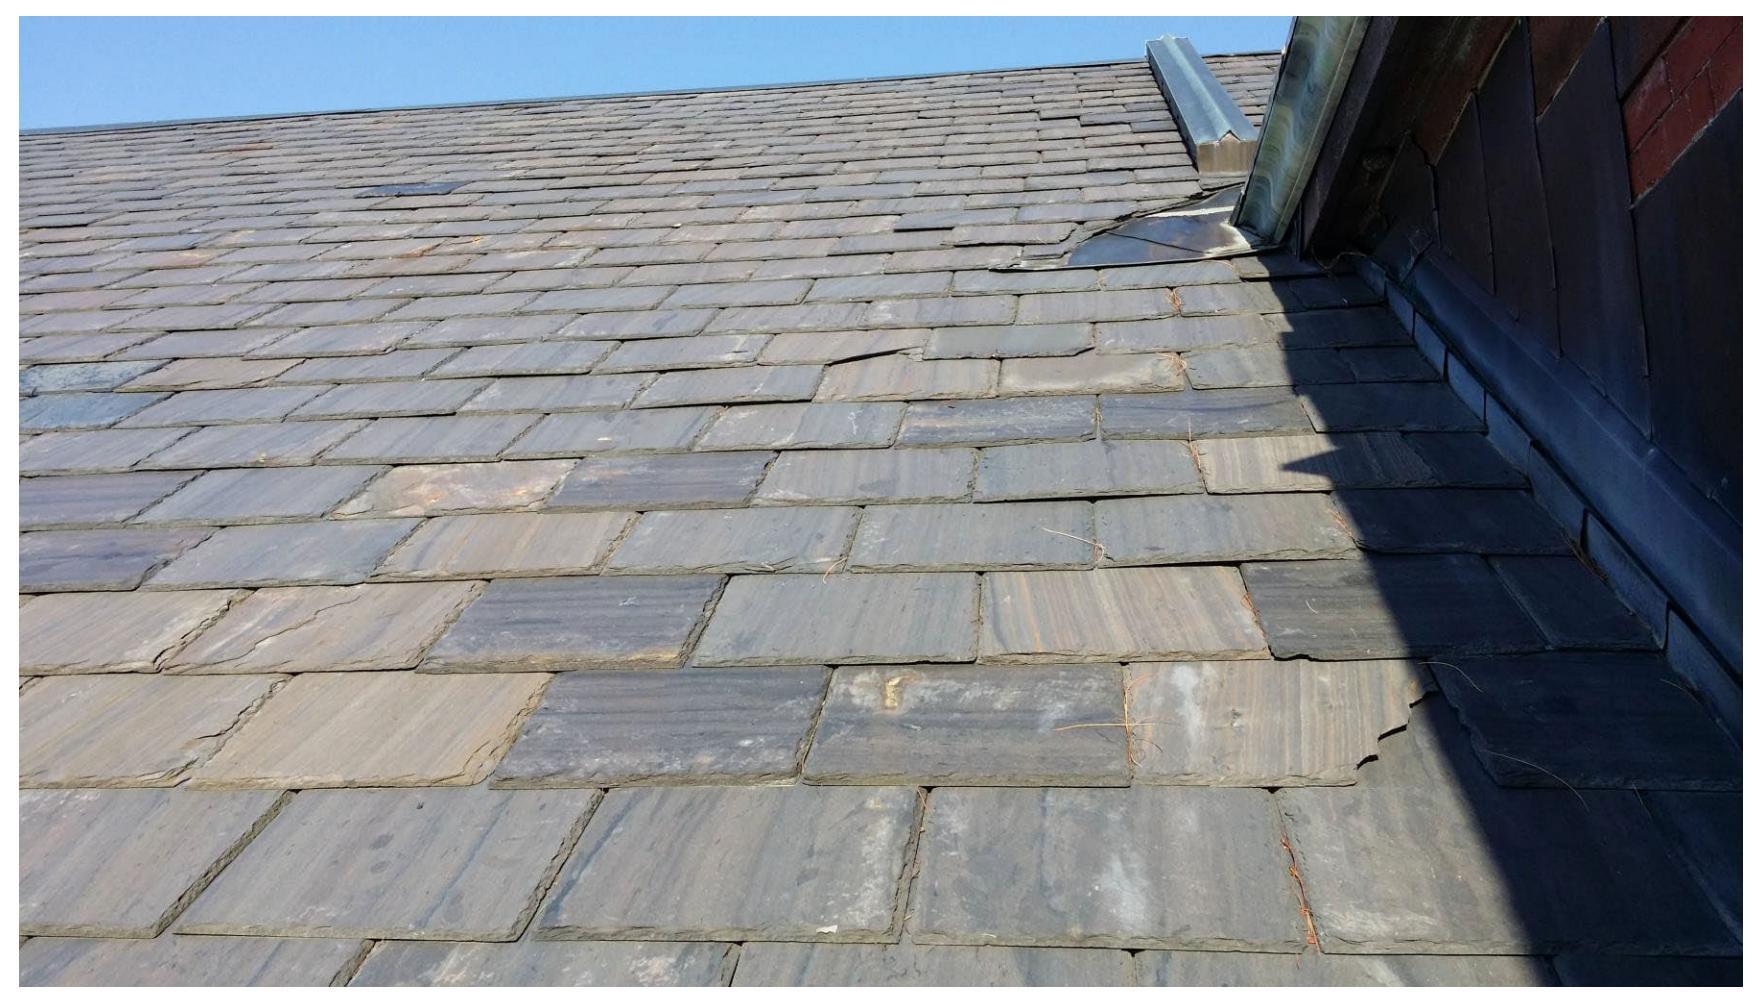
Image 32. Slate repairs should be performed with closely matching, salvaged Monson slate or Vermont black slate. There are two acceptable methods of repair: the "nail-and-bib" technique and the slate hook method. Both are illustrated elsewhere in this report. In each instance, fasteners specified shall be copper or stainless steel and sheet metal bibs shall be copper.

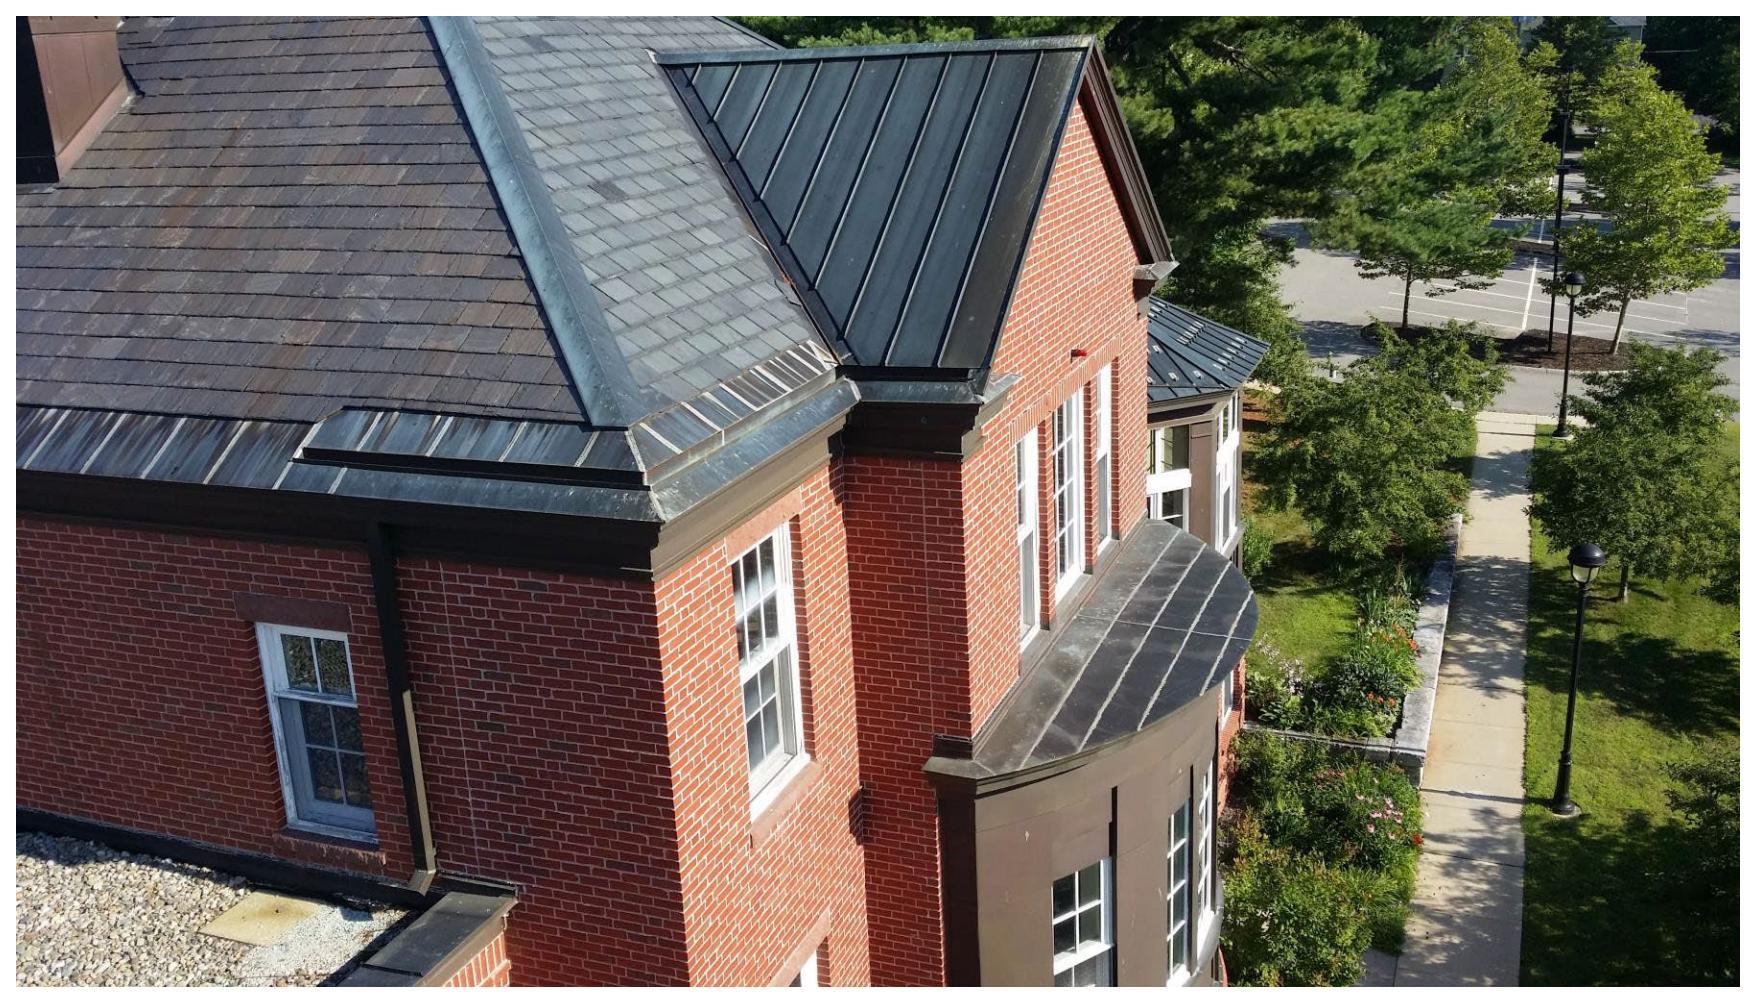
Image 35. The low-sloped and flat roofs of the library are all found in good condition. The low-sloped roofs are clad in copper standing seam at some locations and flat-lock, soldered copper sheet metal in others. A "yankee" gutter helps control roof runoff but, because the outlet and conductor pipe passes through the cornice, special care must be taken to ensure that no blockage occurs.
