Assessment of Roof Conditions

Town of Lancaster

Thayer Memorial Library and the Town Community Center

August 6, 2015

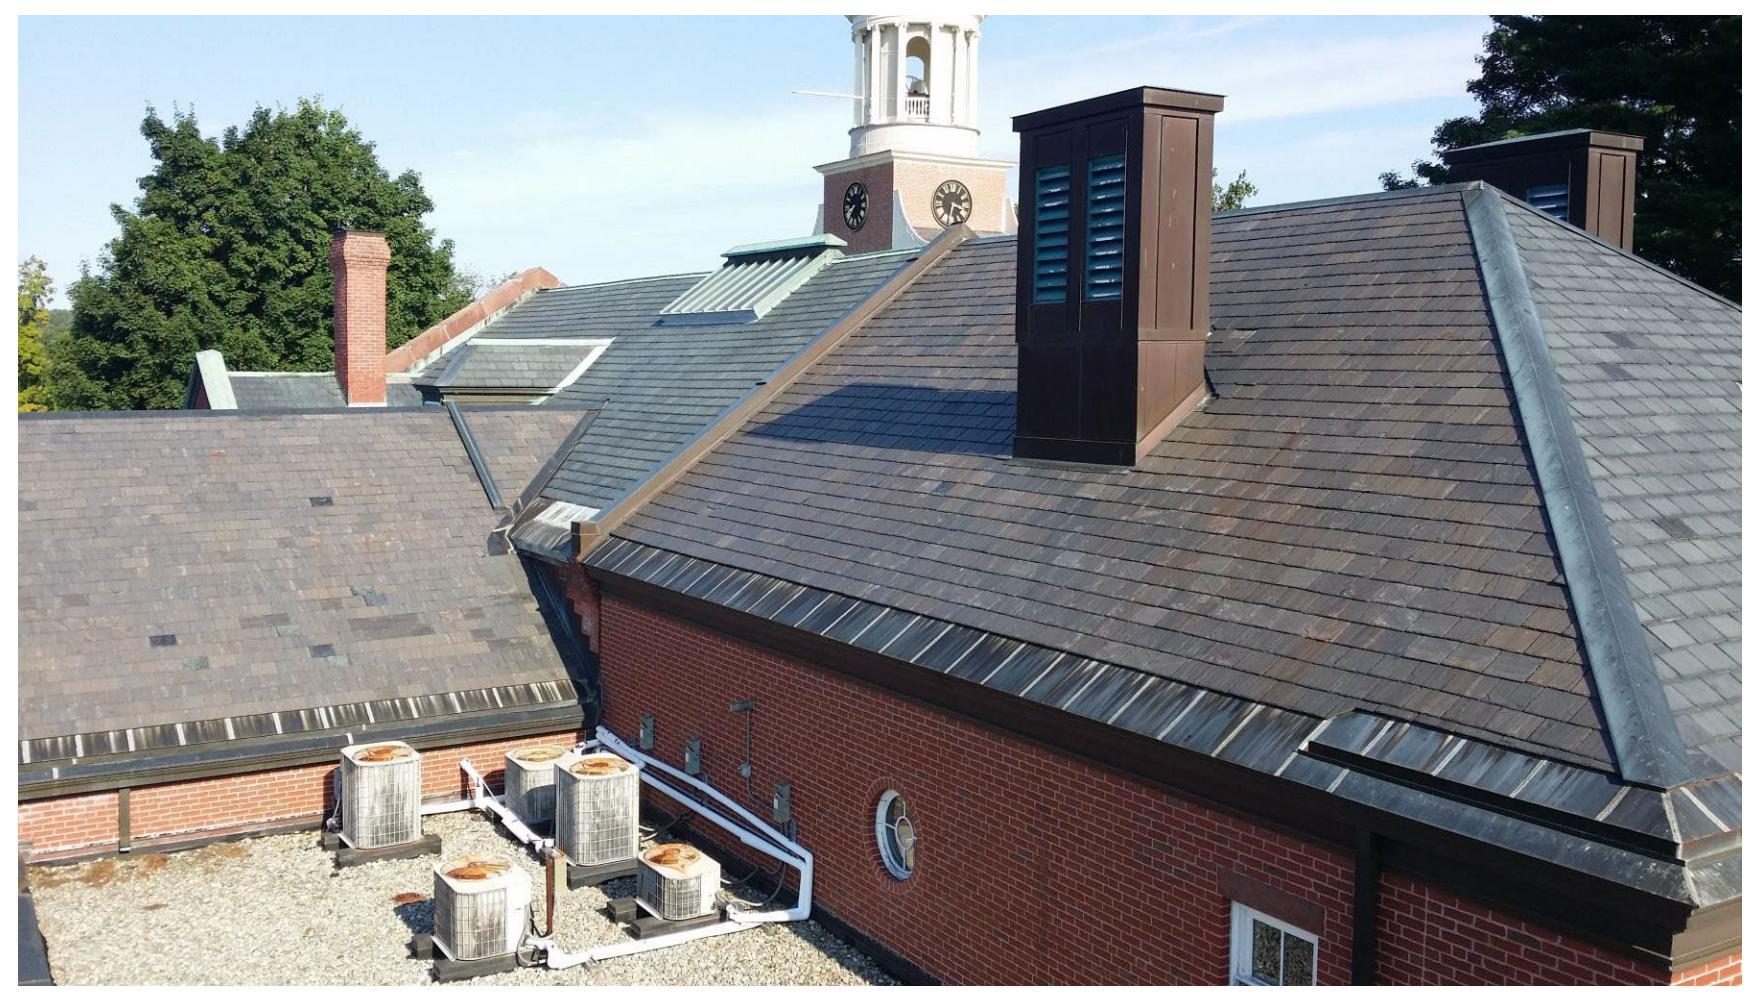
Image 36. A broad view of the roofing at the rear of the library complex.

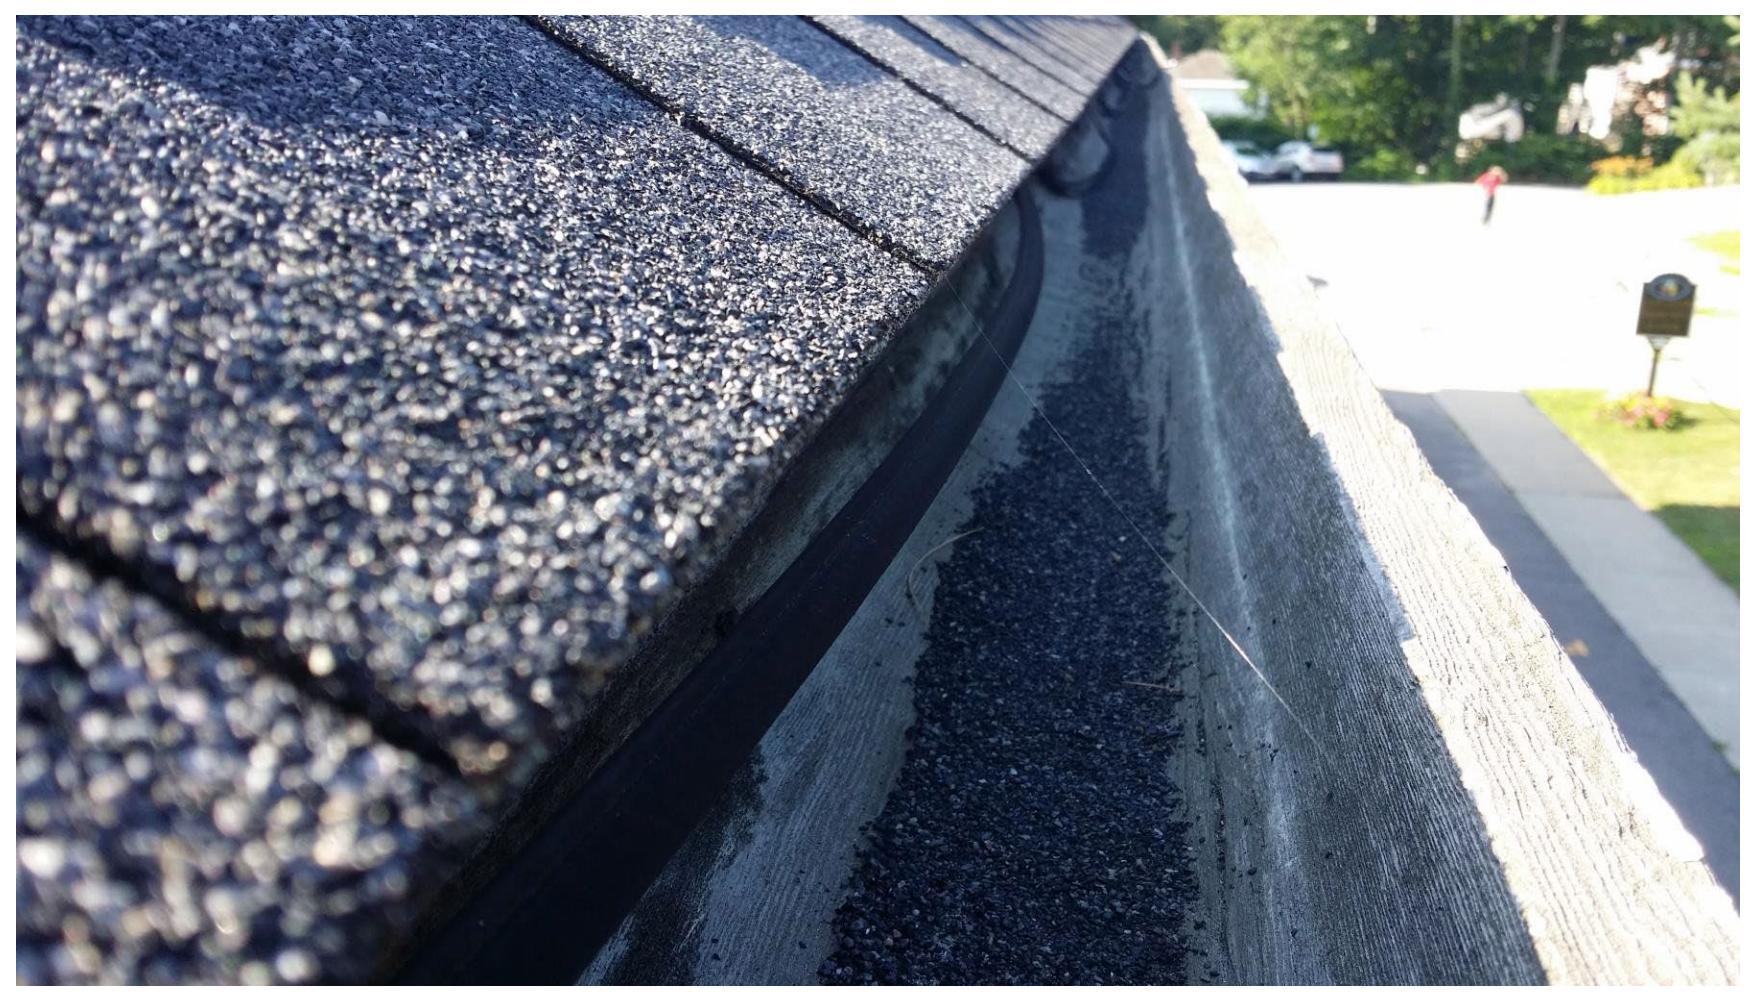
Image 38. Metal wire strainers should be installed at each outlet and checked biannually. If the strainers are maintained and allowed to perform their intended function cleaning the gutters will be limited to the troughs. Otherwise, leaves and debris will find their way into and clog the conductor pipes. If not maintained, gutters will do more harm than good as they require a commitment to maintenance of the system.

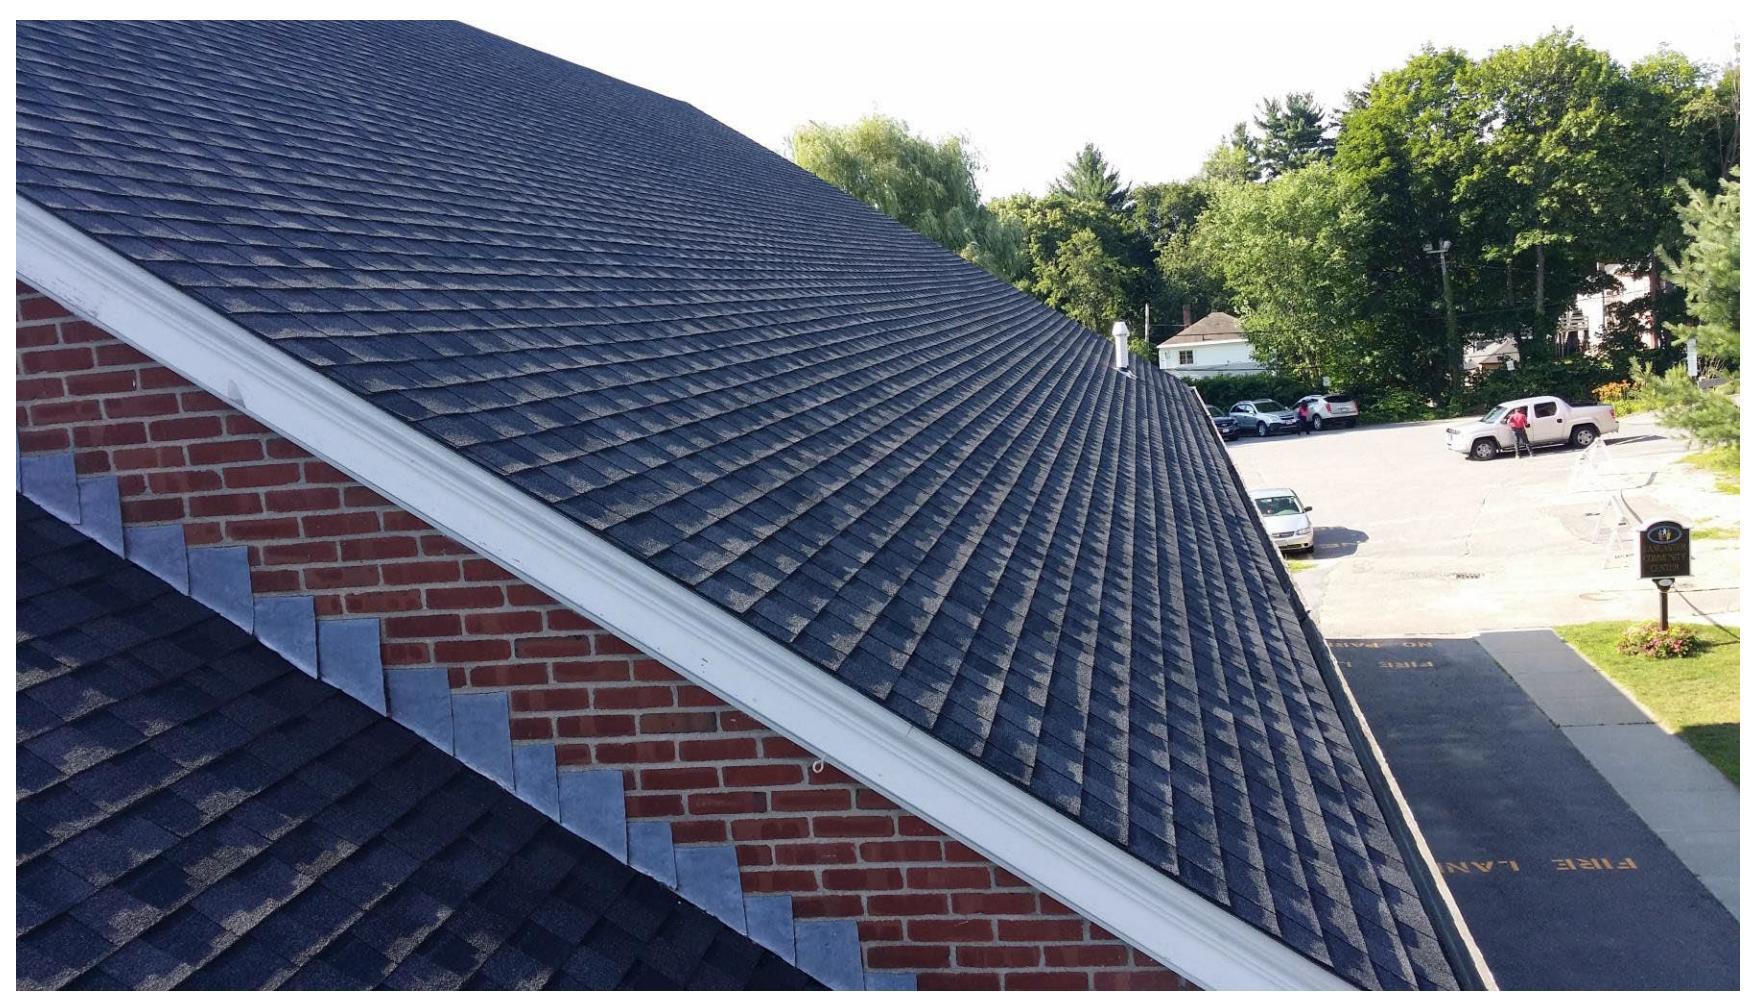
Image 39. At the community center, flashing assemblies at sidewalls and protrusions are aluminum with a sheet lead counter-flashing. All are found to be in good serviceable condition.

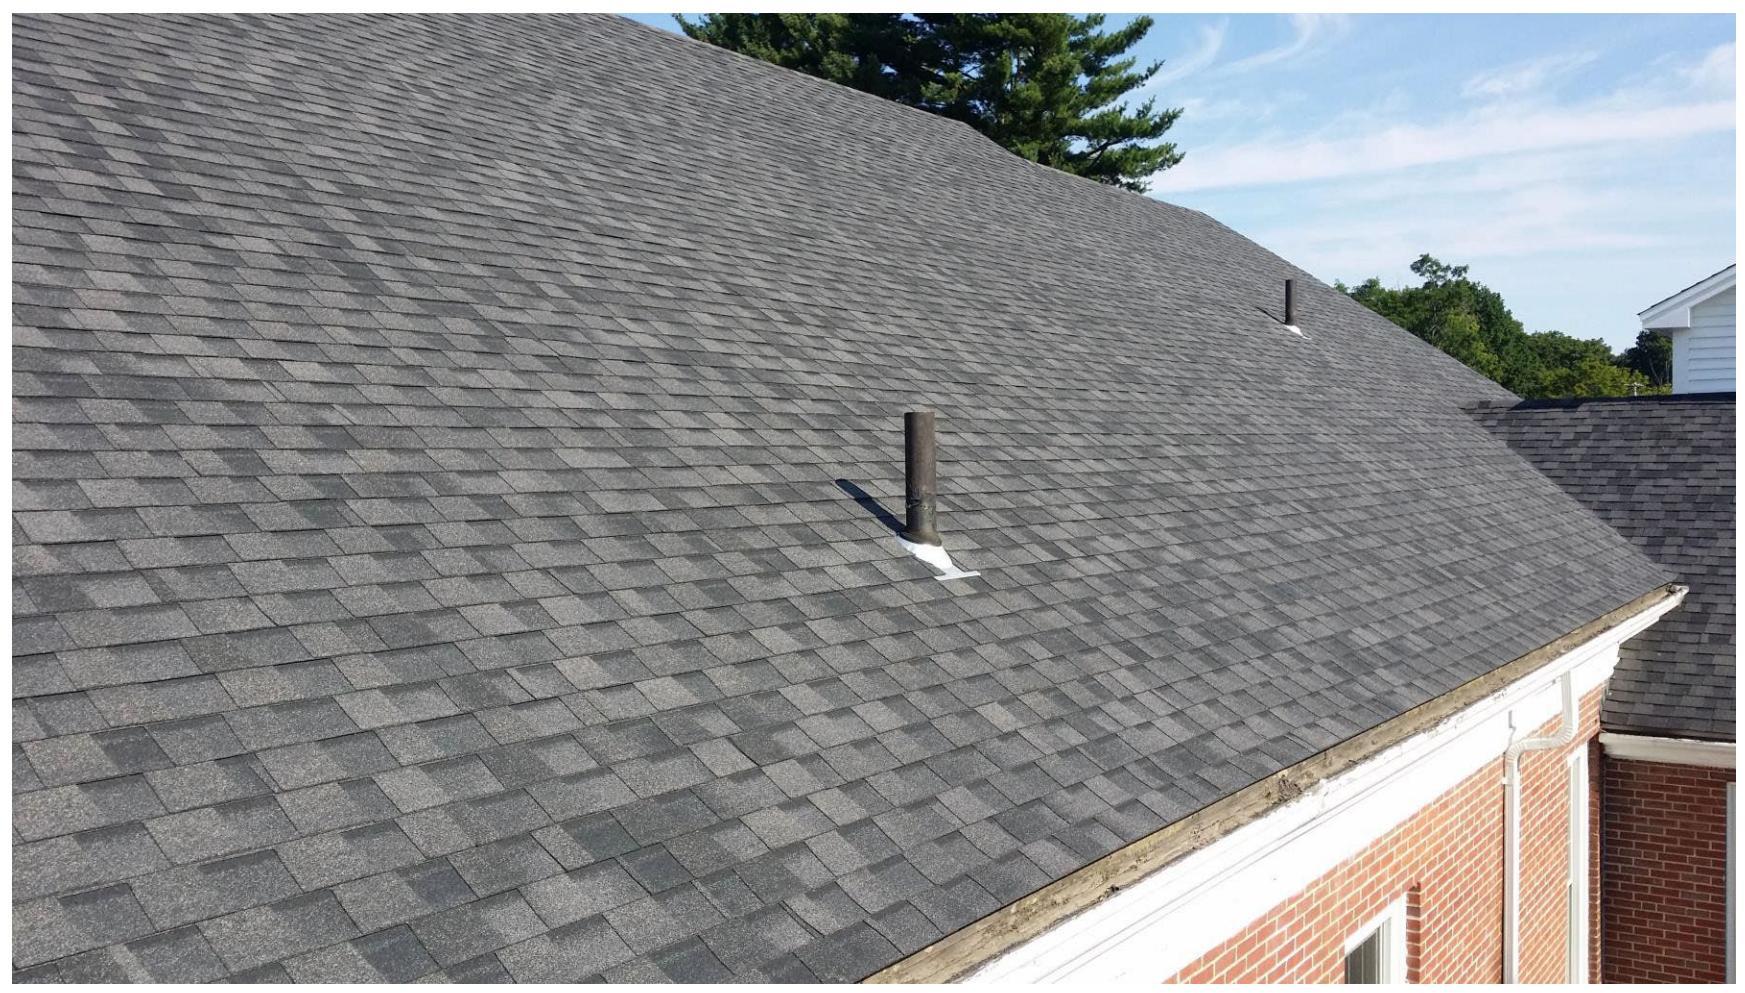
Image 41. The community center is covered in asphalt shingles. They are designed to mimic the texture and appearance of wood shingles and commonly called "architectural shingles."

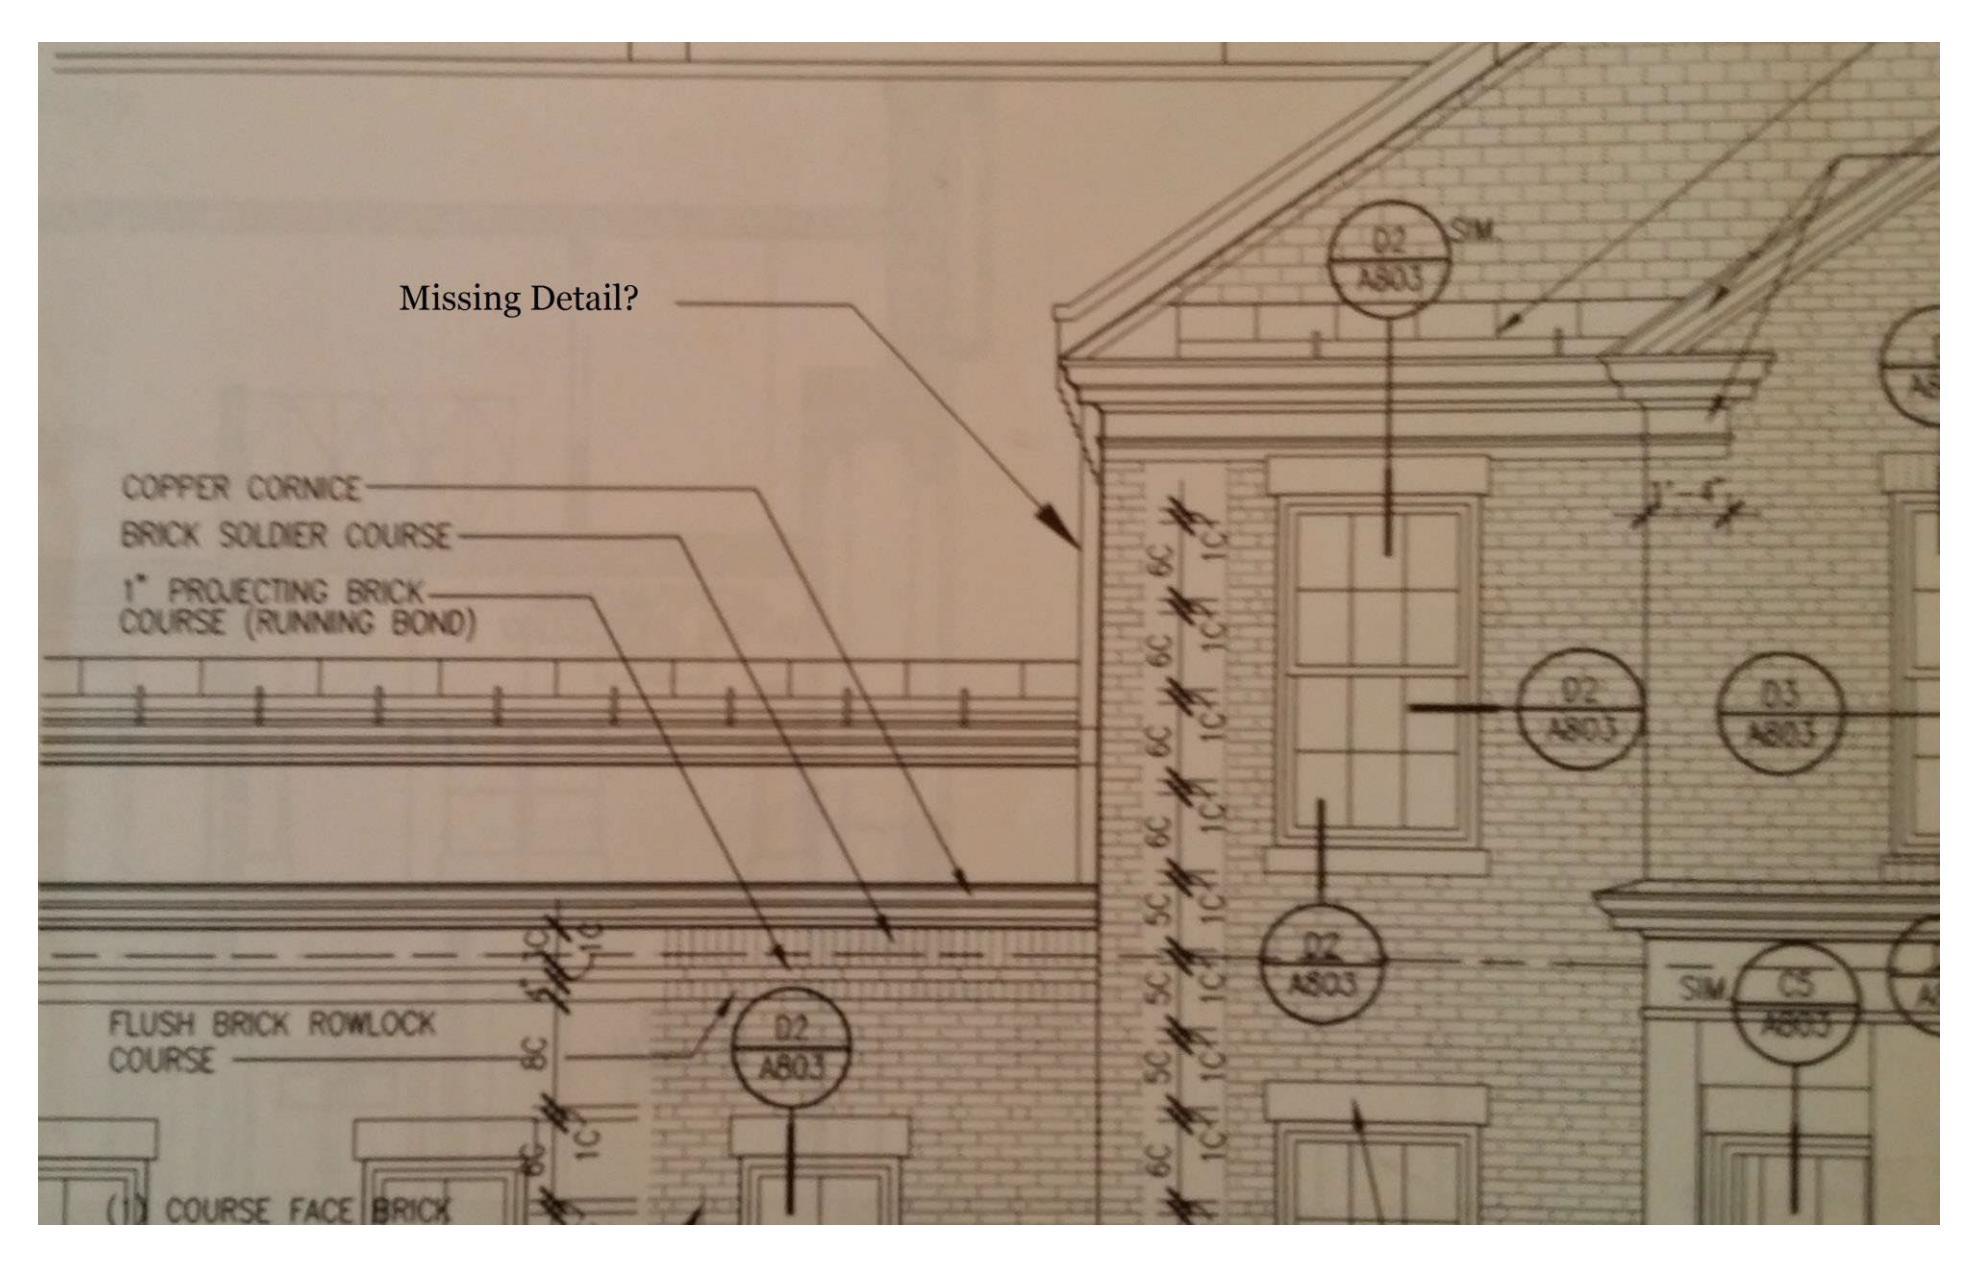
Bid documents - A202 detail 3 dated 21 Apr 1998 – An arrow points to the area in question, or a conductor pipe, but there's no note.

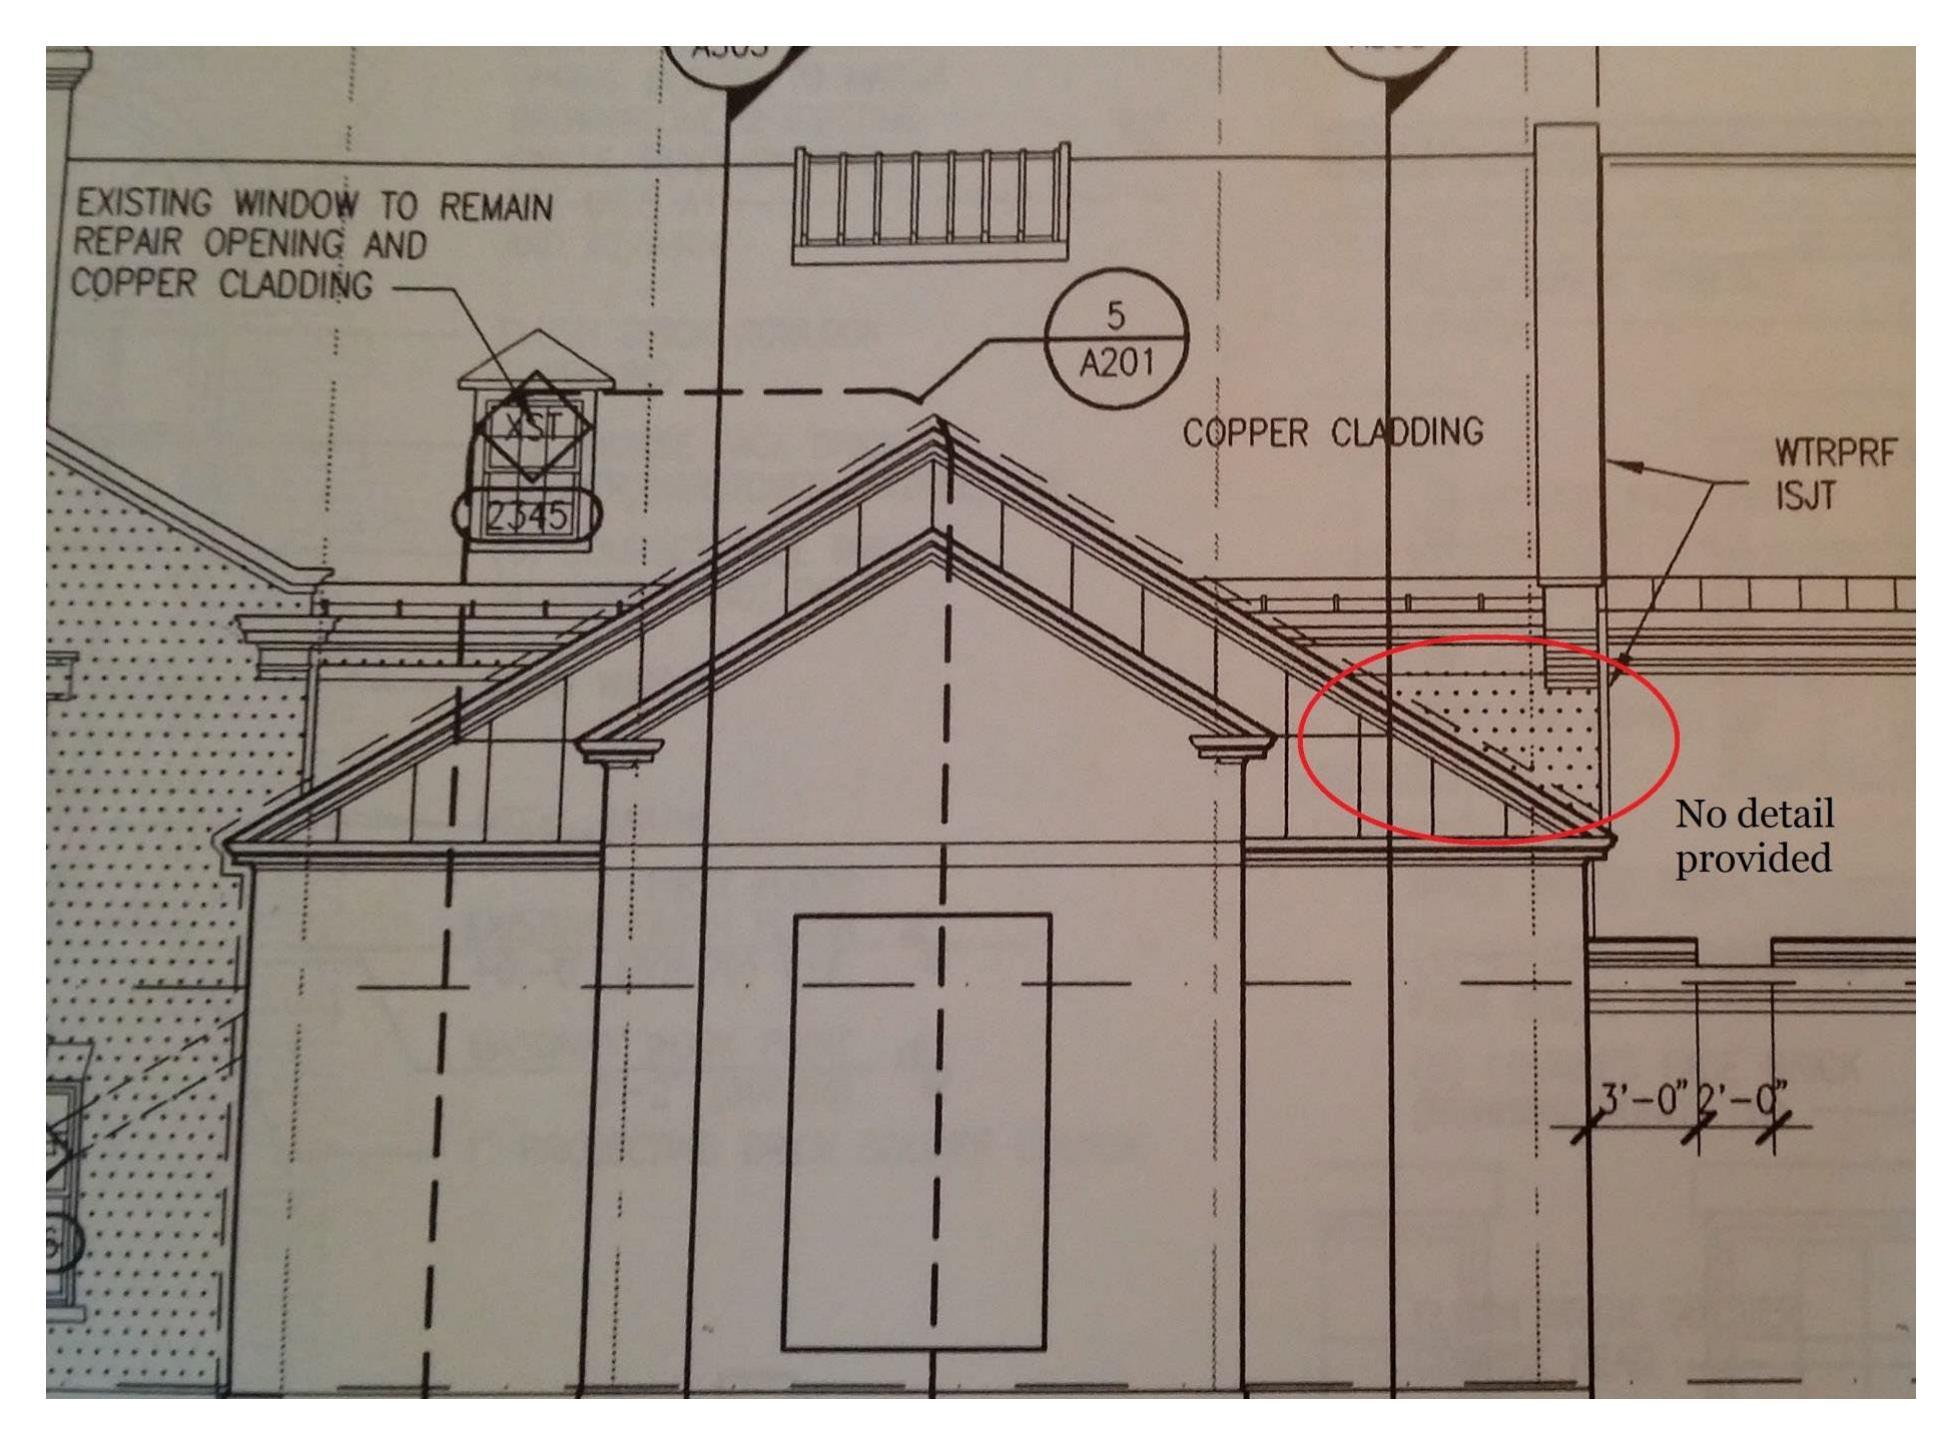
Bid documents - A202 detail 4 dated 21 Apr 1998 – No details or notes pertaining to the area circled in red.

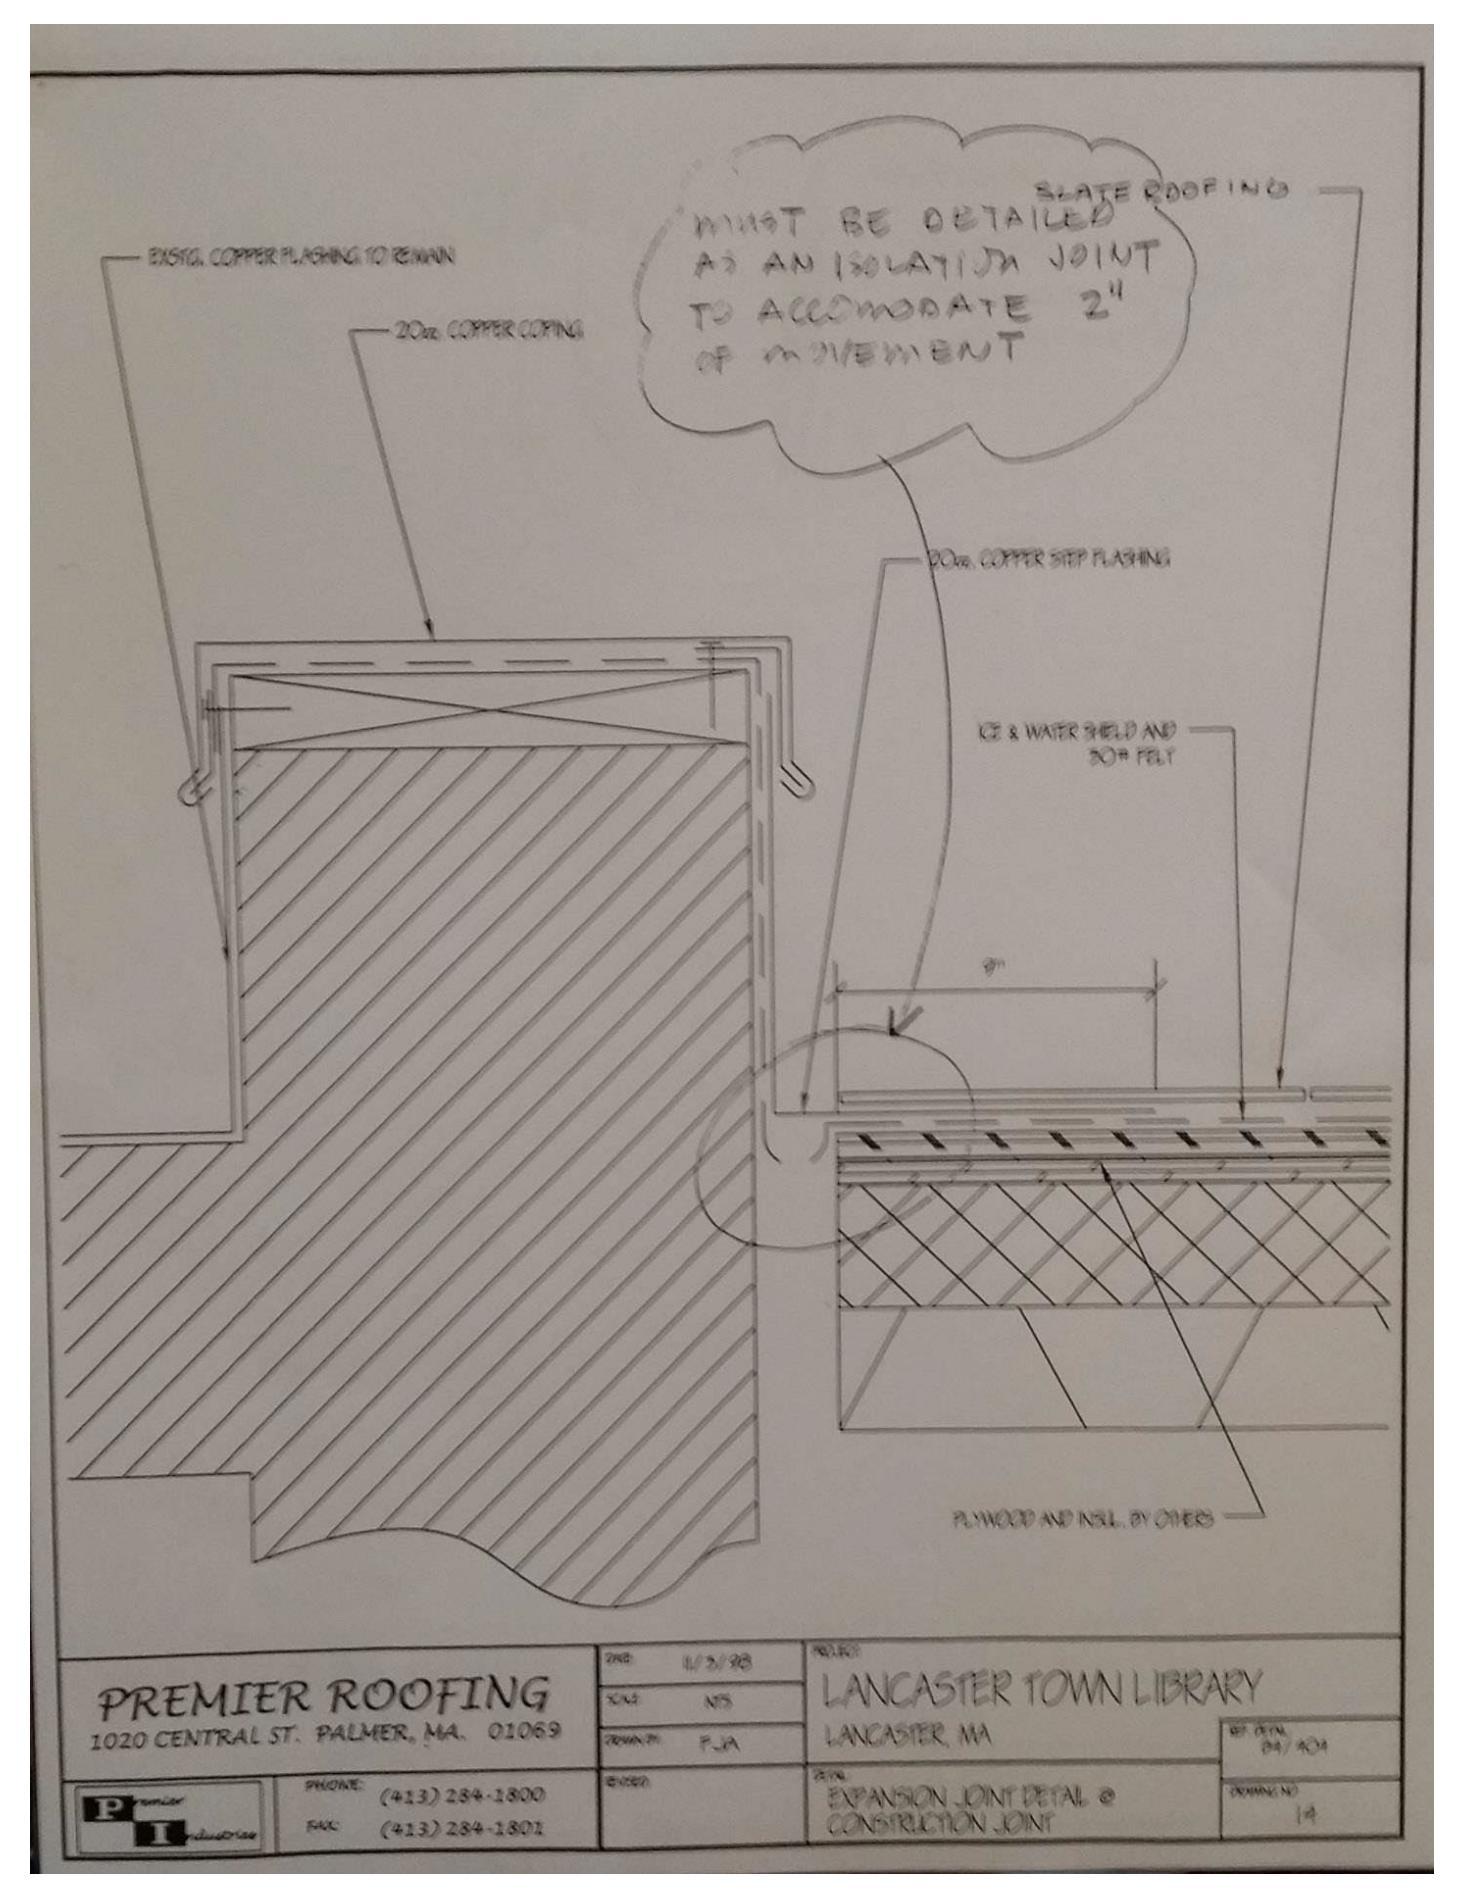
Shop drawing submitted 3 Nov 1998 - Reflects detail shown in bid documents

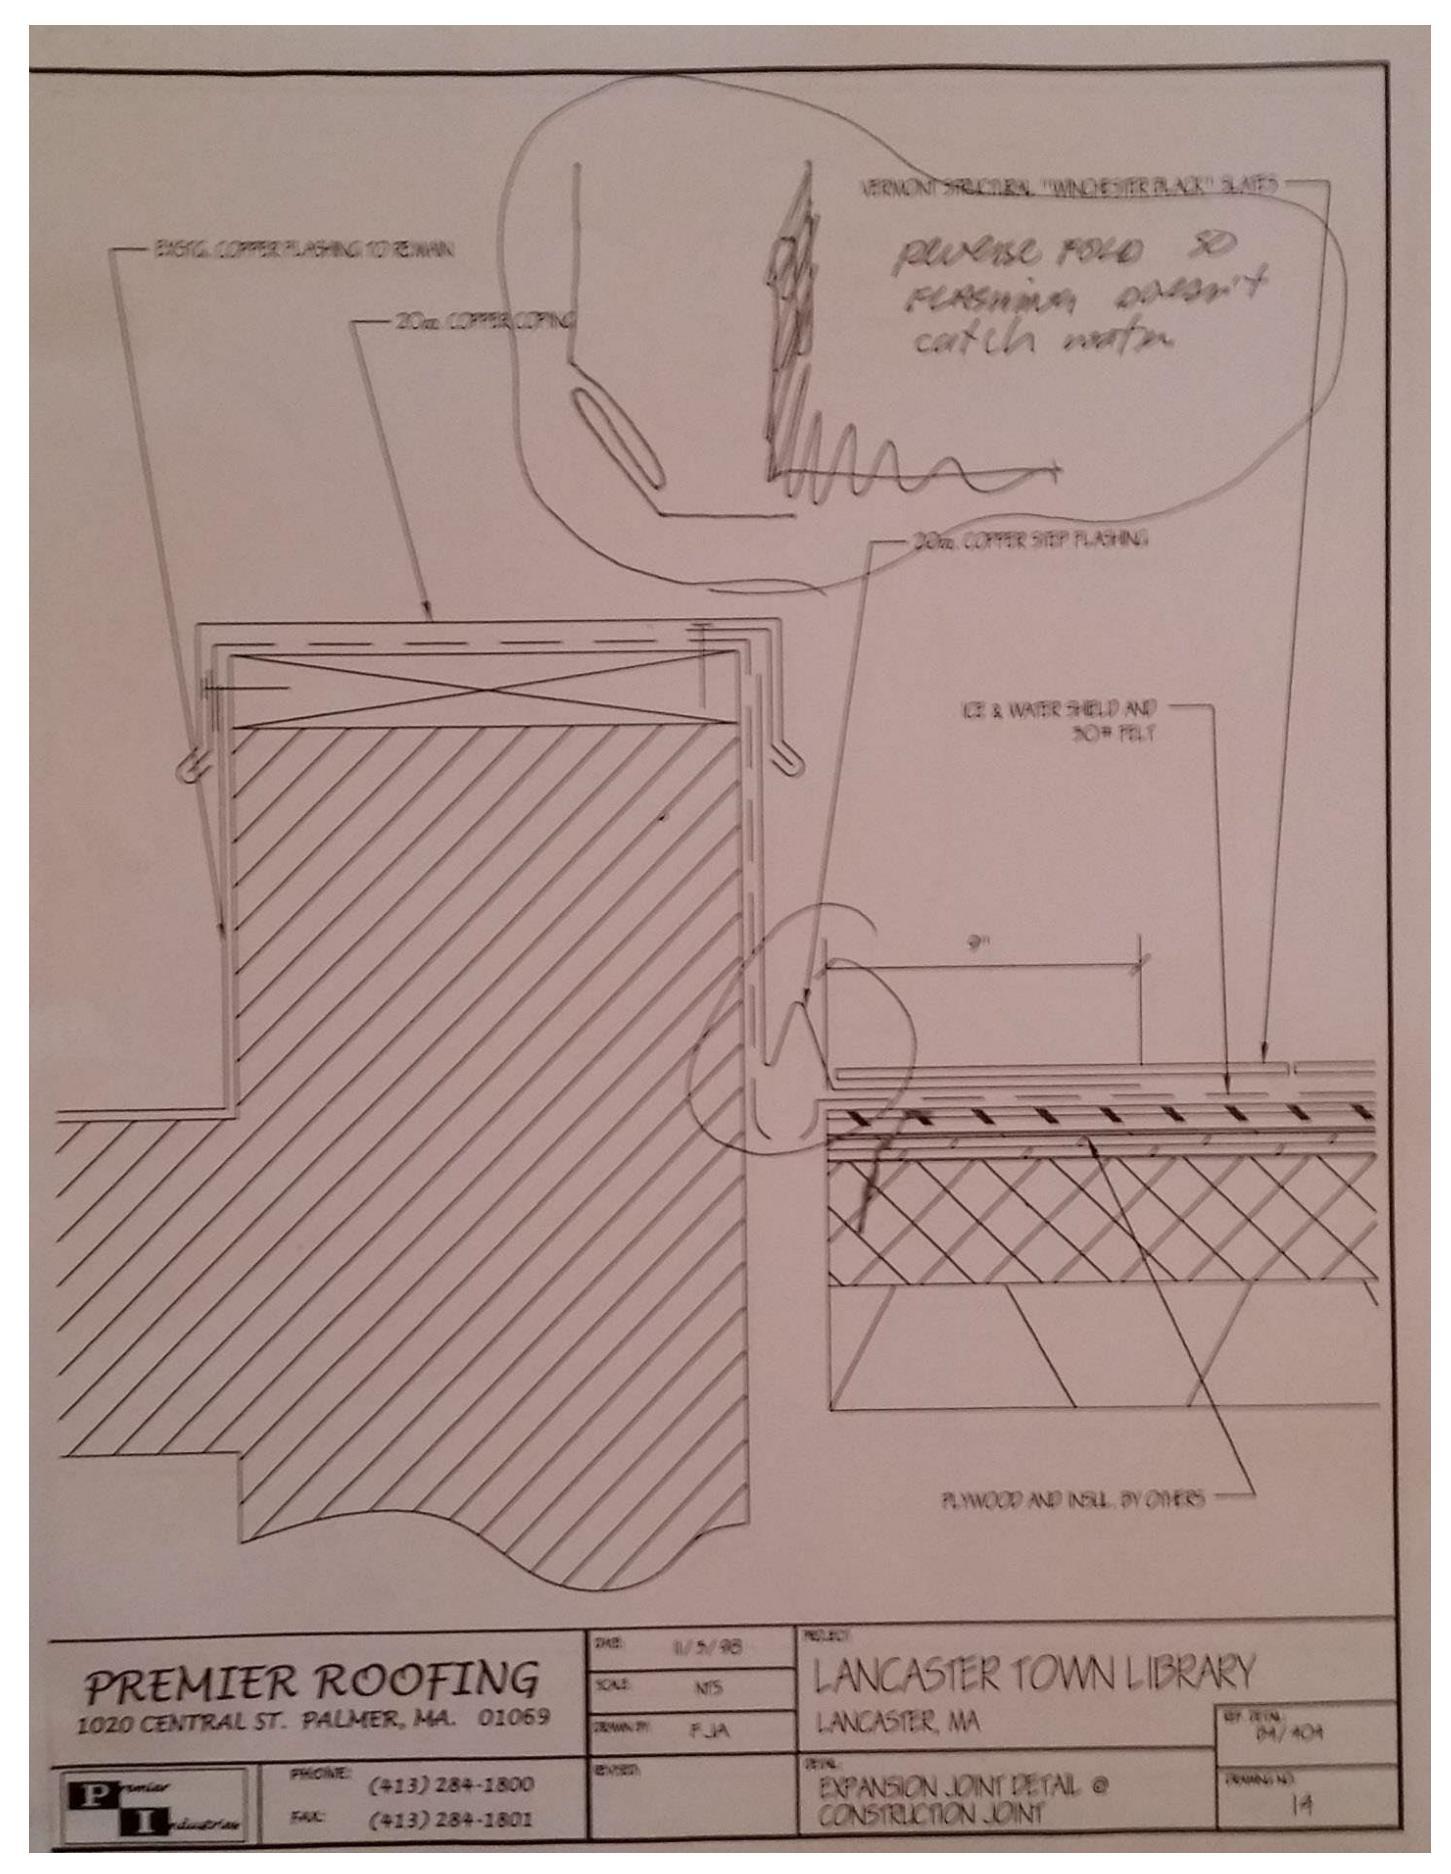
Shop drawing also dated 3 Nov 1998 – Shows the detail as built. Handwritten note says "Reverse fold so flashing doesn't catch water."
